HYBRID / BATTERY CONTROL: HYBRID BATTERY SYSTEM (for M20A-FXS): U115087; Lost Communication with Hybrid Power...

Last Modified: 12-04-2024	6.11:8.1.0	Doc ID: RM100000029A4O				
Model Year Start: 2023	Model: Prius Prime	Prod Date Range: [12/2022 -]				
Title: HYBRID / BATTERY CONTROL: HYBRID BATTERY SYSTEM (for M20A-FXS): U115087; Lost Communication						
with Hybrid Powertrain Control Module (Hybrid/EV Battery Local Bus) Missing Message; 2023 - 2024 MY Prius Prius

DTC	11115087	Lost Communication with Hybrid Powertrain Control Module (Hybrid/EV Battery Local Bus) Missing Message
-----	----------	---

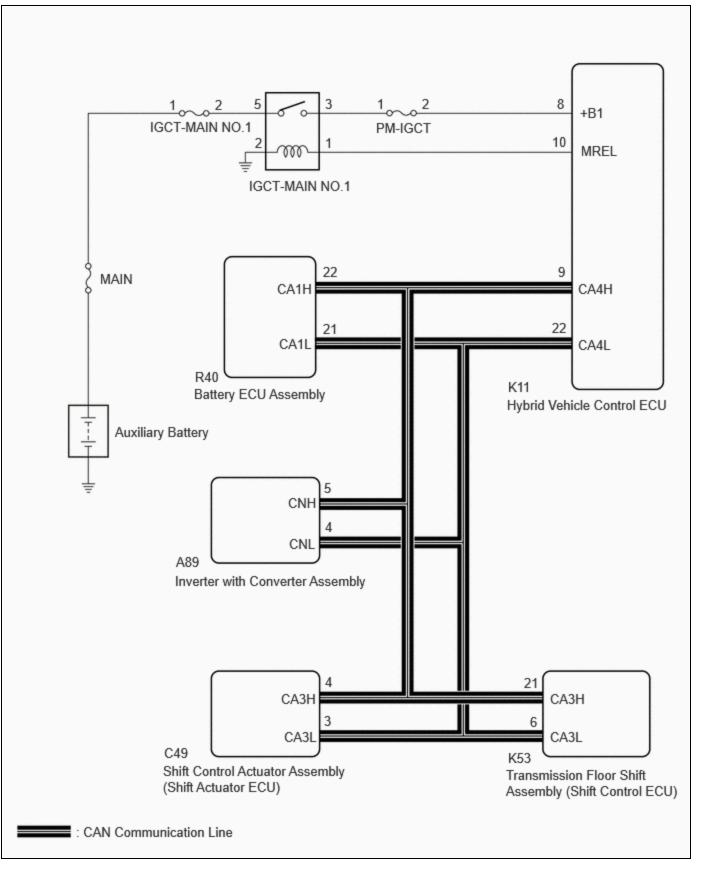
WIRING DIAGRAM

The battery ECU assembly transmits and receives signals via CAN communication to and from the hybrid vehicle control ECU.

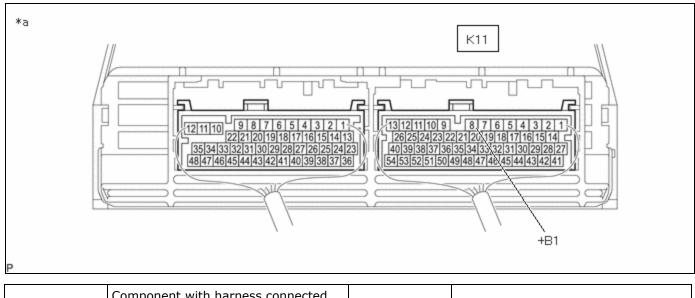
(b) Measure the voltage according to the value(s) in the table below.

* >	Component with harness connected	_	
ď	(Hybrid Vehicle Control ECU)	-	-

TESTER CONNECTION	CONDITION	SPECIFIED CONDITION	RESULT
K11-8 (+B1) - Body ground	Ignition switch ON	11 to 14 V	V
