Last Modified: 12-04-2024	6.11:8.1.0	Doc ID: RM1000000291XO
Model Year Start: 2023	Model: Prius Prime	Prod Date Range: [12/2022 -]
Title: HYBRID / BATTERY CONTROL: HYBRID CONTROL SYSTEM (for M20A-FXS): U117687; Lost Communication with Gear Shift Control Module "A" (Powertrain Bus) Missing Message; 2023 - 2024 MY Prius Prius Prime [12/2022 -]

DTC	U117687	Lost Communication with Gear Shift Control Module "A" (Powertrain Bus) Missing Message
------------	----------------	---

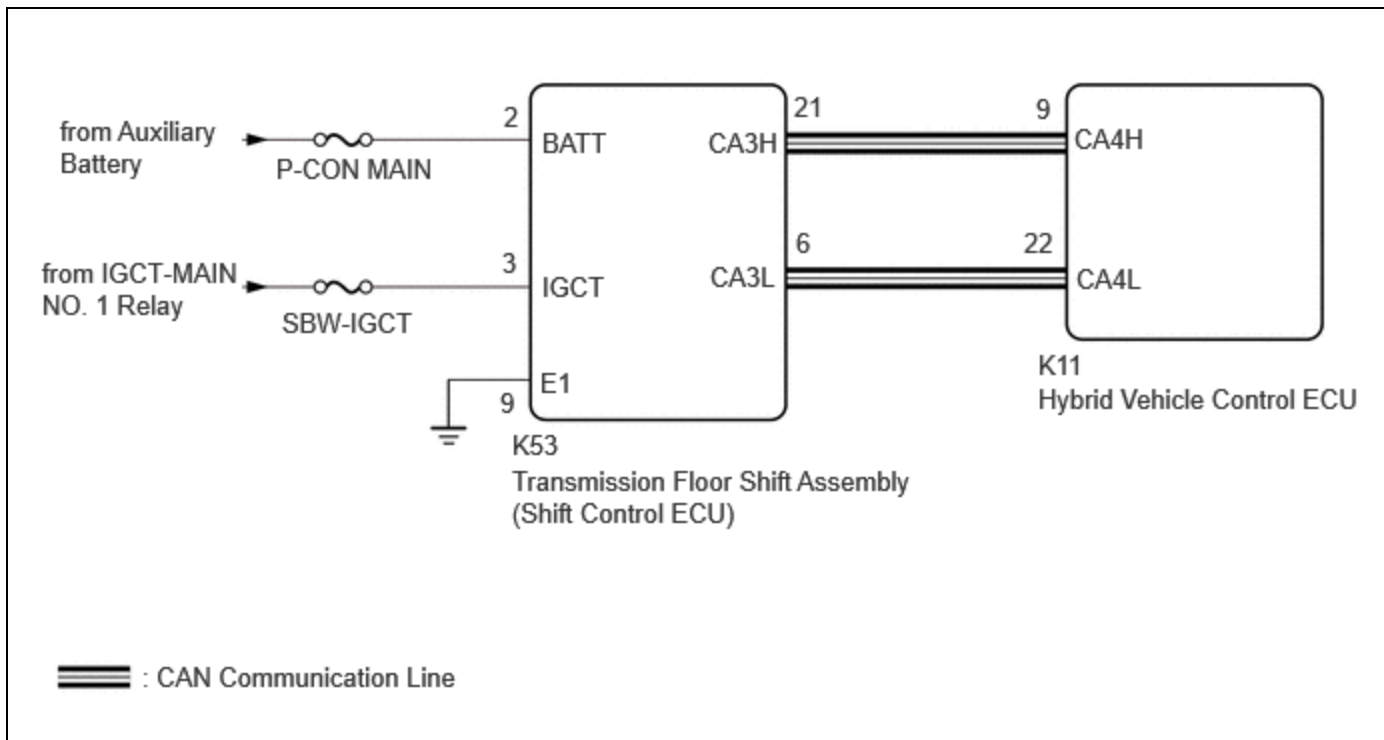
WIRING DIAGRAM

The hybrid vehicle control ECU transmits and receives signals via CAN communication to and from the shift control ECU.
