Last Modified: 12-04-2024	6.11:8.1.0	Doc ID: RM10000002BI2J
Model Year Start: 2023	Model: Prius Prime	Prod Date Range: [03/2023 -]
Title: HYBRID / BATTERY CONTROL: HYBRID CONTROL SYSTEM (for PHEV Model): P0C7396; Motor Electronics Coolant Pump "A" Component Internal Failure; 2023 - 2024 MY Prius Prime [03/2023 -]

DTC	P0C7396	Motor Electronics Coolant Pump "A" Component Internal Failure
------------	----------------	--

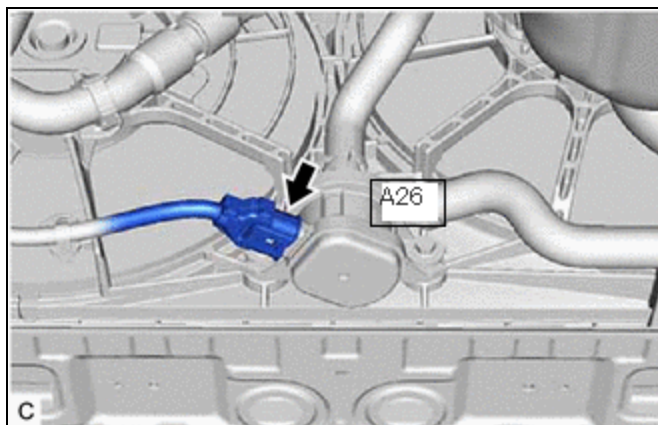
CHECK CONNECTOR CONNECTION CONDITION (INVERTER WATER PUMP ASSEMBLY CONNECTOR)

The connector is connected securely, the terminals are not deformed or corroded and there are no contact problems.

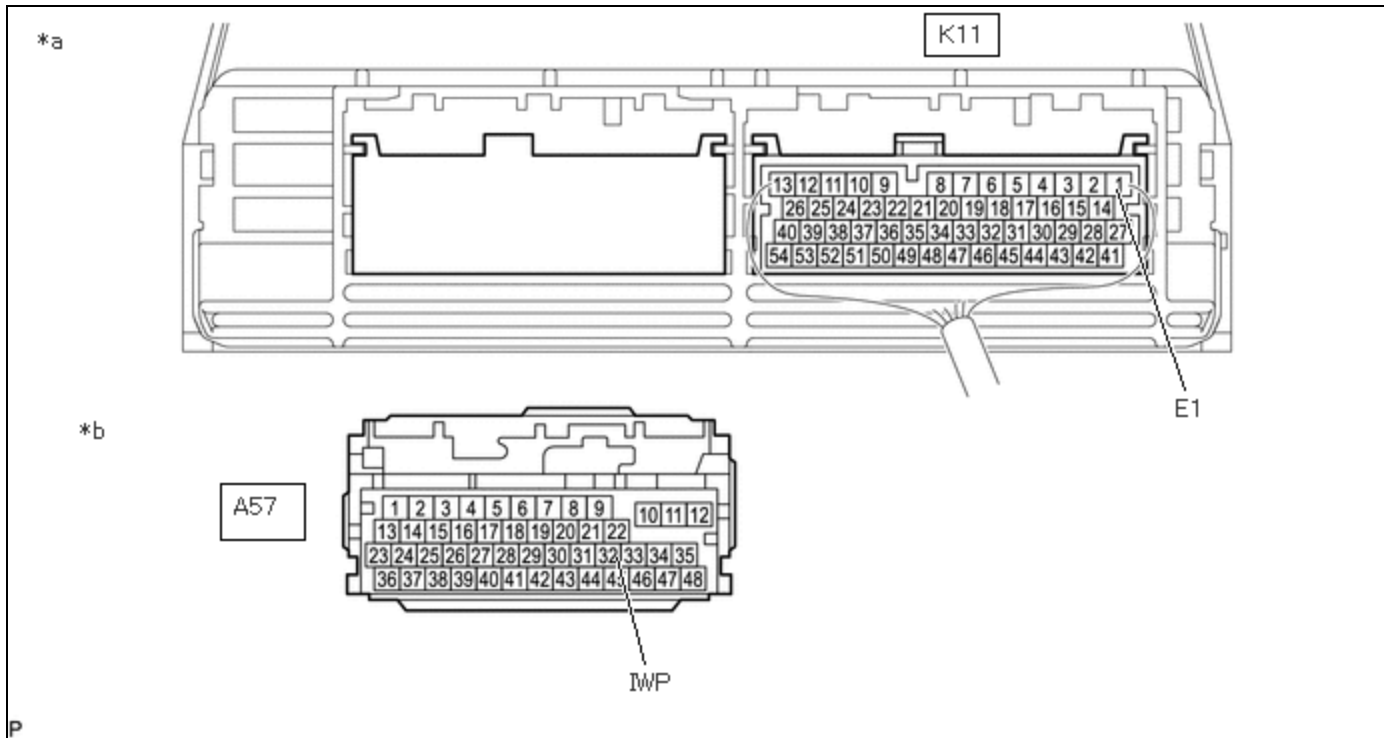
Procedure1

- (c) Measure the voltage according to the value(s) in the table below.

*a	Component with harness connected (Hybrid Vehicle Control ECU)	*b	Front view of wire harness connector (to Hybrid Vehicle Control ECU)
----	---	----	--

TESTER CONNECTION	CONDITION	SPECIFIED CONDITION	RESULT
A57-32 (IWP) - K11-1 (E1)	Ignition switch ON	11 to 14 V	V

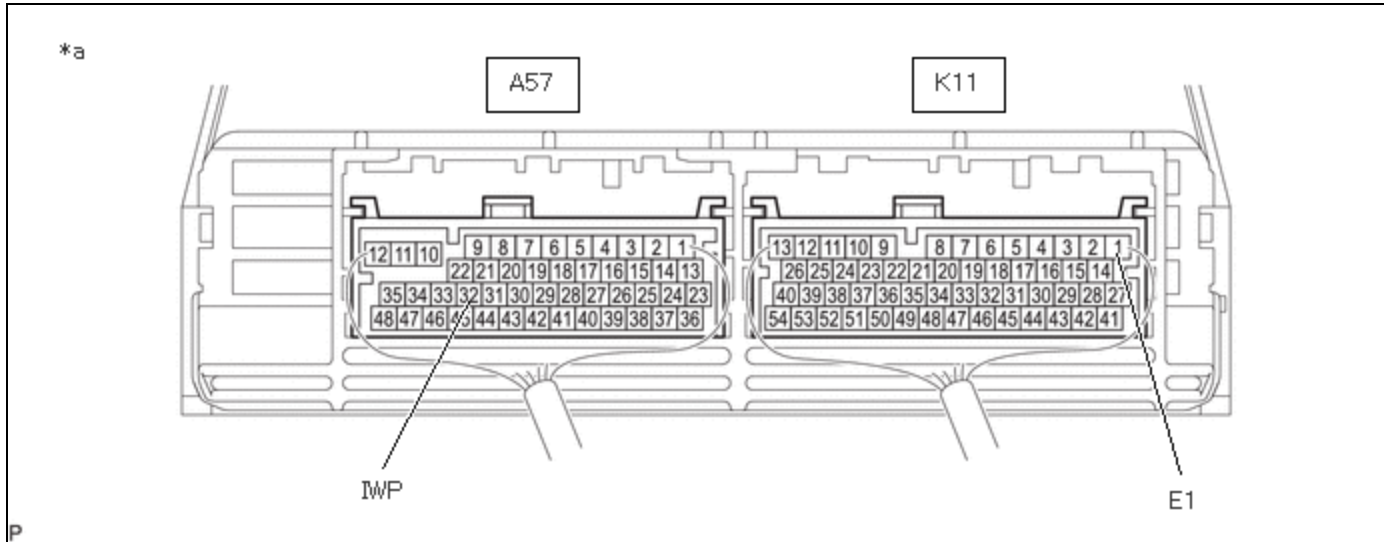
Procedure1

- (c) Check the waveform while turning the ignition switch to ON.

*a	Component with harness connected (Hybrid Vehicle Control ECU)	-	-
----	---	---	---

ITEM	CONTENT
Terminal	A57-32 (IWP) - K11-1 (E1)
Equipment Setting	5 V/DIV., 50 ms./DIV.
Condition	Ignition switch ON
