Last Modified: 12-04-2024	6.11:8.1.0	Doc ID: RM10000002BI3N
Model Year Start: 2023	Model: Prius Prime	Prod Date Range: [03/2023 -]
Title: HYBRID / BATTERY CONTROL: HYBRID CONTROL SYSTEM (for PHEV Model): U117687; Lost Communication with Gear Shift Control Module "A" (Powertrain Bus) Missing Message; 2023 - 2024 MY Prius Prime [03/2023 -]

DTC	U117687	Lost Communication with Gear Shift Control Module "A" (Powertrain Bus) Missing Message
------------	----------------	---

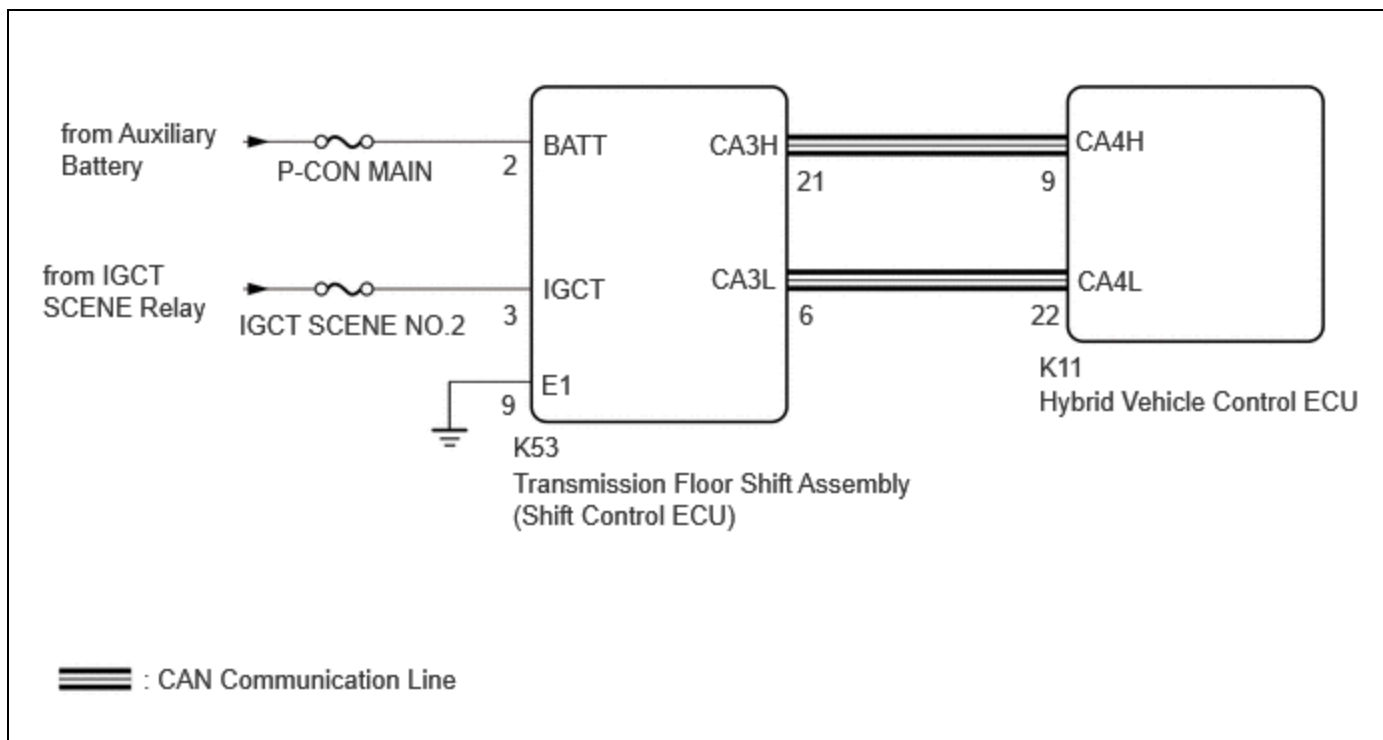
WIRING DIAGRAM

The hybrid vehicle control ECU transmits and receives signals via CAN communication to and from the shift control ECU.
