Last Modified: 12-04-2024	6.11:8.1.0	Doc ID: RM10000002BMEM
Model Year Start: 2023	Model: Prius Prime	Prod Date Range: [03/2023 -]
Title: M20A-FXS (BATTERY / CHARGING): SOLAR CHARGING SYSTEM: Solar Charging System Power Generation Malfunction; 2023 - 2024 MY Prius Prius Prime [03/2023 -]

Solar Charging System Power Generation Malfunction

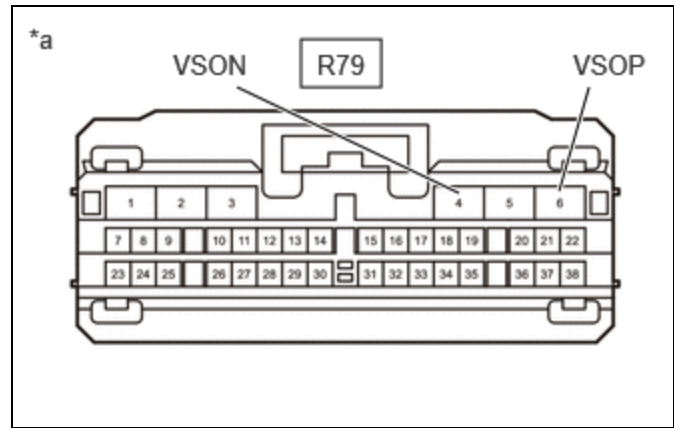
TESTER CONNECTION	CONDITION	SPECIFIED CONDITION
R79-6 (VSOP) - R79-4 (VSON)	Ignition switch off	15 V or higher

*a Front view of wire harness connector (to Solar Energy Control ECU Assembly)

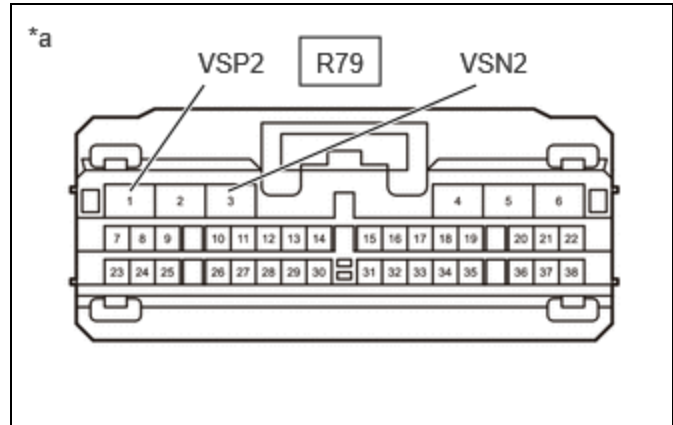
*a Front view of wire harness connector (to Solar Energy Control ECU Assembly)

TESTER CONNECTION	CONDITION	SPECIFIED CONDITION
R79-1 (VSP2) - R79-3 (VSN2)	Ignition switch off	15 V or higher
