M20A-FXS (BATTERY / CHARGING): SOLAR CHARGING SYSTEM: U117B87; Lost Communication with Battery Energy Control ...

DTC	U117B87	Lost Communication with Battery Energy Control Module "A" (ch2) Missing Message
-----	---------	--

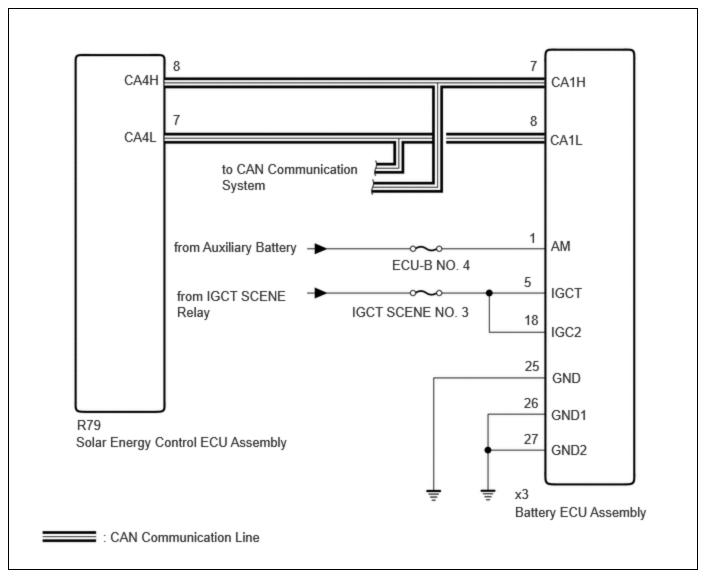
WIRING DIAGRAM

The solar energy control ECU assembly communicates with the battery ECU assembly via CAN communication.

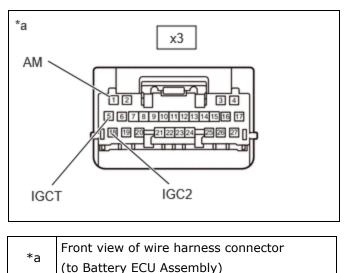
Click Connector(x3)

TESTER CONNECTION	ER CONNECTION CONDITION SPECIFIED CO		RESULT
x3-25 (GND) - Body ground	Ignition switch off	Below 1 Ω	Ω
x3*26 (GND1) - Body ground	Ignition switch off	Below 1 Ω	Ω

TESTER CONNECTION	CONDITION	SPECIFIED CONDITION	RESULT
x3-27 (GND2) - Body ground	Ignition switch off	Below 1 Ω	Ω
