Last Modified: 12-04-2024	6.11:8.1.0	Doc ID: RM10000002C018		
Model Year Start: 2023	Model: Prius Prime	Prod Date Range: [03/2023 -]		
Title: POWER DISTRIBUTION: INTEGRATION CONTROL SUPPLY: REMOVAL; 2023 - 2024 MY Prius Prius Prime				
[03/2023 -]

REMOVAL

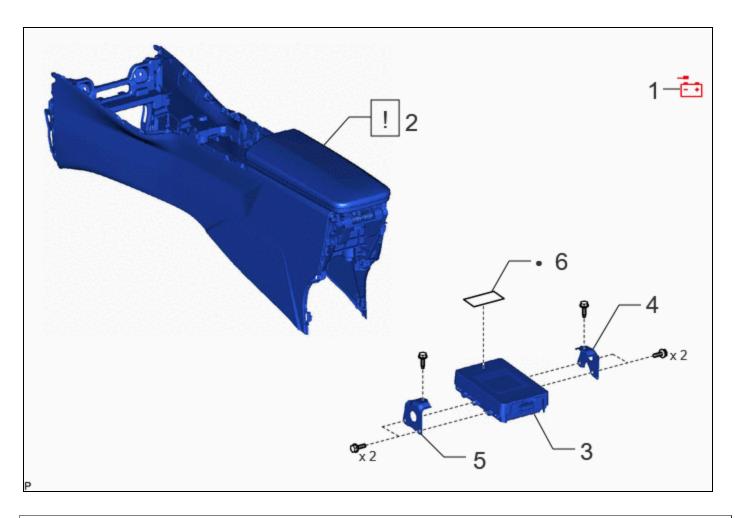
COMPONENTS (REMOVAL)

PROCEDURE	PART NAME CODE	!		
1	DISCONNECT CABLE FROM NEGATIVE AUXILIARY BATTERY TERMINAL	-	-	-	-
2	REAR CONSOLE BOX ASSEMBLY	58910C	INFO	-	-
3	INTEGRATION CONTROL SUPPLY	28912	-	-	-
4	NO. 1 INTEGRATION CONTROL SUPPLY BRACKET	28911	-	-	-
5	NO. 2 INTEGRATION CONTROL SUPPLY BRACKET	28911A	-	-	-
6	INTEGRATION CONTROL COVER	28913	-	-	-

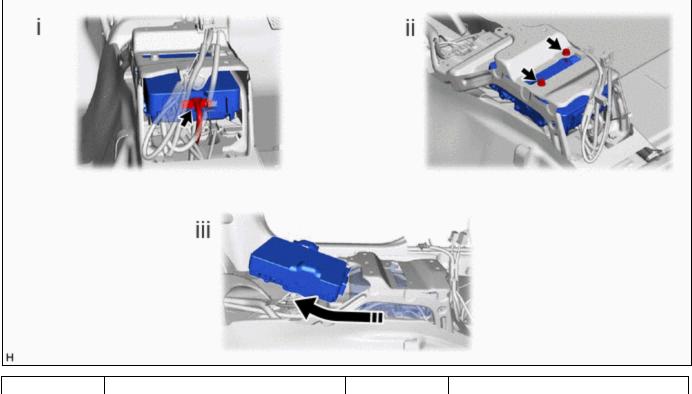
3. REMOVE INTEGRATION CONTROL SUPPLY

Remove in this Direction	_	-	
--------------------------	---	---	--

- (1) Disconnect the connector.
- (2) Remove the 2 bolts.
- (3) Slide the integration control supply as shown in the illustration to remove it.

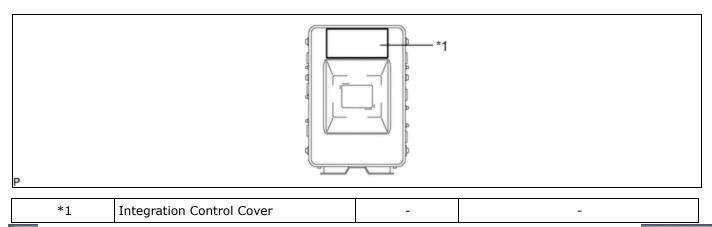
6. REMOVE INTEGRATION CONTROL COVER

Perform this procedure only when replacement of the integration control cover is necessary.
