<b>Last Modified:</b> 12-04-2024	6.11:8.1.0	<b>Doc ID:</b> RM100000028PG2
<b>Model Year Start:</b> 2023	<b>Model:</b> Prius Prime	<b>Prod Date Range:</b> [12/2022 - ]
<b>Title:</b> POWER ASSIST SYSTEMS: POWER STEERING SYSTEM: C151B17; Power Steering Torque Sensor "B" Supply Voltage Circuit Voltage Above Threshold; 2023 - 2024 MY Prius Prius Prime [12/2022 - ]

<b>DTC</b>	<b>C151B17</b>	<b>Power Steering Torque Sensor "B" Supply Voltage Circuit Voltage Above Threshold</b>
------------	----------------	--

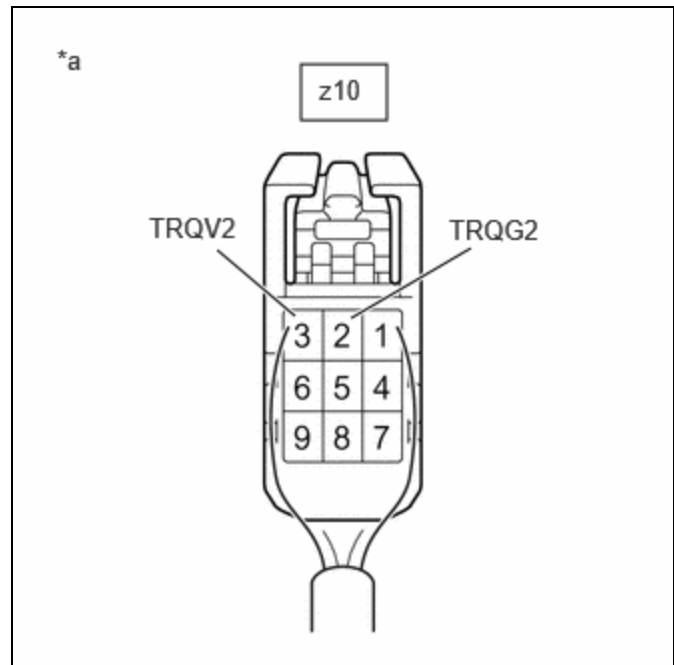
(b) Measure the voltage according to the value(s) in the table below.

TESTER CONNECTION	SWITCH CONDITION	SPECIFIED CONDITION	RESULT
z10-3 (TRQV2) - z10-2 (TRQG2)	Ignition switch ON	4.5 to 5.5 V	V

\*a Component with harness connected (Power Steering ECU Assembly)
