| Last Modified: 12-04-2024 | 6.11:8.1.0 | <b>Doc ID:</b> RM100000002BJBY | | | |
|---|---|---|---|--|--|
| Model Year Start: 2023 | Model: Prius Prime | Prod Date Range: [03/2023 - | ] | | |
| Title: EXTERIOR PANELS / TRIM: WINDSHIELD OUTSIDE MOULDING: REMOVAL; 2023 - 2024 MY Prius Prius Prime | | | | | |

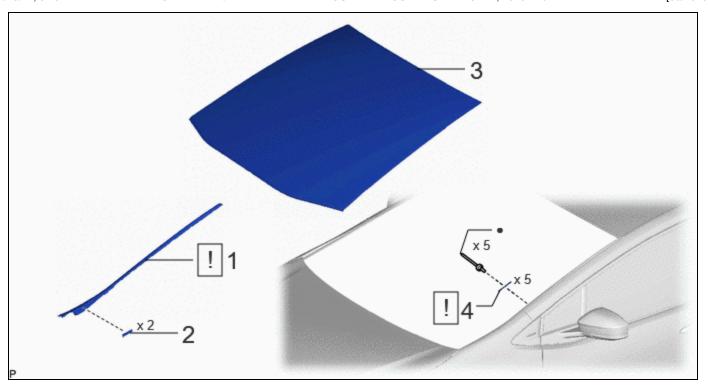
## **COMPONENTS (REMOVAL)**

| | PROCEDURE | PART NAME CODE | ! | | <b>\$</b> |
| 1 | WINDSHIELD LOWER OUTSIDE MOULDING | 75536D | INFO | - | - |
| 2 | NO. 2 WINDSHIELD OUTSIDE MOULDING CLIP | 75546B | - | - | - |
| 3 | WINDSHIELD GLASS SUB-ASSEMBLY | - | - | - | - |
| 4 | NO. 1 WINDSHIELD OUTSIDE MOULDING CLIP | 75545B | INFO | - | - |

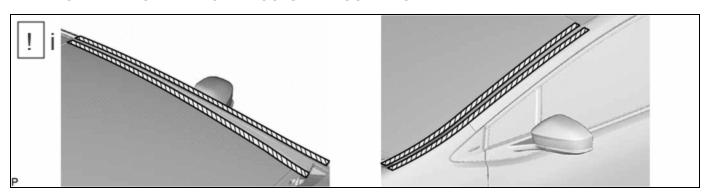
### 1. REMOVE WINDSHIELD LOWER OUTSIDE MOULDING

(1) Apply protective tape around the windshield lower outside moulding as shown in the illustration.

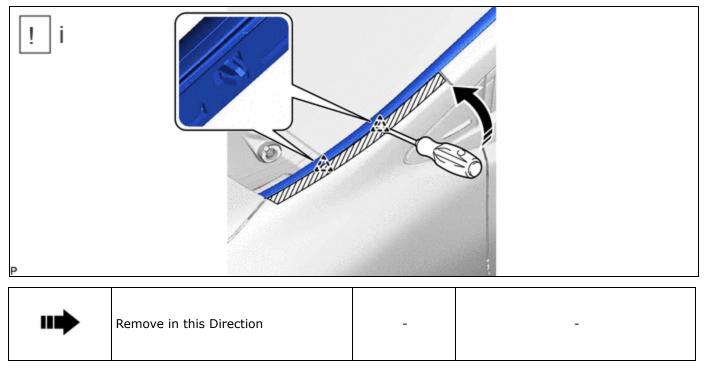
(1) Using a clip remover, disengage the 2 clips as shown in the illustration.

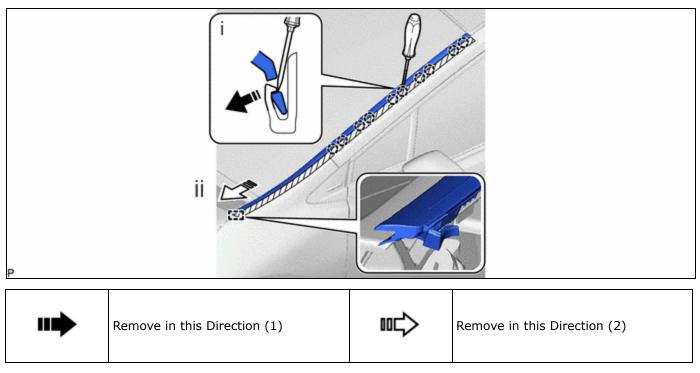
- (1) Using a screwdriver with its tip wrapped with protective tape, disengage the 10 claws as shown in the illustration.
- (2) Disengage the guide and remove the windshield lower outside moulding as shown in the illustration

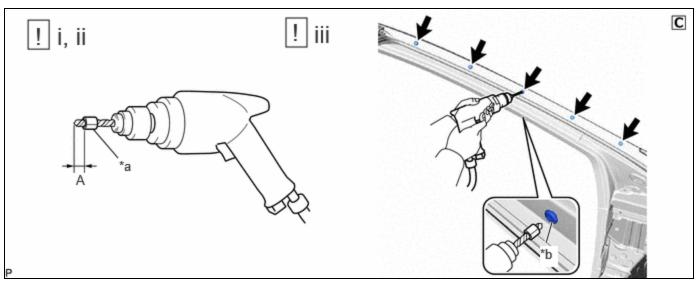
| *a Tape | *b | Flange |

- (1) Insert a 4.0 mm (0.157 in.) drill bit into a drill.
- (2) Tape the 4.0 mm (0.157 in.) drill bit 5.0 mm (0.197 in.) from the tip as shown in the illustration.

Standard Measurement:

| AREA | MEASUREMENT | AREA | MEASUREMENT |
| А | 5.0 mm (0.197 in.) | - | - |

Tape the 4.0 mm (0.157 in.) drill bit to prevent the drill bit from going too deep.

(3) Lightly press the drill against the rivets to drill off the rivet flanges, and remove the 5 rivets.

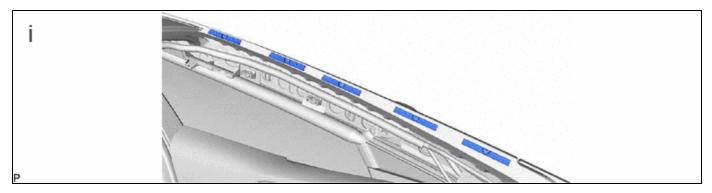
(1) Remove the 5 No. 1 windshield outside moulding clips.
