| Title: ADVANCED PARK: ADVANCED PARK: U117987; Lost Communication with Image Processing Module "B" (ch2); 2023 - 2024 MY Prius Prius Prime [12/2022 -] | | |

| DTC | U117987 | Lost Communication with Image Processing Module "B" (ch2) |

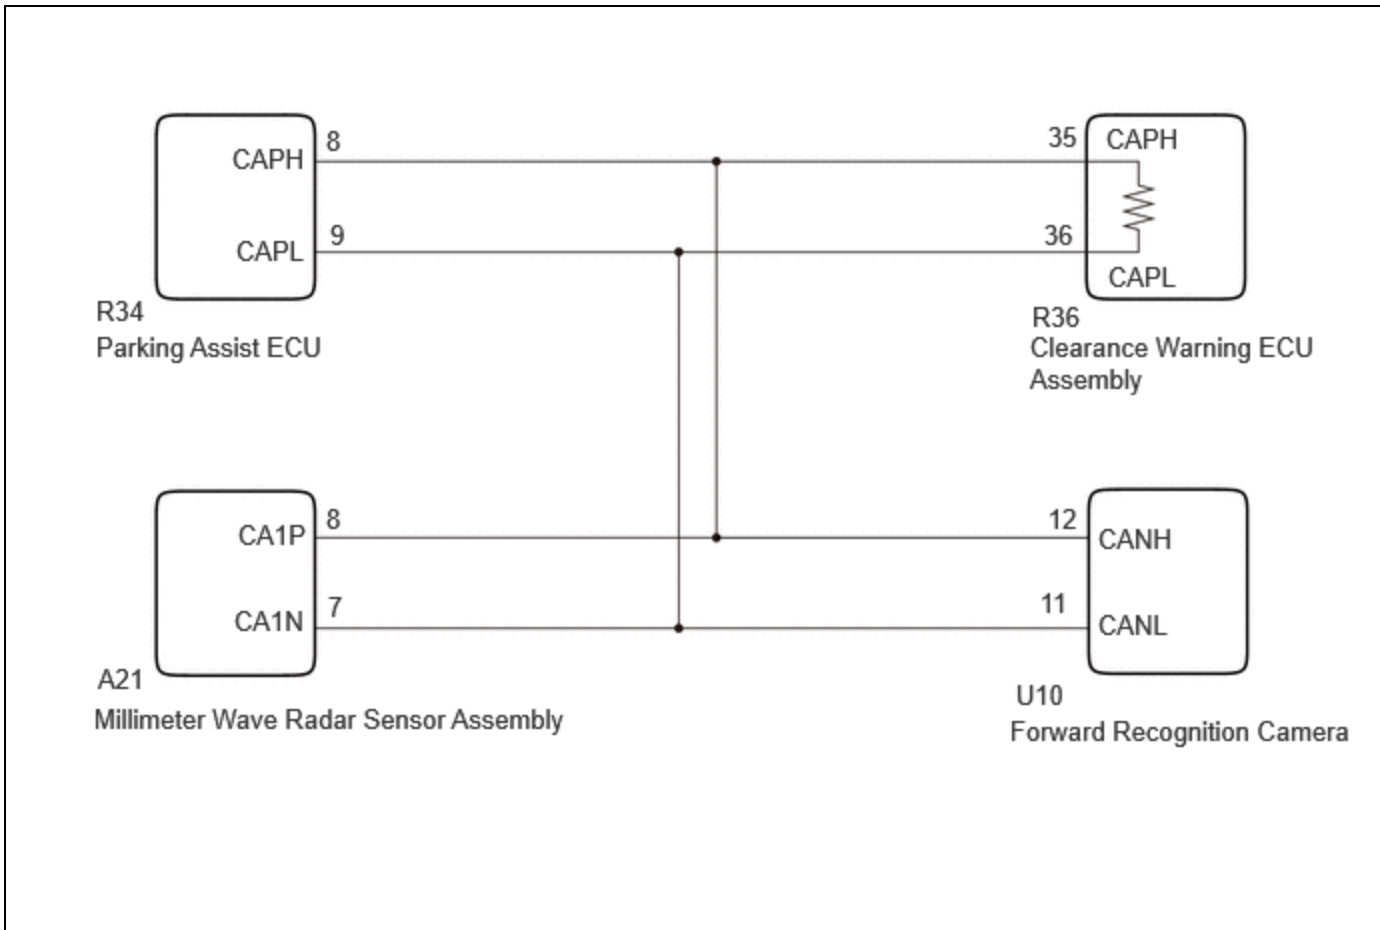
WIRING DIAGRAM

This DTC is output when the clearance warning ECU assembly detects lost communication with the parking assist ECU.
