Last Modified: 12-04-2024	6.11:8.1.0	Doc ID: RM10000000289PE
Model Year Start: 2023	Model: Prius Prime	Prod Date Range: [12/2022 -]
Title: ADVANCED DRIVER ASSISTANCE SYSTEM: MILLIMETER WAVE RADAR SENSOR: TARGET ADJUSTMENT(TRIANGLE TARGET); 2023 - 2024 MY Prius Prius Prime [12/2022 -]

TARGET ADJUSTMENT(TRIANGLE TARGET)

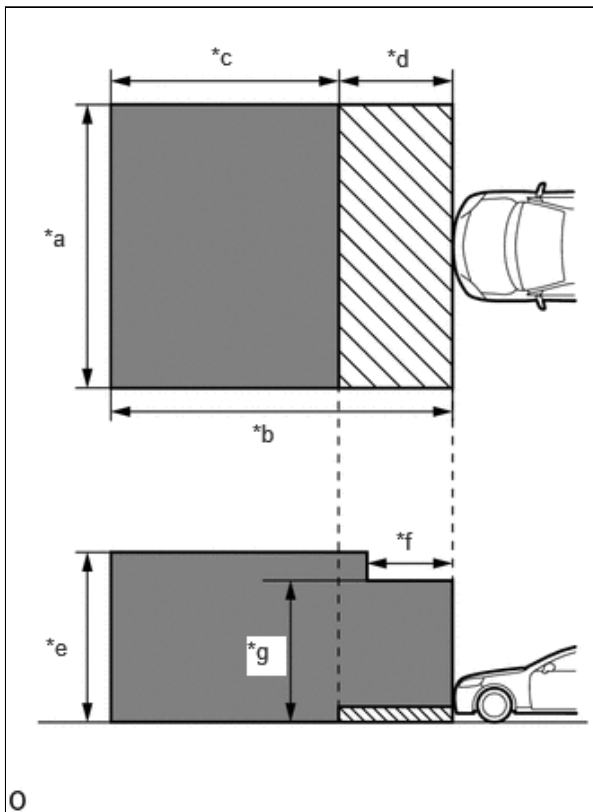
(a) Park the vehicle on a level surface where the area in front of the vehicle shown in the illustration is free of metal objects.

*a	5 m (16.4 ft.)
*b	6 m (19.7 ft.)
*c	4 m (13.1 ft.)
*d	2 m (6.56 ft.)
*e	3 m (9.84 ft.)
*f	1.5 m (4.92 ft.)
*g	2.5 m (8.2 ft.)

Do not place any metal objects in this area

Do not place metal objects with a height of more than 50 mm (1.97 in.) in this area

Metal objects that have a height of 50 mm (1.97 in.) or less do not affect adjustment within 2 m (6.56 ft.) from the front of the vehicle.

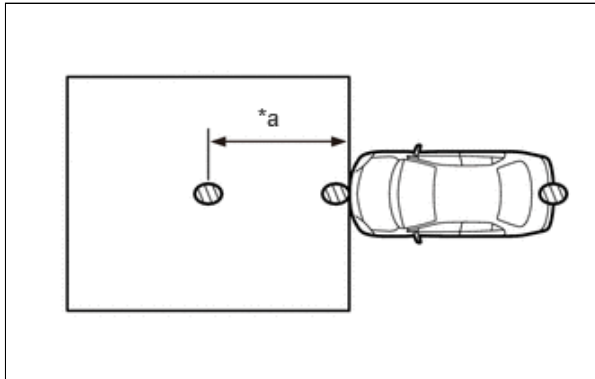
(1) Check the levelness of the ground at the 3 points shown in the illustration.

*a	3 m (9.84 ft.)

Levelness Check Point

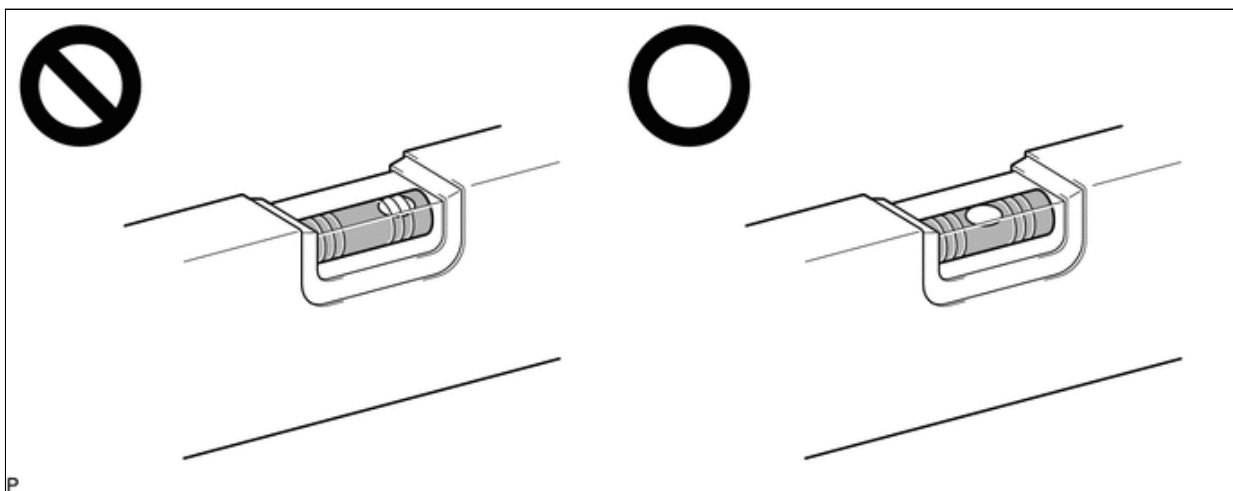
(2) Place the level on each levelness check point and check that the air bubble of the level is centered.

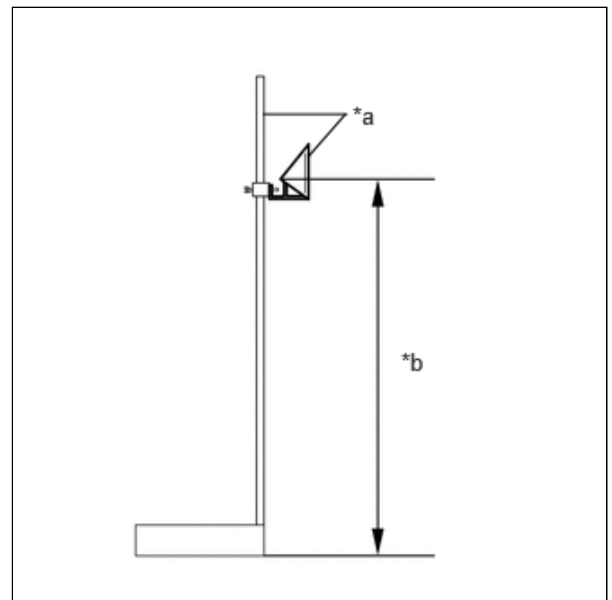
- (1) Adjust SST (reflector) so that the center of SST (reflector) is the same height as the millimeter wave radar sensor.

Set the reflector so that its center is 601 mm (1.97 ft.) above the ground.

*a	SST (reflector)
*b	601 mm (1.97 ft.)

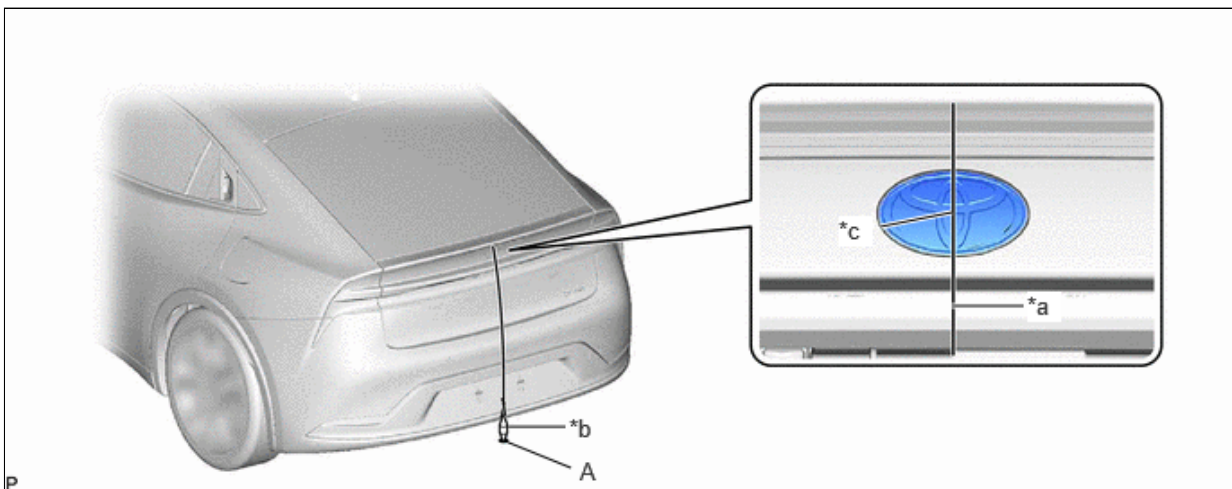
- (1) Hang a weight with a pointed tip from the center of the rear emblem, and mark the rear center point of the vehicle (point A) on the ground.

*a	String	*b	Weight
*c	Center	-	-

Lightly flick the string with your fingers several times to confirm that the string is perpendicular to the ground.

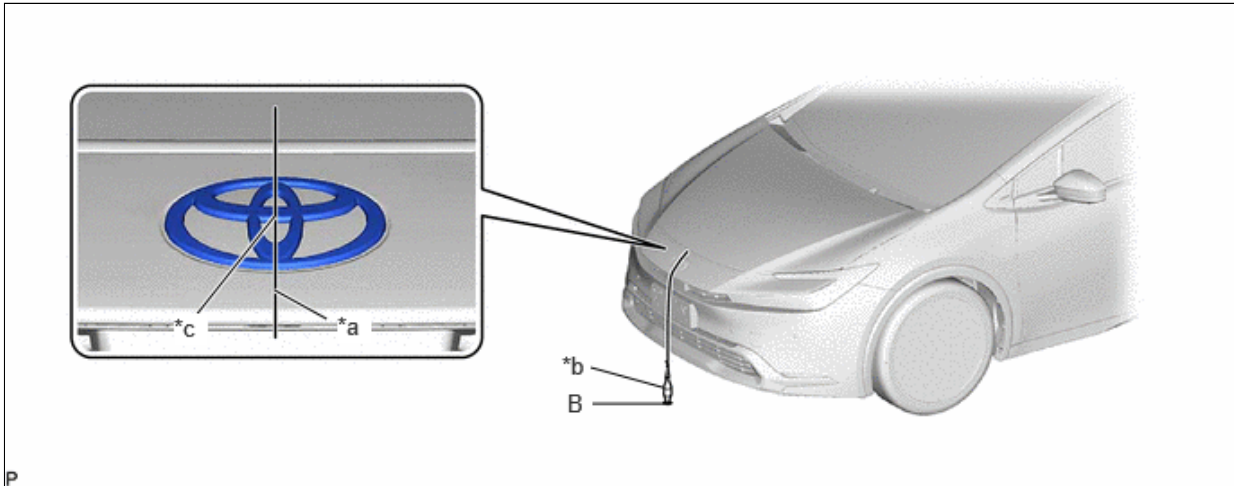
(2) Hang a weight with a pointed tip from the center of the radiator grille (or front panel) emblem, and mark the front center point of the vehicle (point B) on the ground.

*a	String	*b	Weight
*c	Center	-	-

Lightly flick the string with your fingers several times to confirm that the string is perpendicular to the ground.

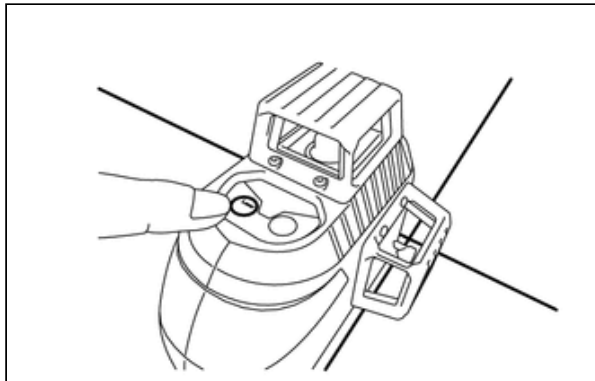
1. Press the laser mode button on the laser line marker to activate the laser line emitters.

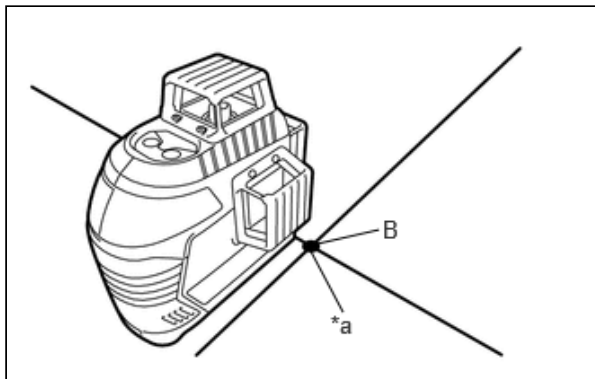
2. Align the laser beam ground marking point (cross portion) with point B.

*a	Ground Marking Point (Cross Portion)
----	--------------------------------------

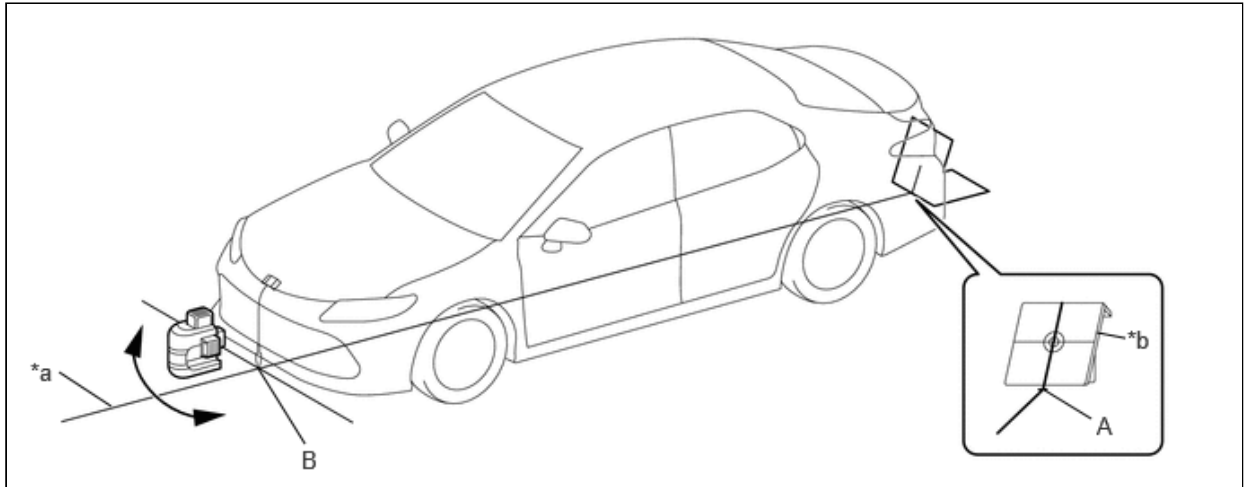
3. Align the center of the target panel with point A, and set the target panel so that it faces forward.

*a	Center Line	*b	Target Panel
----	-------------	----	--------------

4. Adjust the position of the laser line marker so that the laser beam is aligned with the center line of the target panel.

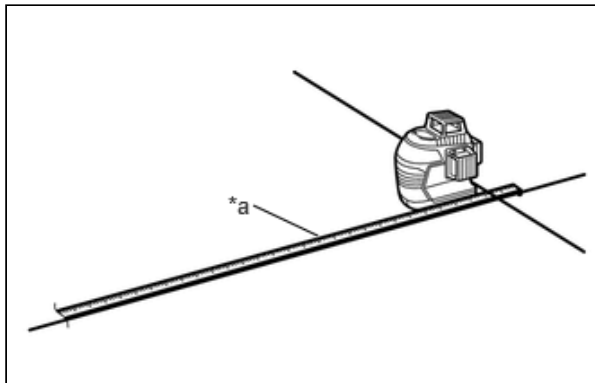
5. Extend a tape measure at least 3000 mm (9.84 ft.) in length from point B, and set the tape measure in place.

*a	Tape Measure
----	--------------

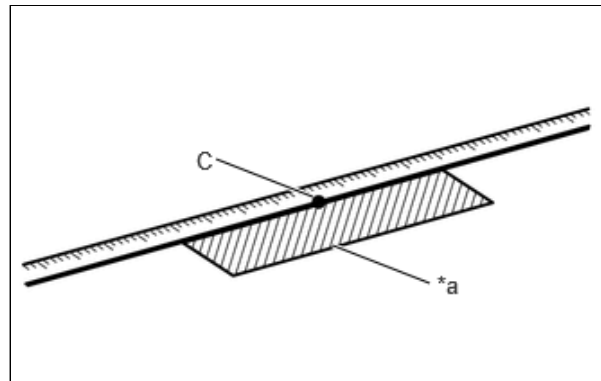
6. At a distance of 3000 mm (9.84 ft.) from point B, apply an approximately 200 mm (7.87 in.) piece of tape

alongside the tape measure, and mark point C.

*a	Tape
----	------

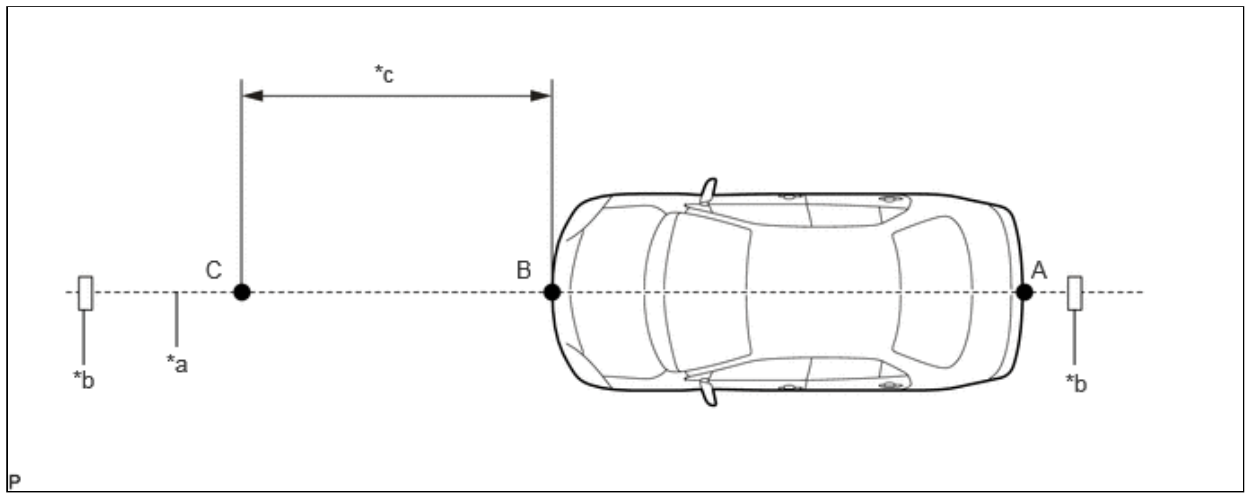
1. Using tape and a string, create a line that connects point B to point A and extends at least 3000 mm (9.84 ft.) beyond the front center point of the vehicle.

*a	String	*b	Tape
*c	2990 to 3010 mm (9.81 to 9.87 ft.)	-	-
