Last Modified: 12-04-2024	6.11:8.1.0	Doc ID: RM100000028VR5
Model Year Start: 2023	Model: Prius Prime	Prod Date Range: [12/2022 -]
Title: PARK ASSIST / MONITORING: INTUITIVE PARKING ASSIST SYSTEM: C1AE587; Ultrasonic Sensor (Front Right Side) Missing Message; 2023 - 2024 MY Prius Prius Prime [12/2022 -]

DTC	C1AE587	Ultrasonic Sensor (Front Right Side) Missing Message
------------	----------------	---

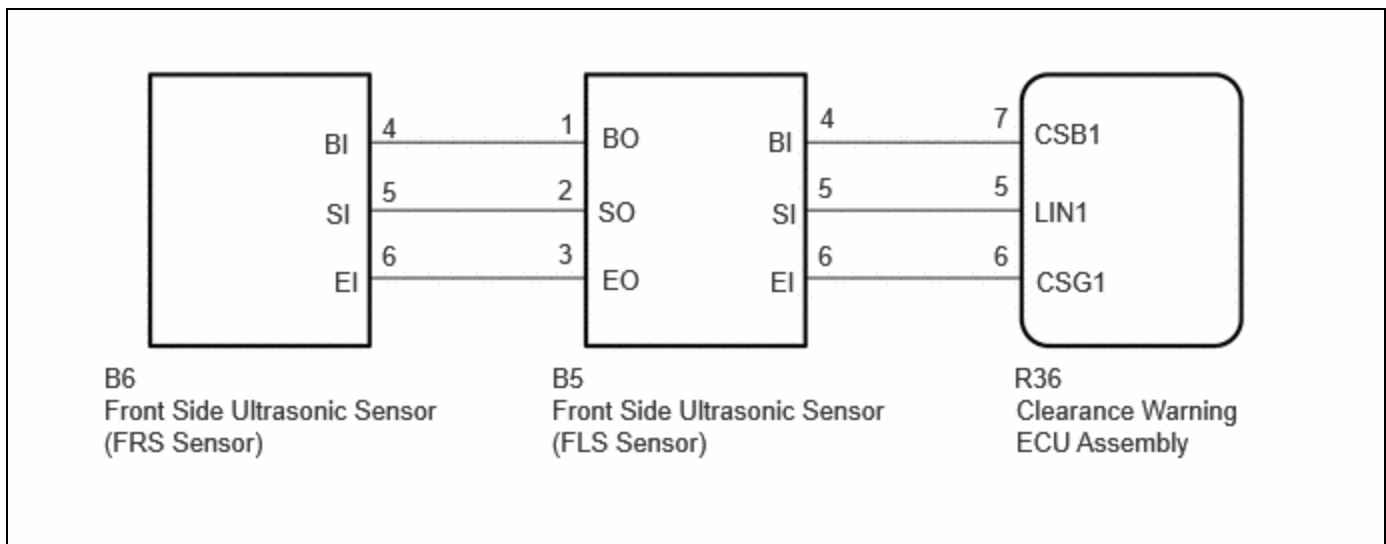
WIRING DIAGRAM

This DTC is output when an open circuit or short occurs in the communication line between a front side ultrasonic sensor (FRS sensor) and the front side ultrasonic sensor (FLS sensor) or when a malfunction occurs in a front side ultrasonic sensor (FRS sensor) on the front.

TESTER CONNECTION	CONDITION	SPECIFIED CONDITION	RESULT
B6-4 (BI) - B5-1 (BO)	Always	Below 1 Ω	Ω
B6-5 (SI) - B5-2 (SO)	Always	Below 1 Ω	Ω
B6-6 (EI) - B5-3 (EO)	Always	Below 1 Ω	Ω
B6-4 (BI) or B5-1 (BO) - Body ground	Always	10 k Ω or higher	k Ω
B6-5 (SI) or B5-2 (SO) - Body ground	Always	10 k Ω or higher	k Ω
B6-6 (EI) or B5-3 (EO) - Body ground	Always	10 k Ω or higher	k Ω
