Last Modified: 12-04-2024	6.11:8.1.0	Doc ID: RM100000028ZVC
Model Year Start: 2023	Model: Prius Prime	Prod Date Range: [12/2022 -]
Title: HYBRID / BATTERY CONTROL: HYBRID CONTROL SYSTEM (for M20A-FXS): P0AA649,P1C7C49-P1C7F49,P1C8049; Hybrid/EV Battery Voltage System Isolation Internal Electronic Failure; 2023 - 2024 MY Prius Prius Prime [12/2022 -]

DTC	P0AA649	Hybrid/EV Battery Voltage System Isolation Internal Electronic Failure
------------	----------------	---

DESCRIPTION

The hybrid vehicle control ECU monitors the battery ECU assembly and detects insulation malfunctions in the high-voltage system.

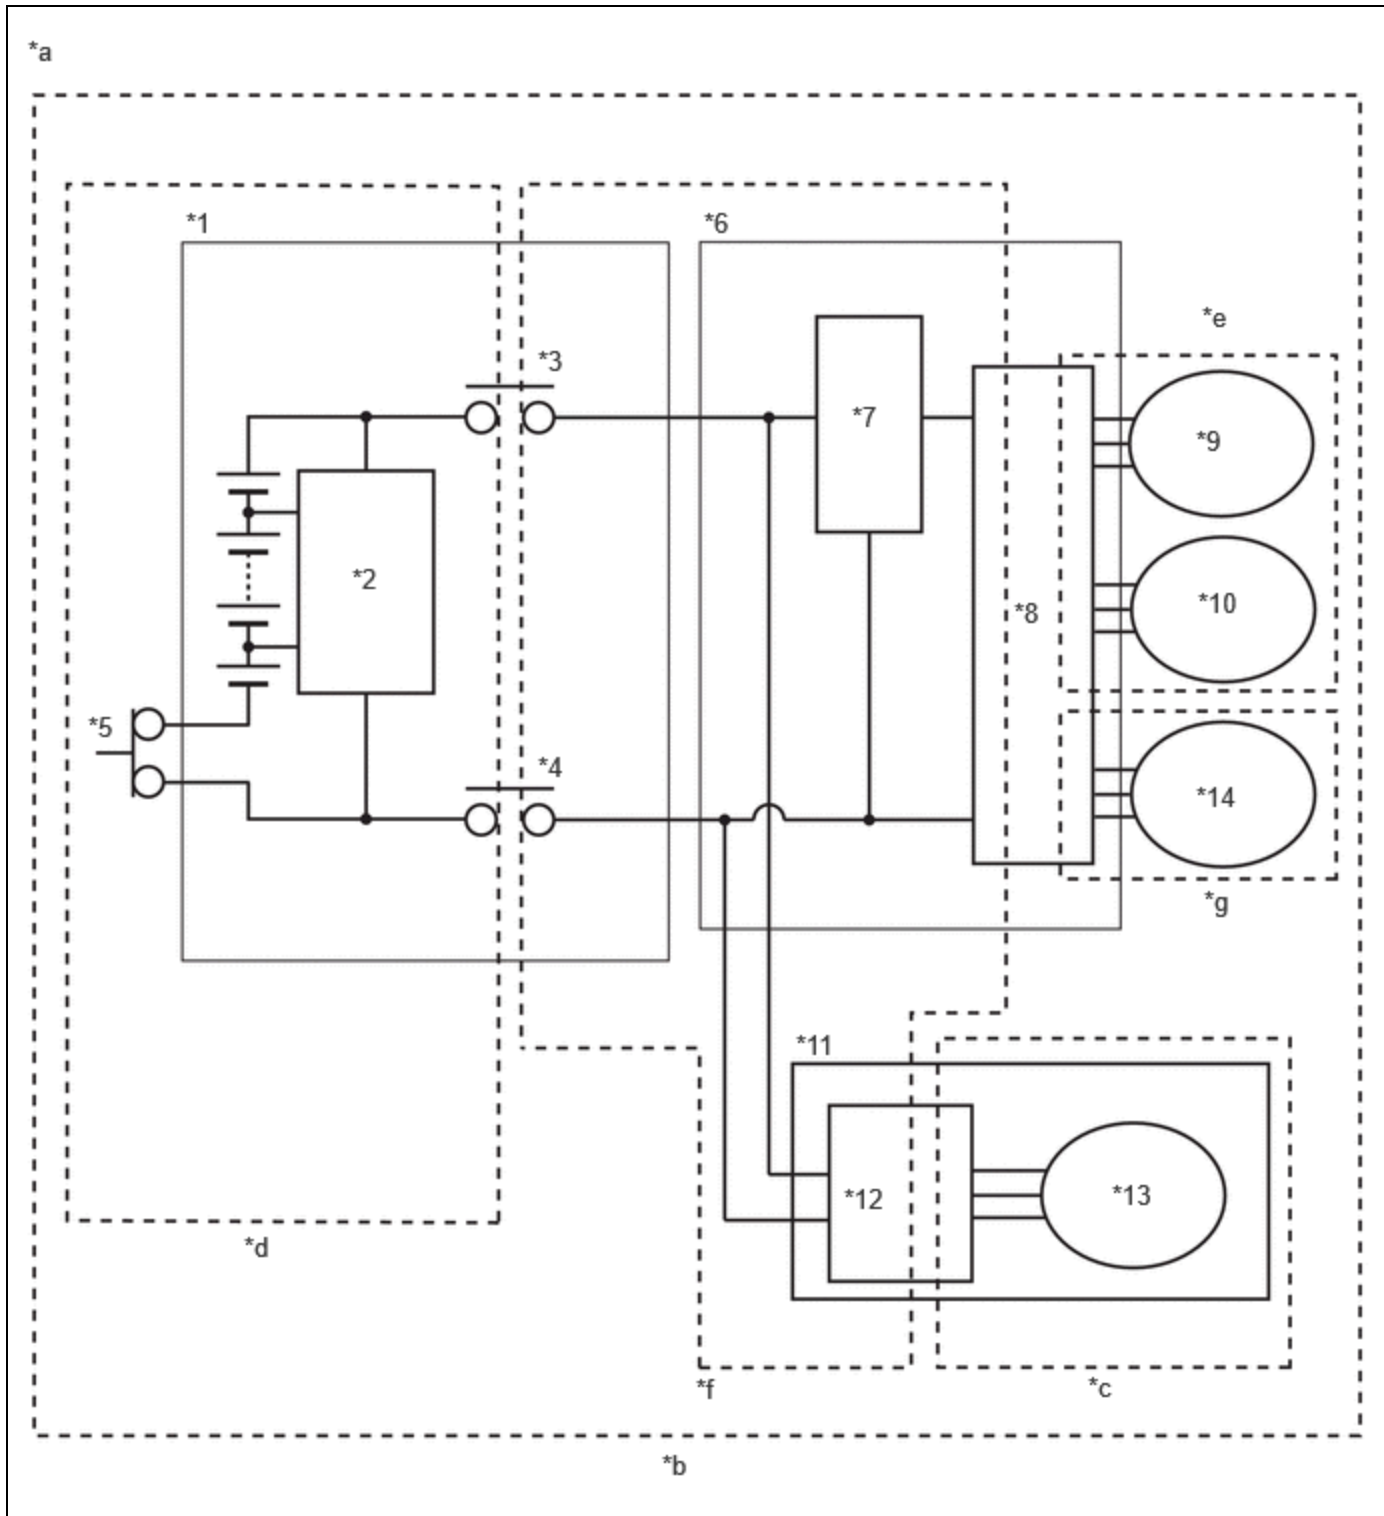
WIRING DIAGRAM

*1	HV Battery	*2	Battery ECU assembly
*3	SMRB	*4	SMRG
*5	Service Plug Grip	*6	Inverter with Converter Assembly
*7	Boost Converter	*8	Inverter
*9	Generator (MG1)	*10	Motor (MG2)
*11	Compressor with Motor Assembly	*12	A/C Inverter
*13	A/C Motor	*14	Rear Motor (MGR) (for AWD)
*a	High-voltage Areas	*b	DTC P0AA649 Vehicle Insulation Resistance Reduction Area

*c	DTC P1C7C49 Air Conditioning System Area	*d	DTC P1C7D49 HV Battery Area
*e	DTC P1C7E49 Hybrid Vehicle Transaxle Assembly Area or Inverter with Converter Assembly AC (Alternation Current) Section Area	*f	DTC P1C7F49 High Voltage Direct Current Area
*g	DTC P1C8049 Rear Motor Area	-	-

A/C Consumption Power	<p>The compressor with motor assembly AC (alternating current) section ((*c) in the wiring diagram) includes the air conditioning motor, wiring between the air conditioning motor and air conditioning inverter, and the AC (alternating current) section of the air conditioning motor drive circuit in the air conditioning inverter.</p> <p>With the vehicle stopped, turn on/off the air conditioning system and observe "Short Wave Highest Value Level" to use as a diagnosis reference.</p>

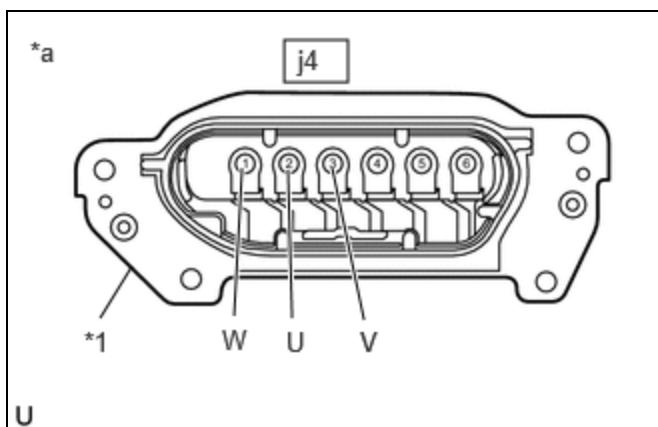
As the insulation resistance may vary when motor (MG2) rotates, perform this inspection while rotating the front wheels.

*1	Shield Ground
*a	Motor Cable (for MG2) (Inverter with Converter Assembly Side)

TESTER CONNECTION	CONDITION	SPECIFIED CONDITION
j4-2 (U) - Body ground and shield ground	Ignition switch ON	100 MΩ or higher
j4-3 (V) - Body ground and shield ground	Ignition switch ON	100 MΩ or higher
j4-1 (W) - Body ground and shield ground	Ignition switch ON	100 MΩ or higher

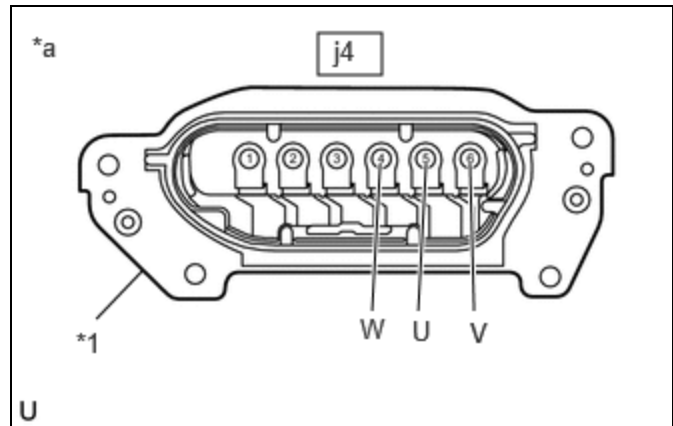
*1	Shield Ground
*a	Motor Cable (for MG1) (Inverter with Converter Assembly Side)

TESTER CONNECTION	CONDITION	SPECIFIED CONDITION
j4-5 (U) - Body ground and shield ground	Ignition switch ON	100 MΩ or higher
j4-6 (V) - Body ground and shield ground	Ignition switch ON	100 MΩ or higher
j4-4 (W) - Body ground and shield ground	Ignition switch ON	100 MΩ or higher

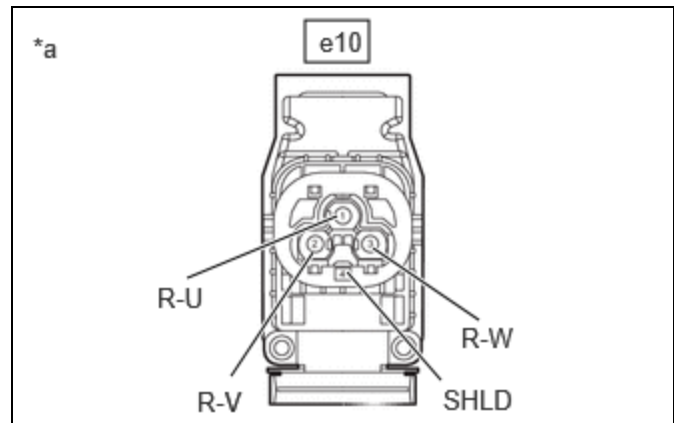
TESTER CONNECTION	CONDITION	SPECIFIED CONDITION
e10-1 (R-U) - e10-4 (SHLD) and Body ground and shield ground	Ignition switch off	100 MΩ or higher
e10-2 (R-V) - e10-4 (SHLD) and Body ground and shield ground	Ignition switch off	100 MΩ or higher
e10-3 (R-W) - e10-4 (SHLD) and Body ground and shield ground	Ignition switch off	100 MΩ or higher

*a	HV Floor Under Wire (Rear Traction Motor Cable) (Inverter with Converter Assembly Side)
----	--

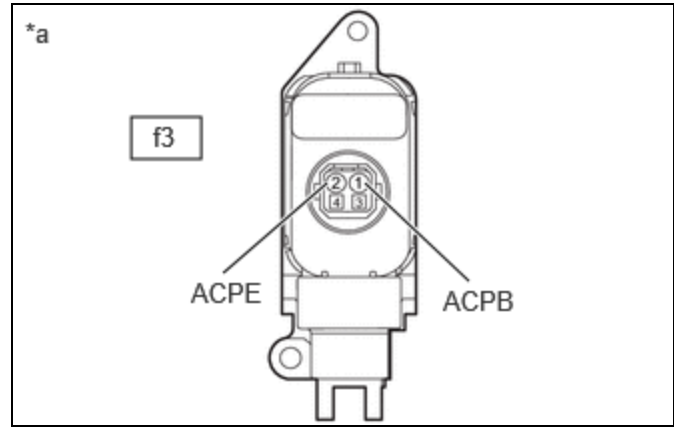
TESTER CONNECTION	CONDITION	SPECIFIED CONDITION
f3-1 (ACPB) - Body ground	Ignition switch off	3 MΩ or higher
f3-2 (ACPE) - Body ground	Ignition switch off	3 MΩ or higher

*a	HV Air Conditioning Wire (Inverter with Converter Assembly Side)
----	---

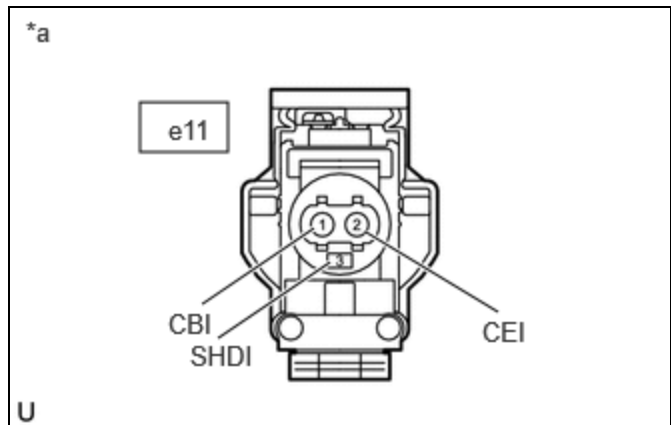
*a	HV Floor Under Wire (Inverter with Converter Assembly Side)
----	--

TESTER CONNECTION	CONDITION	SPECIFIED CONDITION
e11-1 (CBI) - e11-3 (SHDI) and Body ground	Ignition switch off	10 MΩ or higher
e11-2 (CEI) - e11-3 (SHDI) and Body ground	Ignition switch off	10 MΩ or higher

Visually inspect the HV floor under wire for damage. If there is any damage, then this is the likely cause of low insulation resistance.

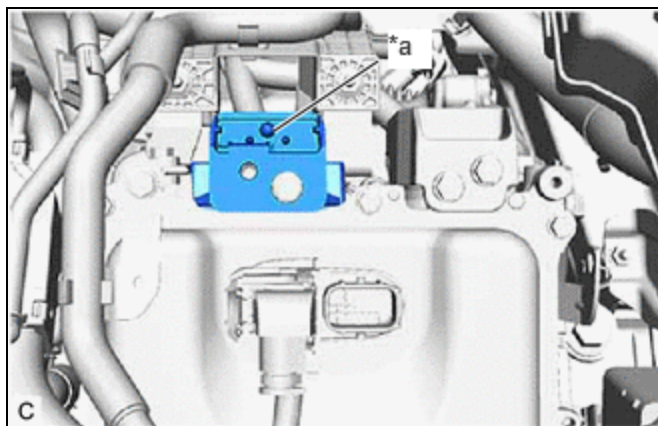
TESTER CONNECTION	CONDITION	SPECIFIED CONDITION
High voltage terminal - Body ground	Ignition switch off	1 MΩ or higher

Perform this inspection with the motor cable, HV floor under wire and HV air conditioning wire disconnected from the inverter with converter assembly.

*a	High Voltage Terminal
----	-----------------------

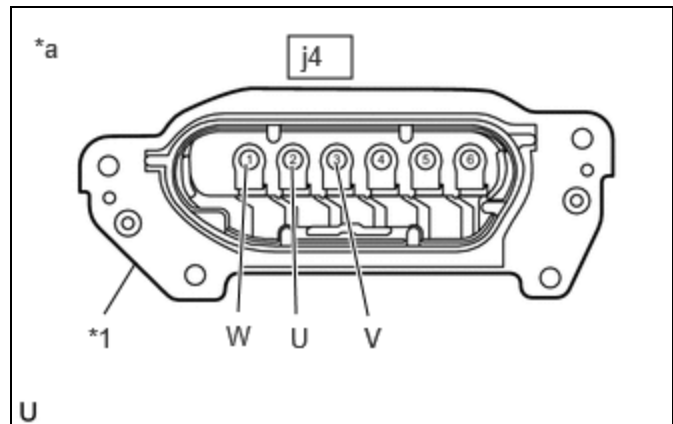
*1	Shield Ground
*a	Motor Cable (for MG2) (Inverter with Converter Assembly Side)

TESTER CONNECTION	CONDITION	SPECIFIED CONDITION
j4-2 (U) - Shield ground	Ignition switch off	100 MΩ or higher
j4-3 (V) - Shield ground	Ignition switch off	100 MΩ or higher
j4-1 (W) - Shield ground	Ignition switch off	100 MΩ or higher

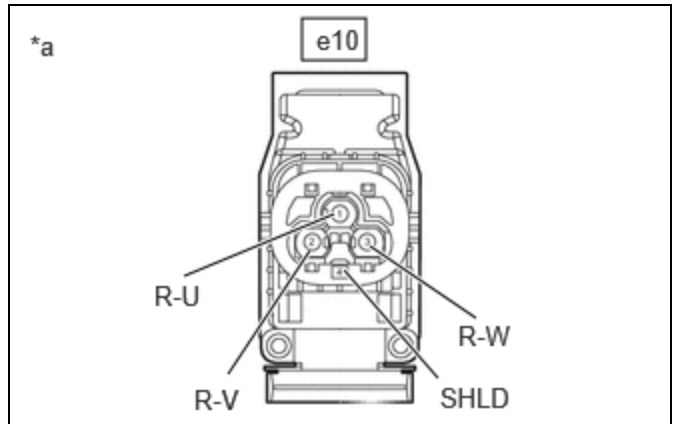
*a	HV Floor Under Wire (Rear Traction Motor Cable) (Inverter with Converter Assembly Side)
----	--

TESTER CONNECTION	CONDITION	SPECIFIED CONDITION
e10-1 (R-U) - Shield ground	Ignition switch off	100 MΩ or higher
e10-2 (R-V) - Shield ground	Ignition switch off	100 MΩ or higher
e10-3 (R-W) - Shield ground	Ignition switch off	100 MΩ or higher

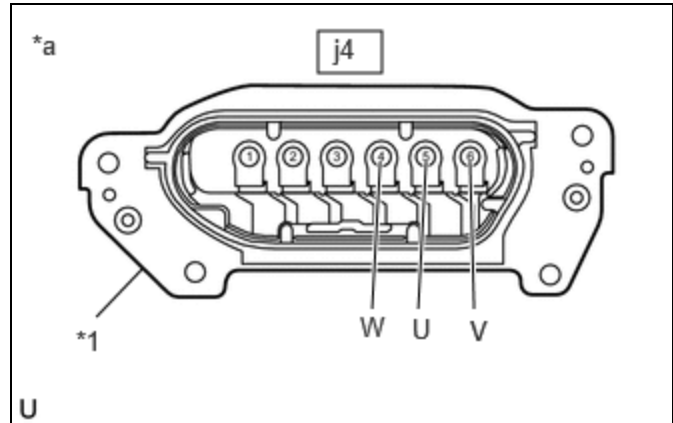
TESTER CONNECTION	CONDITION	SPECIFIED CONDITION
j4-5 (U) - Shield ground	Ignition switch off	100 MΩ or higher
j4-6 (V) - Shield ground	Ignition switch off	100 MΩ or higher
j4-4 (W) - Shield ground	Ignition switch off	100 MΩ or higher

*1	Shield Ground
*a	Motor Cable (for MG1) (Inverter with Converter Assembly Side)

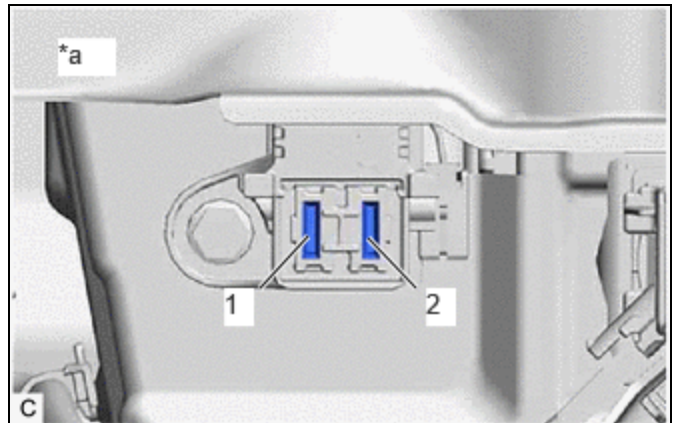
TESTER CONNECTION	CONDITION	SPECIFIED CONDITION
1 - Body ground	Ignition switch off	10 MΩ or higher
2 - Body ground	Ignition switch off	10 MΩ or higher

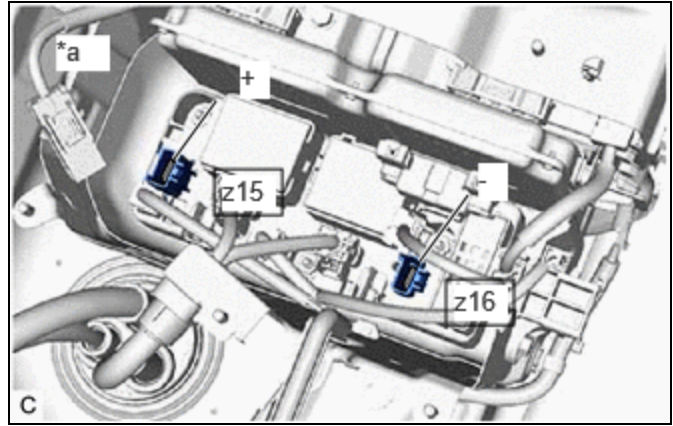
*a	Component without harness connected (HV Battery Junction Block Assembly)
----	--

TESTER CONNECTION	CONDITION	SPECIFIED CONDITION
z15-1 (+) - Body ground	Ignition switch off	10 MΩ or higher
z16-1 (-) - Body ground	Ignition switch off	10 MΩ or higher

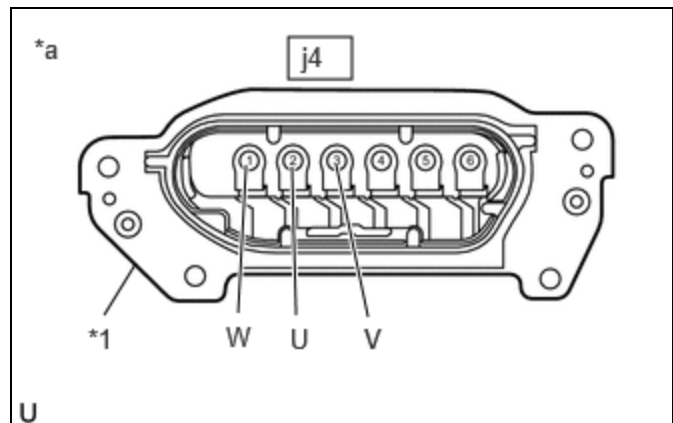
*1	Shield Ground
----	---------------

TESTER CONNECTION	CONDITION	SPECIFIED CONDITION
j4-2 (U) - Shield ground	Ignition switch off	100 MΩ or higher
j4-3 (V) - Shield ground	Ignition switch off	100 MΩ or higher
j4-1 (W) - Shield ground	Ignition switch off	100 MΩ or higher

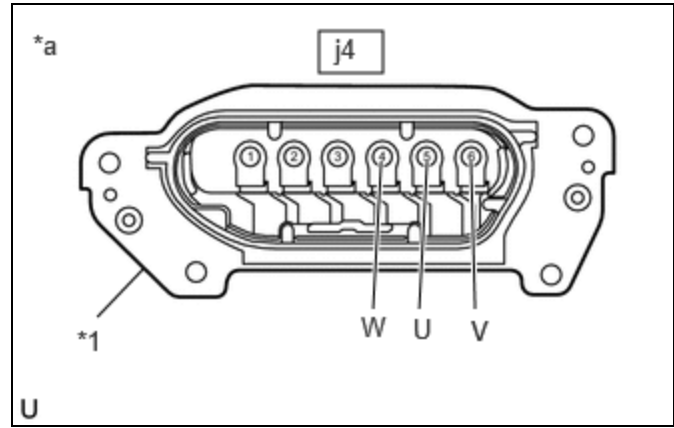
*1	Shield Ground
*a	Motor Cable (for MG1) (Inverter with Converter Assembly Side)

TESTER CONNECTION	CONDITION	SPECIFIED CONDITION
j4-5 (U) - Shield ground	Ignition switch off	100 MΩ or higher
j4-6 (V) - Shield ground	Ignition switch off	100 MΩ or higher
j4-4 (W) - Shield ground	Ignition switch off	100 MΩ or higher

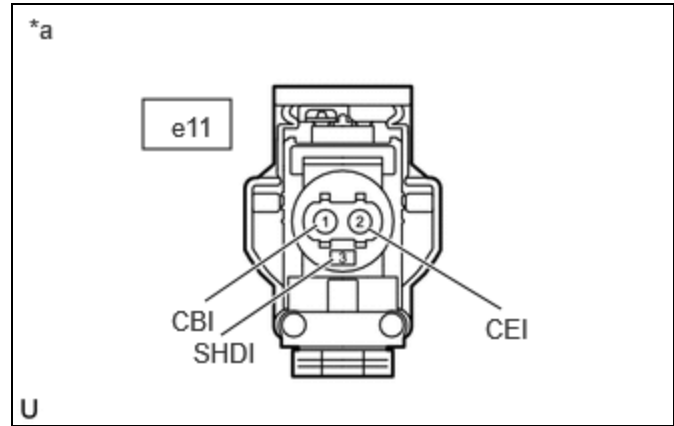
TESTER CONNECTION	CONDITION	SPECIFIED CONDITION
e11-1 (CBI) - e11-3 (SHDI) and Body ground	Ignition switch off	10 MΩ or higher
e11-2 (CEI) - e11-3 (SHDI) and Body ground and	Ignition switch off	10 MΩ or higher

*a	HV Floor Under Wire (Inverter with Converter Assembly Side)
----	---

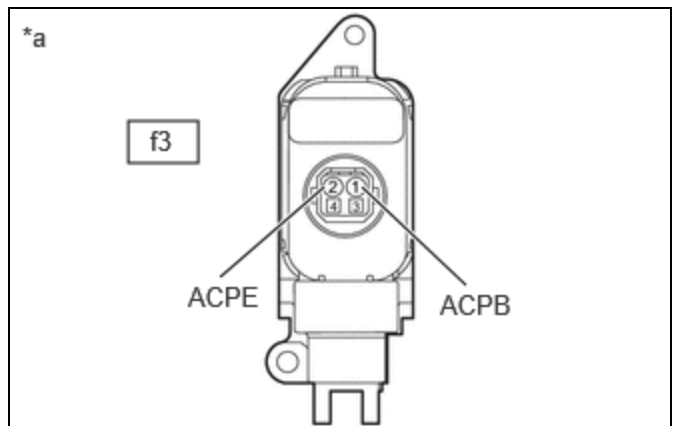
*a	HV Air Conditioning Wire (Inverter with Converter Assembly Side)
----	---

TESTER CONNECTION	CONDITION	SPECIFIED CONDITION
f3-1 (ACPB) - Body ground	Ignition switch off	3 MΩ or higher
f3-2 (ACPE) - Body ground	Ignition switch off	3 MΩ or higher

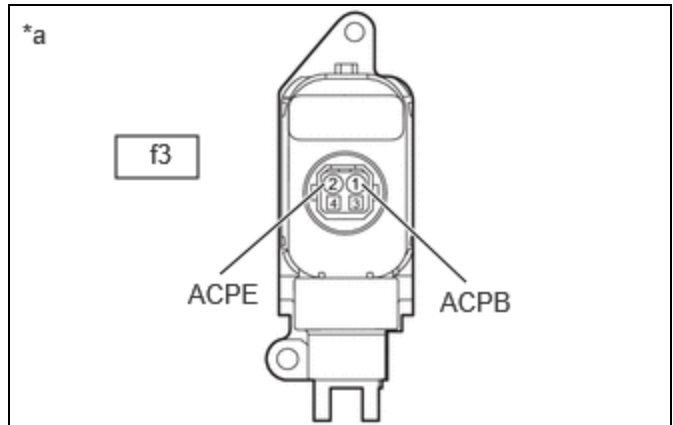
*a	HV Air Conditioning Wire (Inverter with Converter Assembly Side)
----	---

TESTER CONNECTION	CONDITION	SPECIFIED CONDITION
f3-1 (ACPB) - Body ground	Ignition switch off	10 MΩ or higher
f3-2 (ACPE) - Body ground	Ignition switch off	10 MΩ or higher

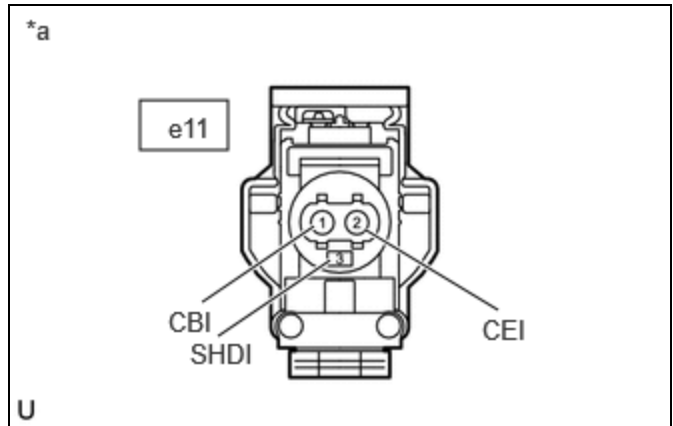
*a	HV Floor Under Wire (Inverter with Converter Assembly Side)
----	--

TESTER CONNECTION	CONDITION	SPECIFIED CONDITION
e11-1 (CBI) - e11-3 (SHDI) and Body ground	Ignition switch off	10 MΩ or higher
e11-2 (CEI) - e11-3 (SHDI) and Body ground	Ignition switch off	10 MΩ or higher

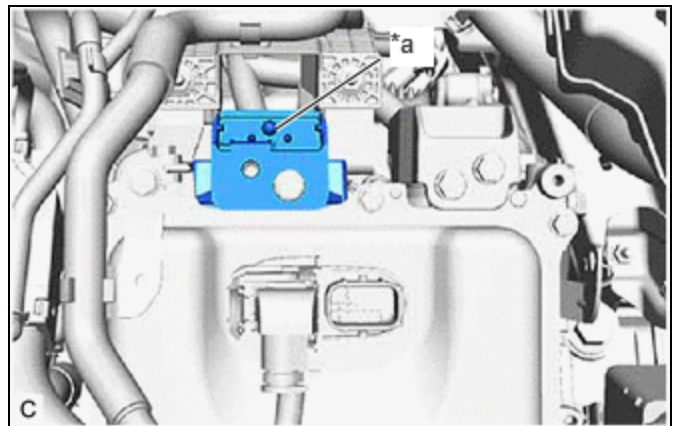
Perform this inspection with the HV floor under wire (rear traction motor cable) disconnected from the inverter with converter assembly.

*a	High Voltage Terminal
----	-----------------------

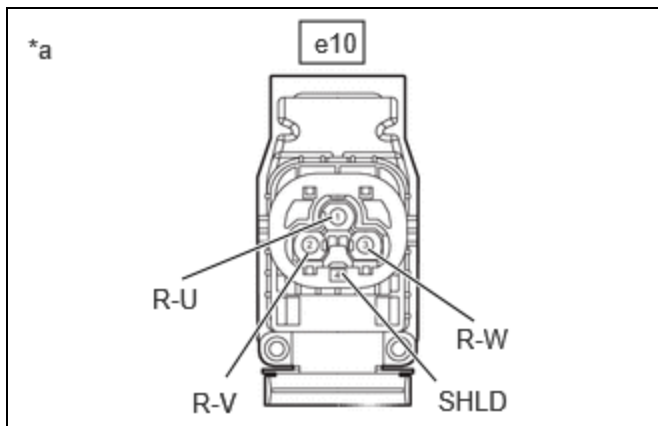
*a	HV Floor Under Wire (Rear Traction Motor Cable) (Inverter with Converter Assembly Side)
----	--
