# GTS+ ECU Flash Reprogramming With Security Signature

**Service Category** Engine/Hybrid System

**Section** Engine Control

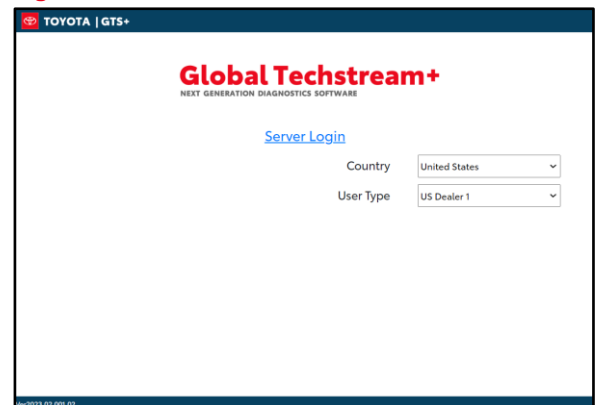
**Figure 1.**

3. Click Server Login.

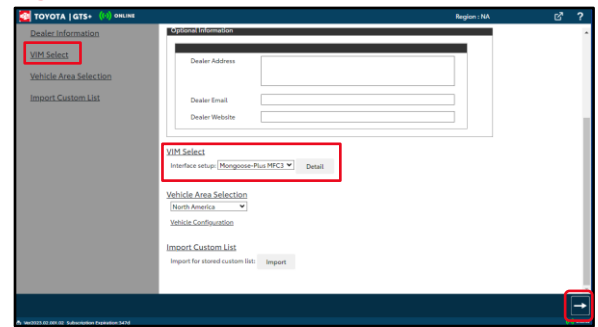
**Figure 2.**

1. Select GTS+ Settings from the Main Menu screen.
2. Select VIM Select from the GTS+ Settings menu.
3. Select the correct interface setup from the dropdown list.
  - Mongoose-Plus MFC3 VIM:
    - Techstream Lite w/Blue & Black Case w/Detachable Cable
    - Techstream ADVi w/Grey Case
  - MongoosePro MFC2 VIM:
    - Techstream Lite w/Green Case
    - Techstream ADVi w/Black Case
  - MongoosePro MFC VIM:
    - Techstream Lite w/Blue Case
    - Techstream Lite w/Updated Clear Case
    - Techstream 2.0

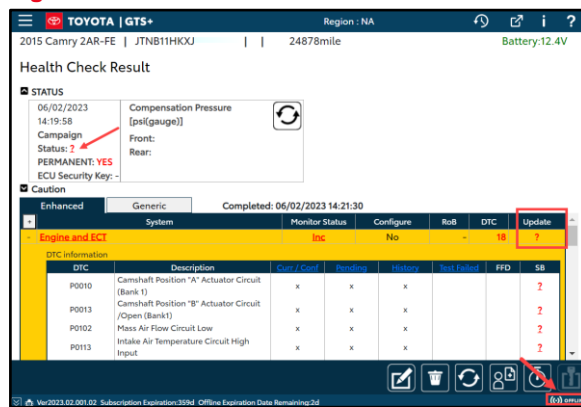
**Figure 3.**

- GTS+ will automatically search TIS for the appropriate Service Bulletin using the current calibration ID from the vehicle if the PC is connected to the network (see the figures below).
- Calibration file links can be found embedded in the corresponding Service Bulletin.

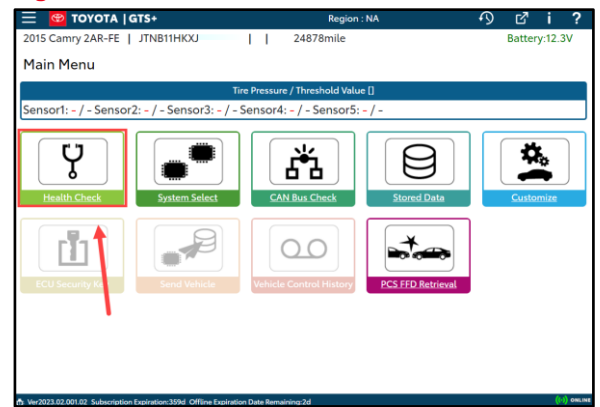
**Figure 5.**

1. Verify the vehicle’s applicability for recalibration and locate the desired calibration file.
  - A. Connect GTS+ and establish a vehicle connection.
  - B. Click the Health Check button on the Main Menu.

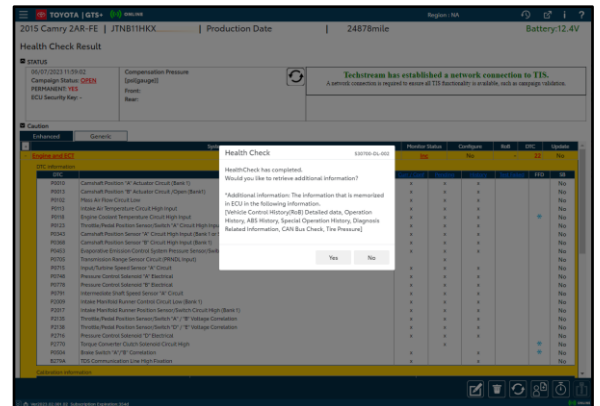
**Figure 6.**

- C. A Health Check completed window opens. To continue, click either Yes or No.
  - (1) Click Yes to include additional information in the Health Check.
  - (2) Click No if additional information is NOT desired.

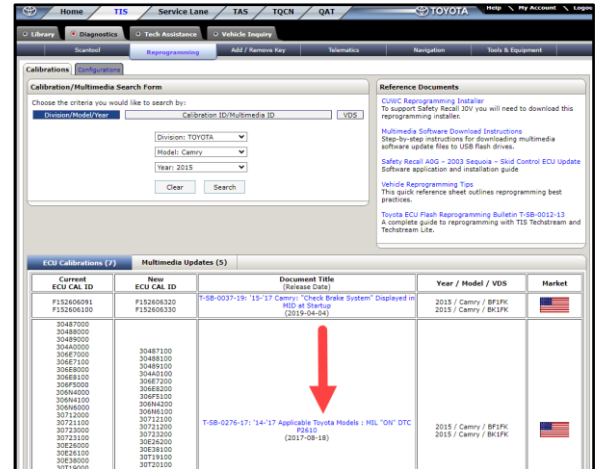
**Figure 8.**

- F. To review the Service Bulletin and access the calibration file, click the Service Bulletin link in the Document Title column of the Calibration Search Result portlet.

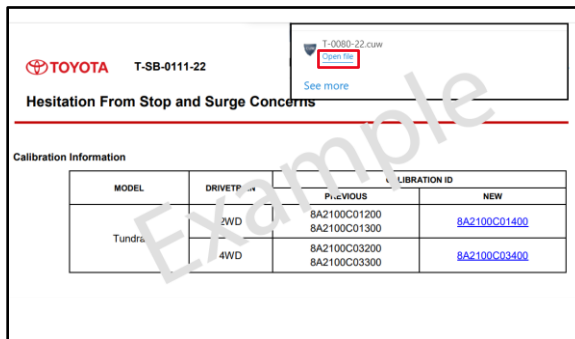
Figure 10.

- B. Click Open to load the calibration file information. If prompted to choose GTS or GTS+, select GTS+.

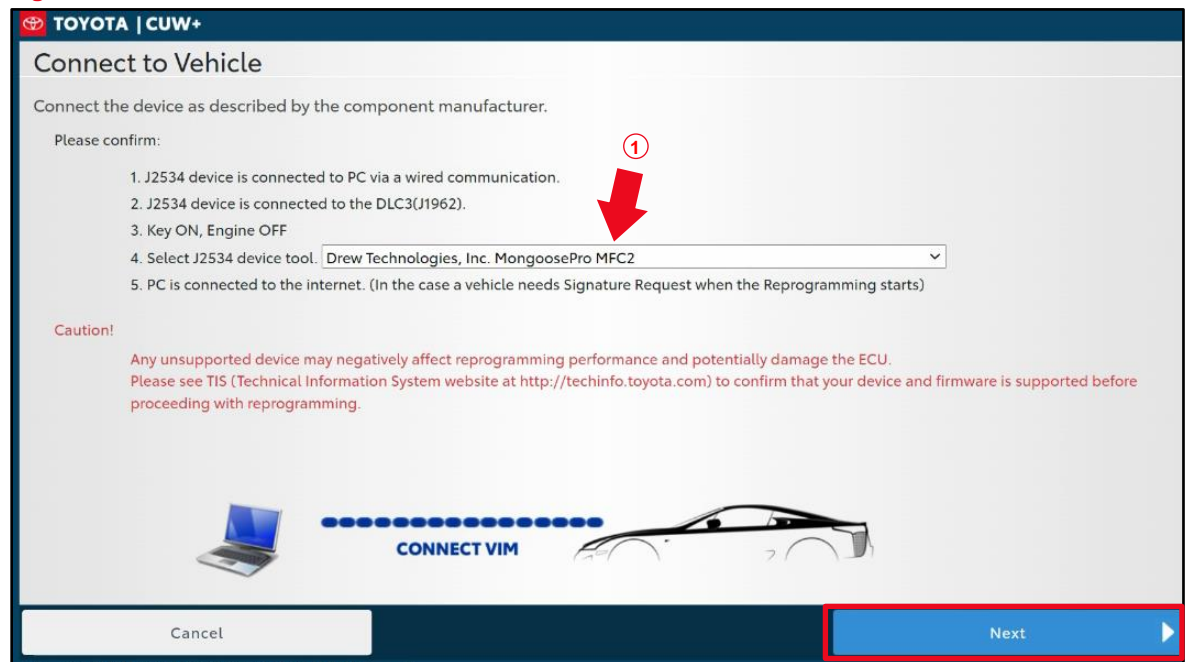
**Figure 13.**

- D. Confirm the following:

- The PC is connected to VIM.
- The VIM is connected to DLC3 connector.
- The Ignition is ON and the engine is OFF or READY-OFF (hybrid vehicles).

<b>1</b>	<b>Select the Correct Device Tool (“MongoosePro MFC,” “MongoosePro MFC2,” or “Mongoose-Plus MFC3” VIM)</b>
----------	--

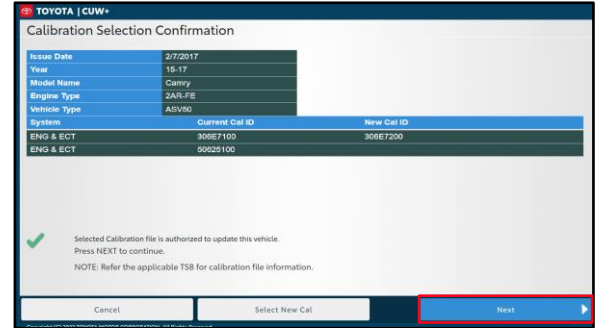
**Figure 14.**

- The total number of calibration IDs in the calibration file corresponds to the number of reprogrammable processors in the ECU.
- The figure to the right shows an example of the update procedure for a two-processor ECU.

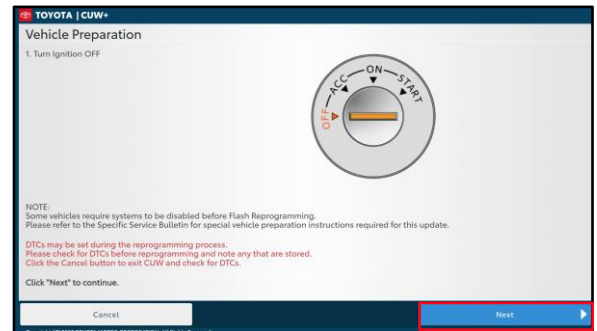
**Figure 15.**

- F. Turn the ignition OFF, click Next, and wait at least 10 seconds before proceeding.

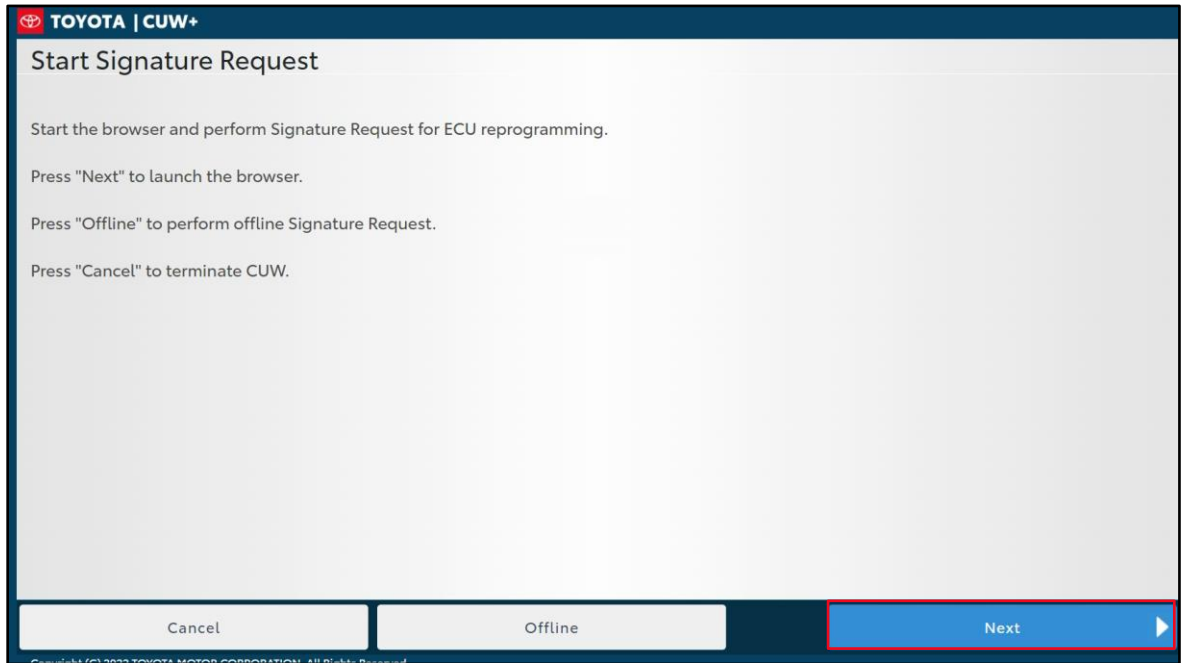
**Figure 17.**

- I. This vehicle is equipped with additional security measures requiring a Signature from TIS. Select Next to open TIS and retrieve the Signature.

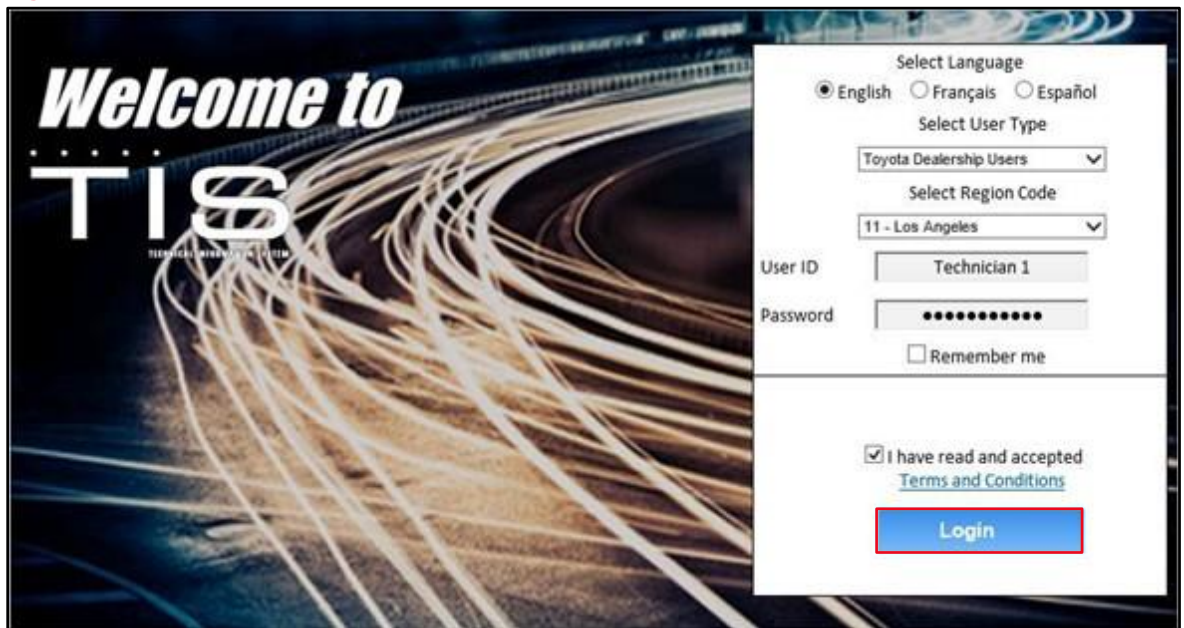
**Figure 18.**

- J. Input TIS login credentials and select Login.

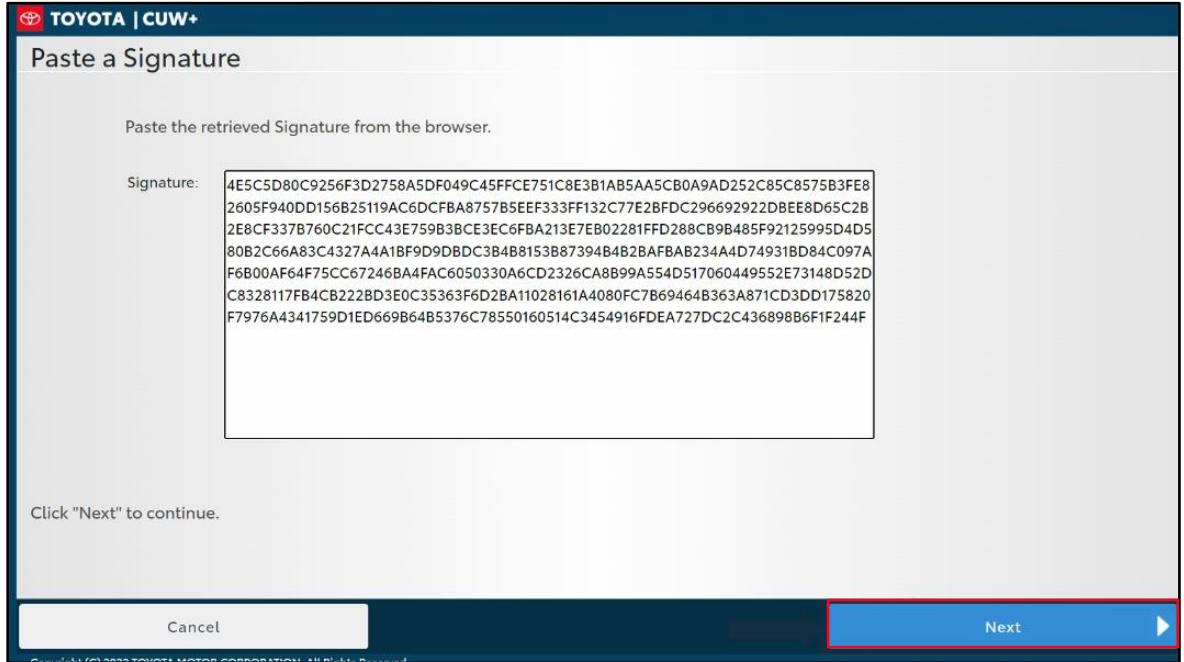
Figure 22.

N. Paste the Signature into CUW+ and select Next.

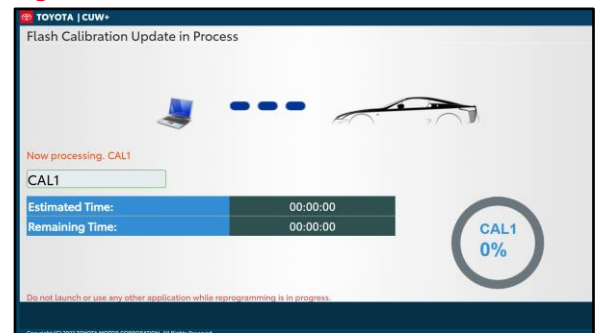
Figure 23.

O. Do NOT disturb the vehicle during flash reprogramming.

- ECU flash reprogramming may take 3 – 30 minutes per calibration file.
- Reprogramming time will vary depending on model and ECU communication protocol. Vehicles using CAN communication protocol will reprogram much faster (2 – 7 minutes).

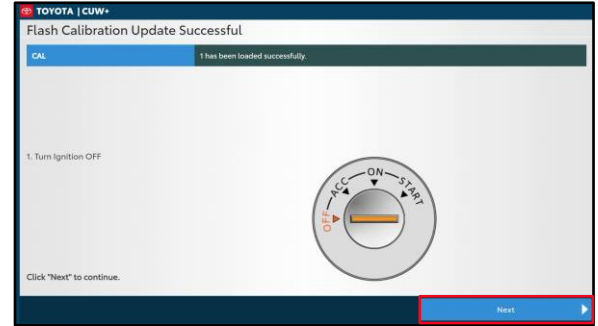
**Figure 24.**

- Q. When Cal 1 completes the update process, turn the ignition OFF, click Next, and wait a MINIMUM of 10 seconds before proceeding.

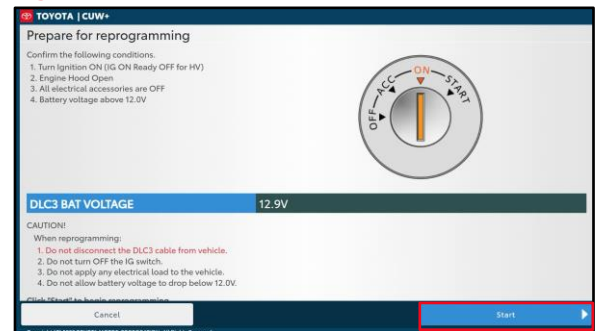
**Figure 25.**

- R. Turn the ignition to the ON position, then click Start.

If the key cycle is NOT done properly, reprogramming may fail, and an error message will appear prompting you to restart Cal 2.

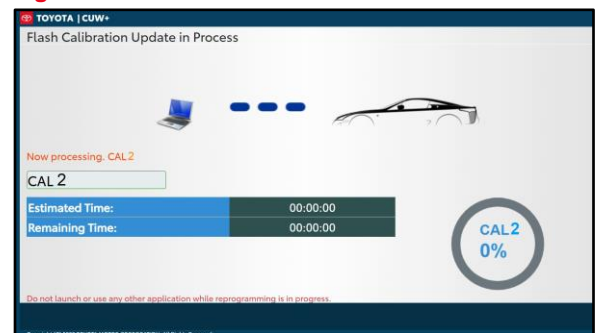
**Figure 26.**

- S. Do NOT disturb the vehicle during flash reprogramming.

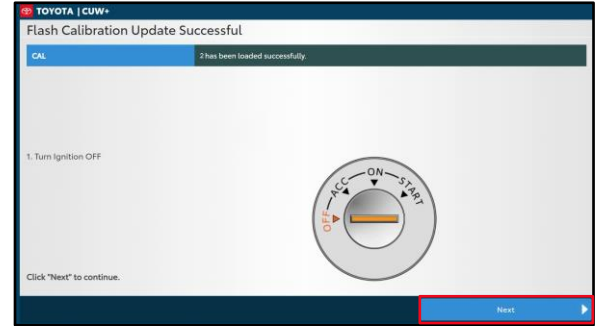
**Figure 27.**

- T. Turn the ignition OFF, click Next, and wait a MINIMUM of 10 seconds before proceeding.

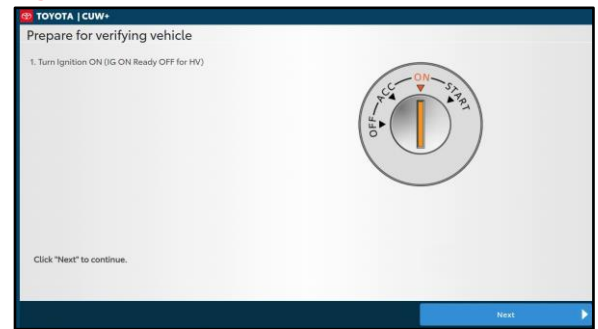
**Figure 28.**

- U. Turn the ignition to the ON position, then click Next.

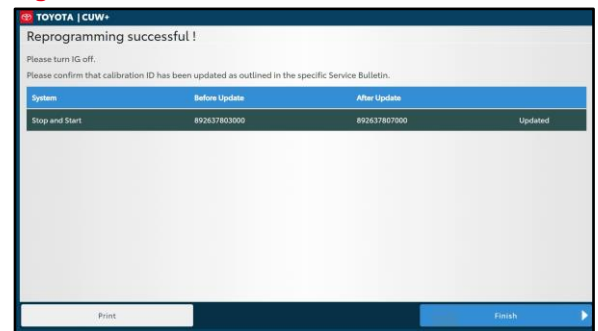
**Figure 29.**

- V. Confirm calibrations were updated and click Finish.
