Accurate Inspection of Damaged Parts (Visual)

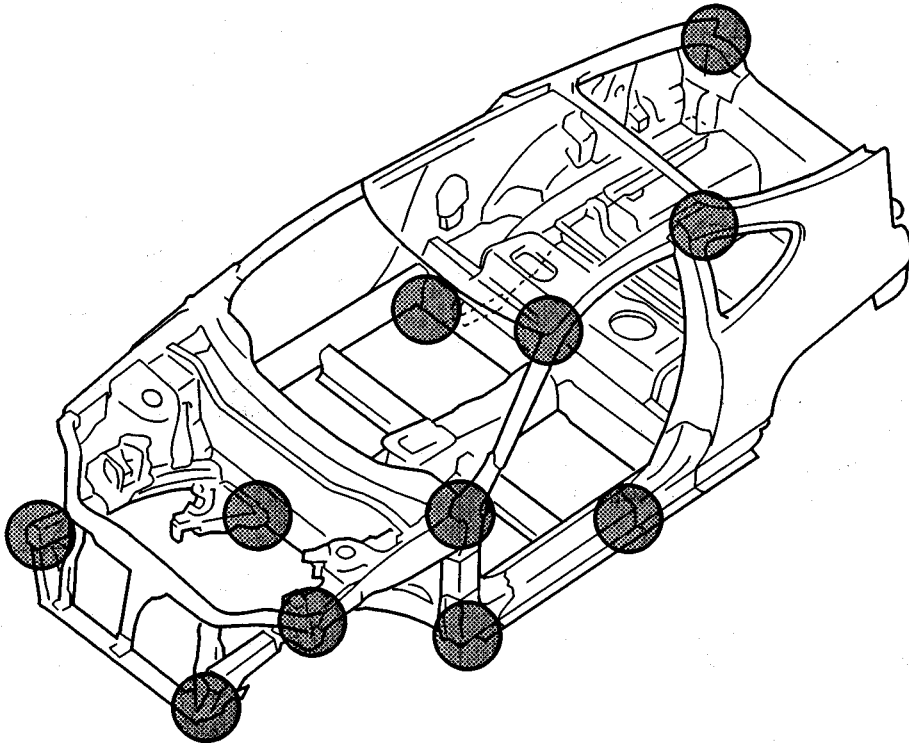
Distortion to the vehicle, bends, inclines, and gaps between parts should be thoroughly checked. Also, check for paint peeling at welded areas corners and the sealing coat.

: Carefully checked.
