Applies To: **2000 Insight – ALL**
May 15, 2003
2001 Insight with M/T – From VIN JHMZE1...1T000001 thru JHMZE1...1T001923

Product Update: Insight Parking Brake Lever

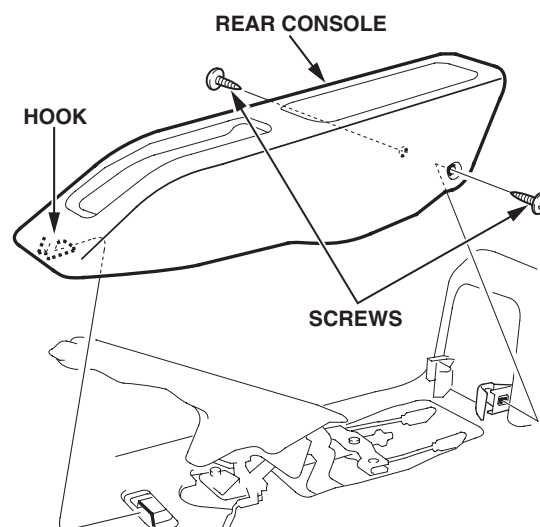
1. Remove the rear console:
 - Remove the two screws.
 - Move the console forward to detach it from the hook.

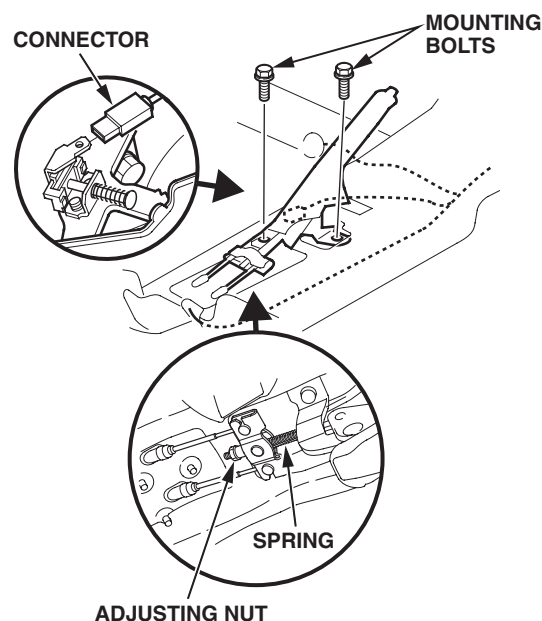
2. Remove the parking brake lever:
 - Remove the adjusting nut and the spring.
 - Disconnect the parking brake switch connector.
 - Remove the two mounting bolts.

3. Install the new parking brake lever, and torque the mounting bolts to 22 N·m (16 lb-ft).
4. Connect the parking brake switch connector, then install the original spring and the adjusting nut.
5. Block the front wheels, then raise the rear of the vehicle, and support it with safety stands.
6. Pull up the parking brake lever one click.
7. Tighten the parking brake lever adjusting nut until you get a slight drag on the rear brakes when you turn the rear wheels.
8. Release the parking brake lever. If the rear wheels don't turn freely, repeat steps 6 thru 8.
9. Lower the vehicle.
10. Install the rear center console.
11. Center-punch a completion mark above the tenth character of the engine compartment VIN.
