<b>Last Modified:</b> 12-04-2024	6.11:8.1.0	<b>Doc ID:</b> RM1000000289PM
<b>Model Year Start:</b> 2023	<b>Model:</b> Prius Prime	<b>Prod Date Range:</b> [12/2022 - ]
<b>Title:</b> ADVANCED DRIVER ASSISTANCE SYSTEM: AUTOMATIC HIGH BEAM MAIN SWITCH: REMOVAL; 2023 - 2024 MY Prius Prius Prime [12/2022 - ]

## REMOVAL

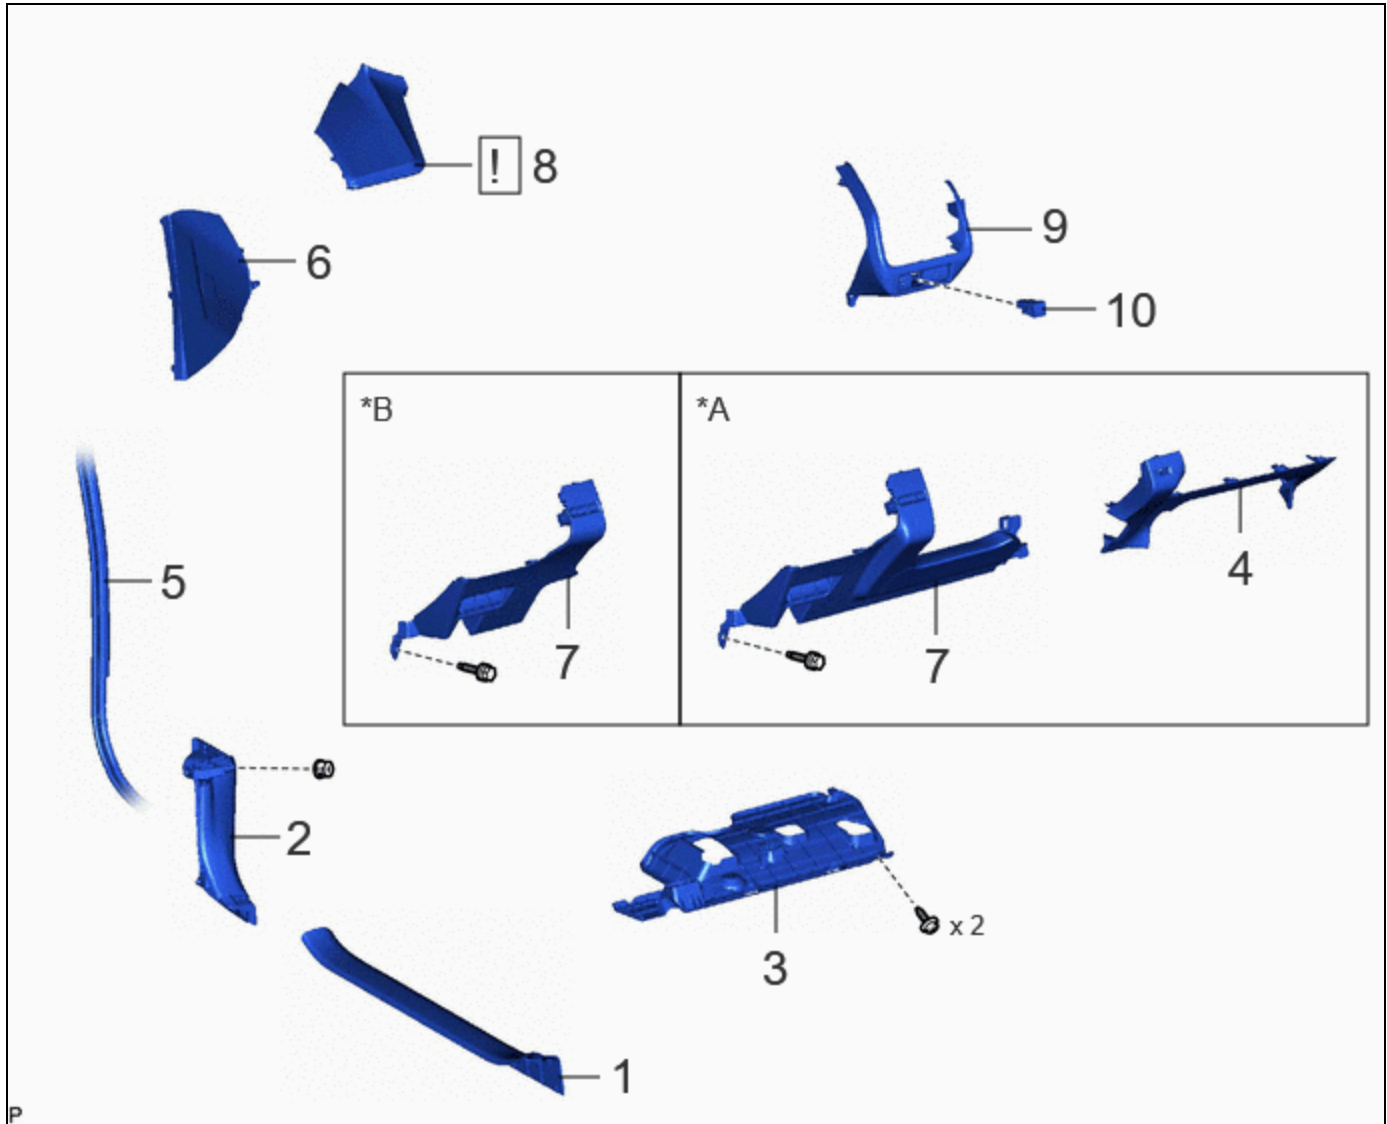
#### COMPONENTS (REMOVAL)

PROCEDURE		PART NAME CODE			
1	FRONT DOOR SCUFF PLATE LH	67914	-	-	-
2	COWL SIDE TRIM BOARD LH	62112	-	-	-

3	NO. 1 INSTRUMENT PANEL UNDER COVER SUB-ASSEMBLY	55606	-	-	-
4	LOWER CENTER INSTRUMENT PANEL FINISH PANEL	55434B	-	-	-
5	FRONT DOOR OPENING TRIM WEATHERSTRIP LH	62312B	-	-	-
6	INSTRUMENT SIDE PANEL LH	55318C	-	-	-
7	LOWER INSTRUMENT PANEL FINISH PANEL ASSEMBLY	55480D	-	-	-
8	INSTRUMENT CLUSTER FINISH PANEL ASSEMBLY	55410C	<a href="#">INFO</a>	-	-
9	NO. 1 INSTRUMENT PANEL GARNISH SUB-ASSEMBLY	55011A	-	-	-
10	AUTO HIGH BEAM SWITCH	84153	-	-	-

*A	w/o Knee Airbag	*B	w/ Knee Airbag
----	-----------------	----	----------------

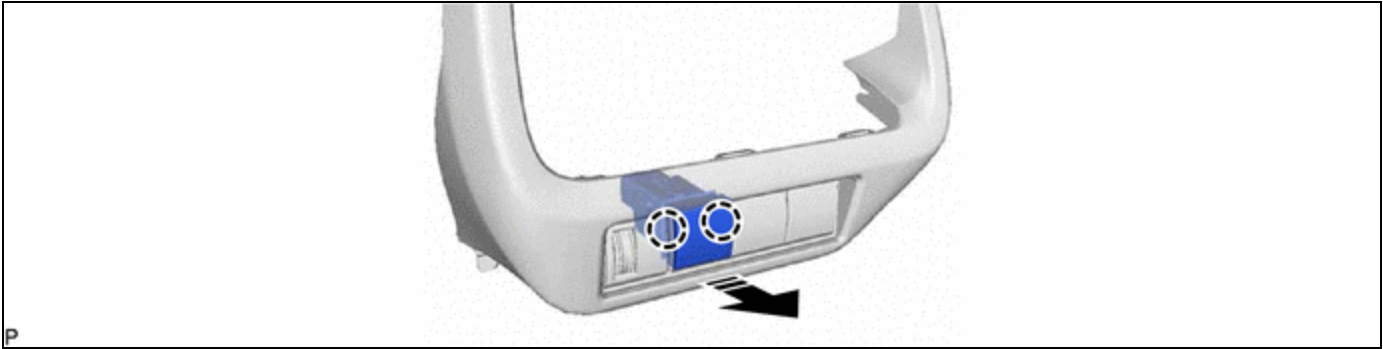
### 10. REMOVE AUTO HIGH BEAM SWITCH

Remove in this Direction	-	-
---	--------------------------	---	---
