Last Modified: 12-04-2024	6.11:8.1.0	Doc ID: RM100000002BZ6U
Model Year Start: 2023	Model: Prius Prime	Prod Date Range: [03/2023 -]
Title: AUDIO / VIDEO: AMPLIFIER ANTENNA: REMOVAL; 2023 - 2024 MY Prius Prius Prime [03/2023 -]

REMOVAL

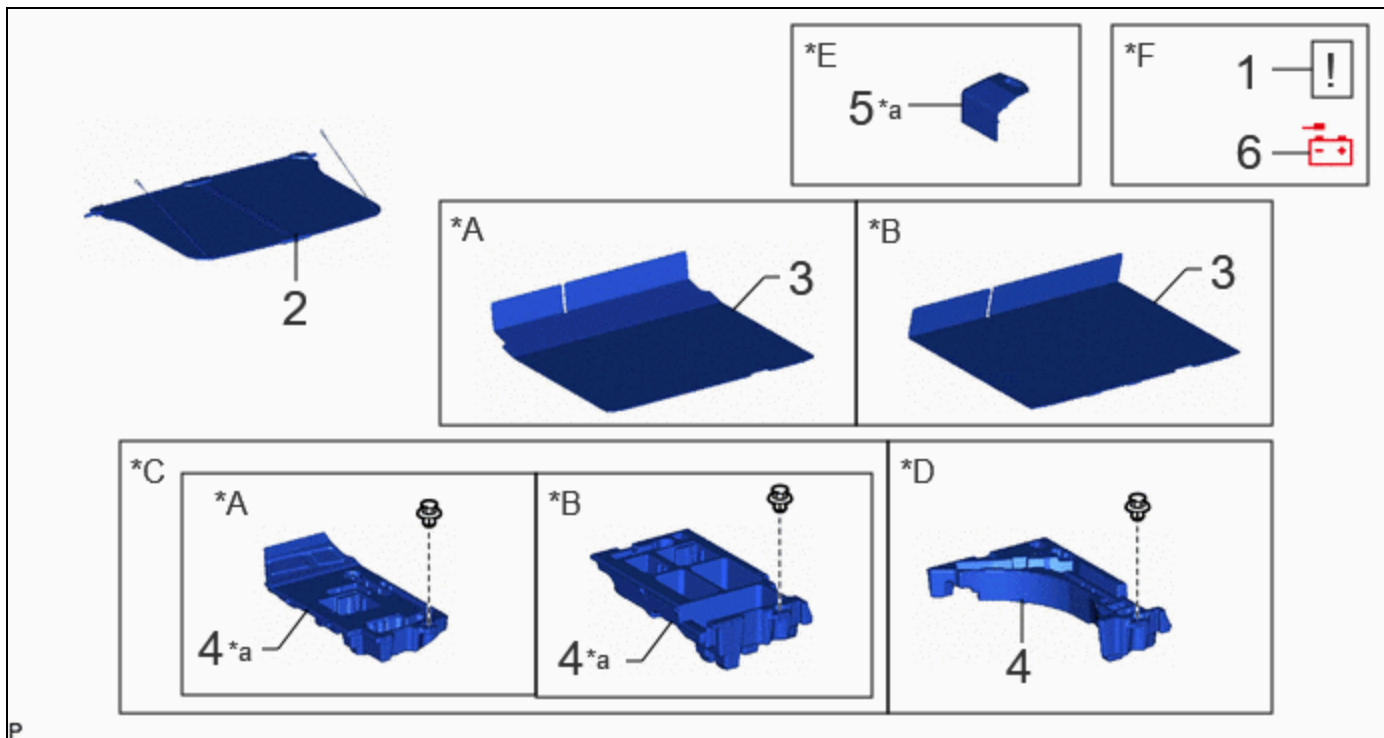
COMPONENTS (REMOVAL)

PROCEDURE		PART NAME CODE			
1	PRECAUTION	-	INFO	-	-
2	TONNEAU COVER ASSEMBLY	64910J	-	-	-

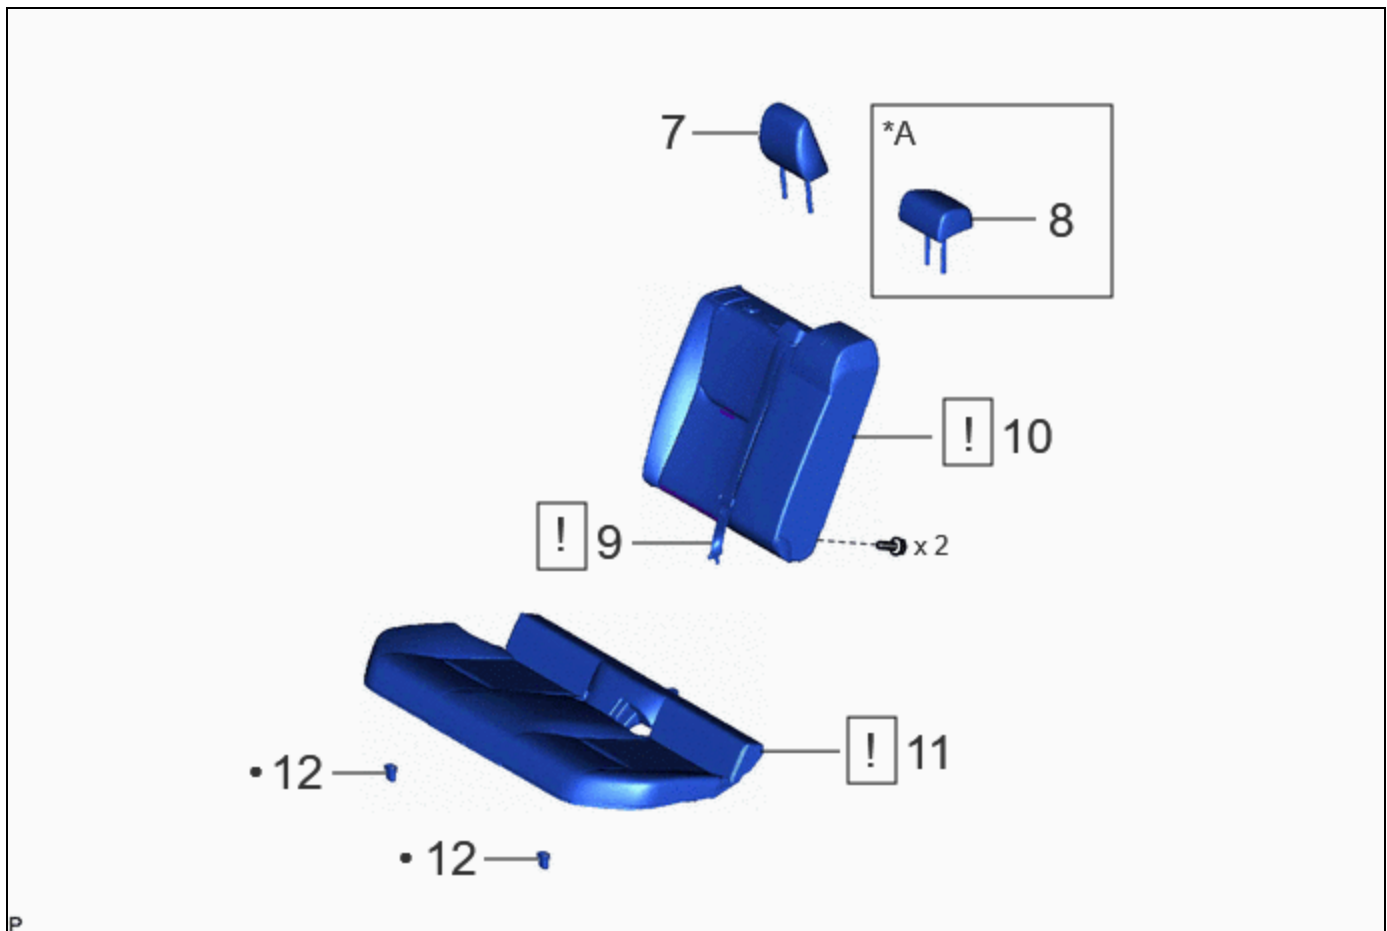
7	REAR SEAT HEADREST ASSEMBLY	71940A	-	-	-
8	REAR SEAT CENTER HEADREST ASSEMBLY	71960B	-	-	-
9	REAR CENTER SEAT OUTER BELT ASSEMBLY	73350C	INFO	-	-
10	REAR SEATBACK ASSEMBLY RH	-	INFO	-	-
11	REAR SEAT CUSHION ASSEMBLY	-	INFO	-	-
12	REAR SEAT CUSHION LOCK HOOK	72693	-	-	-

*A	w/ Center Headrest	-	-
•	Non-reusable part	-	-

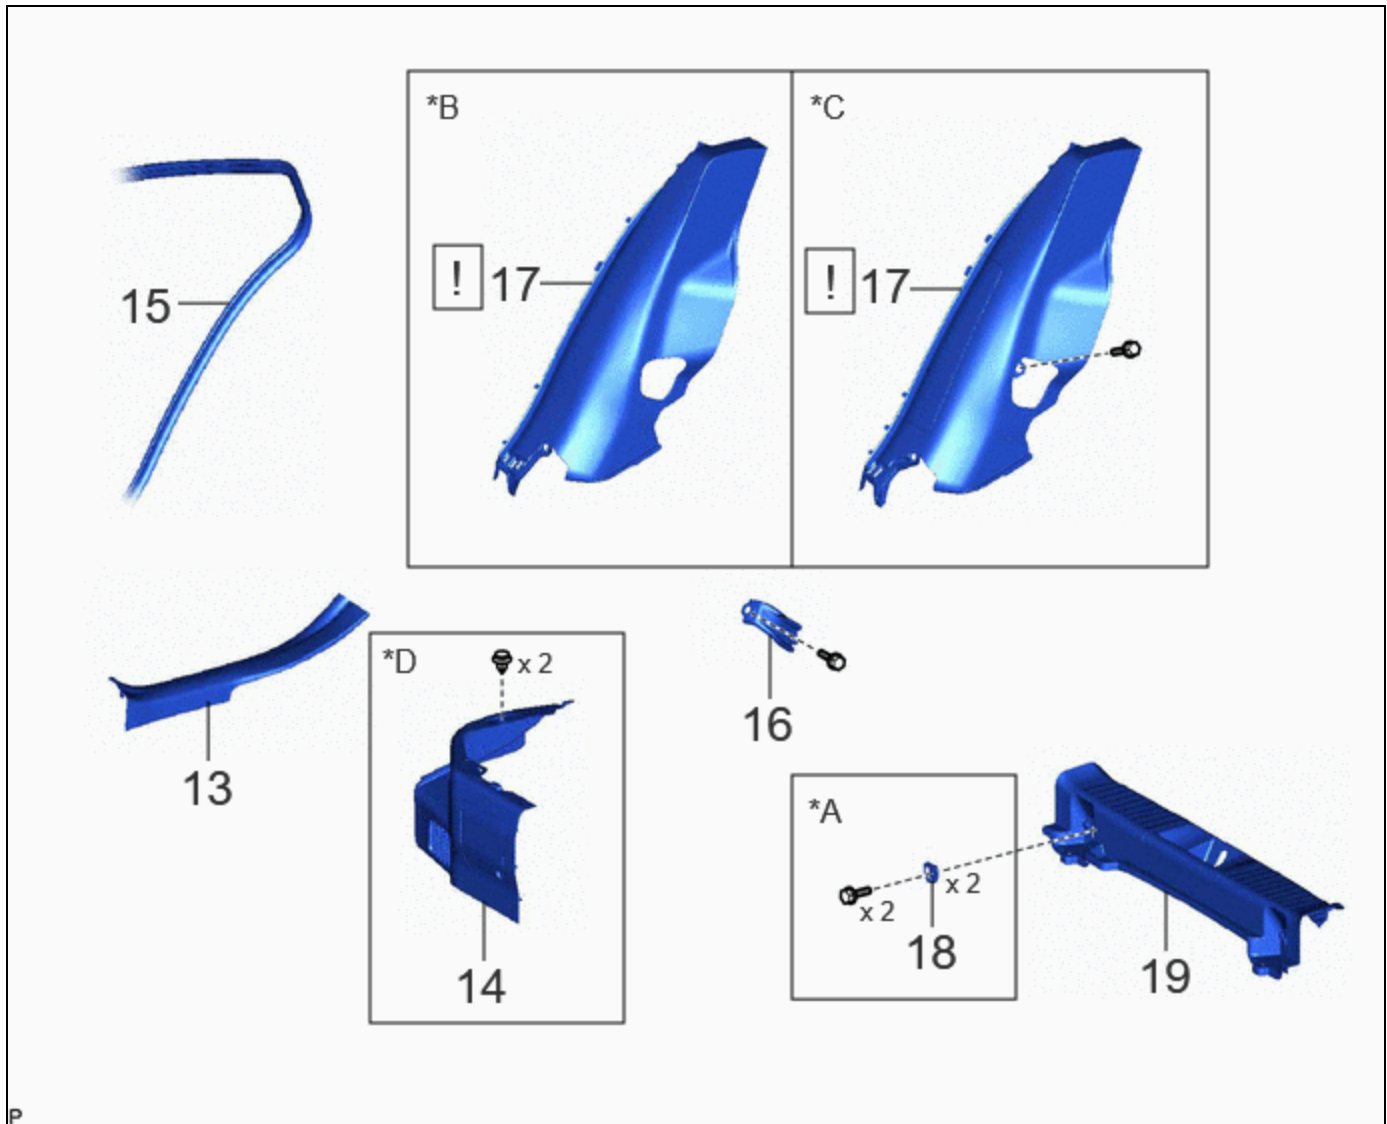
13	REAR DOOR SCUFF PLATE INSIDE RH	67917F	-	-	-
14	REAR UNDER SIDE COVER RH	76973E	-	-	-
15	REAR DOOR OPENING TRIM WEATHERSTRIP RH	62331A	-	-	-
16	REAR SEATBACK HINGE SUB-ASSEMBLY RH	71303C	-	-	-
17	REAR SEAT SIDE GARNISH RH	62551F	INFO	-	-
18	LUGGAGE HOLD BELT STRIKER ASSEMBLY	58460D	-	-	-
19	REAR DECK TRIM COVER	64716D	-	-	-

*A	for Rear Side	*B	w/o Rear Seat Side Airbag
*C	w/ Rear Seat Side Airbag	*D	for HEV Model

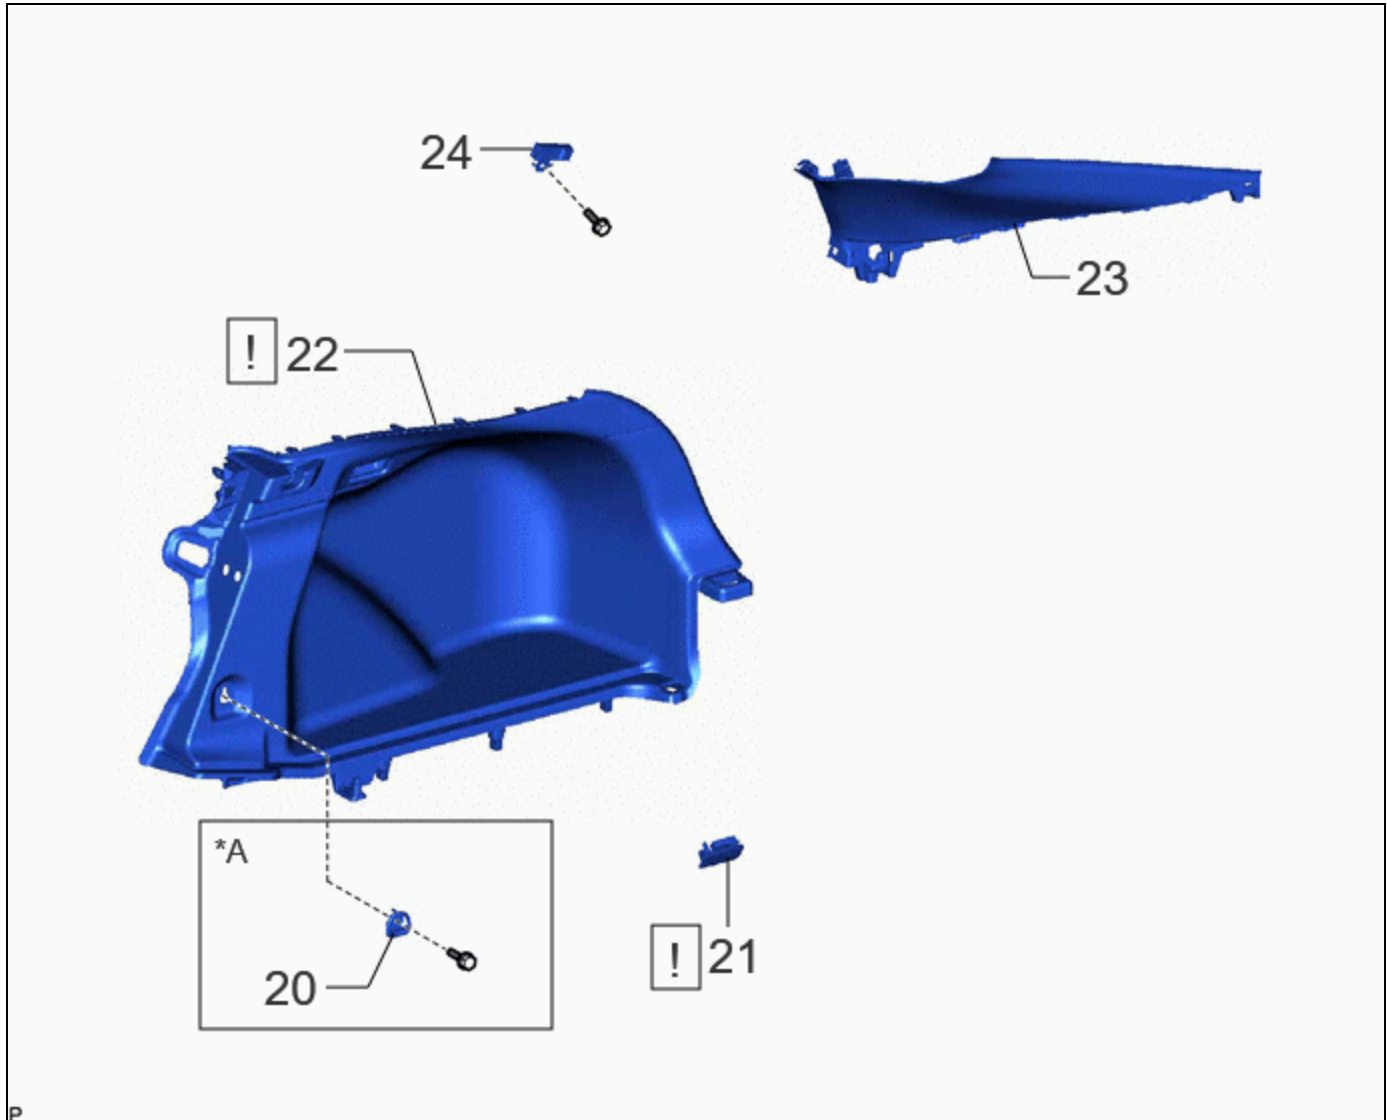
20	LUGGAGE HOLD BELT STRIKER ASSEMBLY	58460D	-	-	-
21	NO. 1 LUGGAGE COMPARTMENT LIGHT ASSEMBLY	81330	INFO	-	-
22	DECK TRIM SIDE PANEL ASSEMBLY RH	64730B	INFO	-	-
23	ROOF SIDE INNER GARNISH ASSEMBLY RH	62470A	-	-	-
24	NO. 1 AMPLIFIER ANTENNA ASSEMBLY	86300B	-	-	-

*A	for RH Side	-	-
----	-------------	---	---
