Last Modified: 12-04-2024	6.11:8.1.0	Doc ID: RM100000002BLBZ	
Model Year Start: 2023	Model: Prius Prime	Prod Date Range: [03/2023 -]
Title: AUDIO / VIDEO: MICROPHONE: REMOVAL; 2023 - 2024 MY Prius Prius Prime [03/2023 -]

REMOVAL

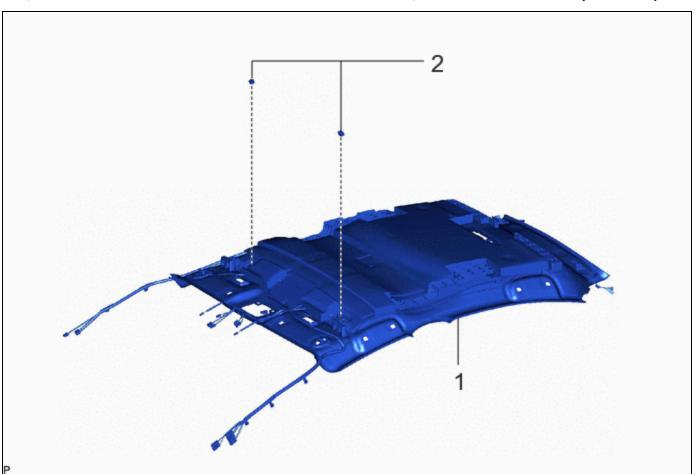
COMPONENTS (REMOVAL)

PROCEDURE	PART NAME CODE	!		
1 ROOF HEADLINING ASSEMBLY	-	-	-	-
2 TELEPHONE MICROPHONE ASSEMBLY	86730A	-	-	-

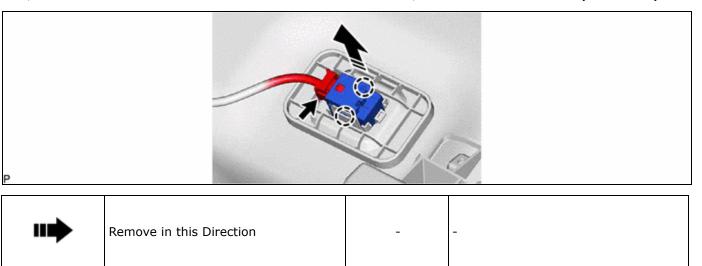
2. REMOVE TELEPHONE MICROPHONE ASSEMBLY

Use the same procedure for the RH side and LH side.
