Last Modified: 12-04-2024	6.11:8.1.0	Doc ID: RM100000002BZ6X
Model Year Start: 2023	Model: Prius Prime	Prod Date Range: [03/2023 -]
Title: AUDIO / VIDEO: NOISE FILTER: REMOVAL; 2023 - 2024 MY Prius Prius Prime [03/2023 -]

REMOVAL

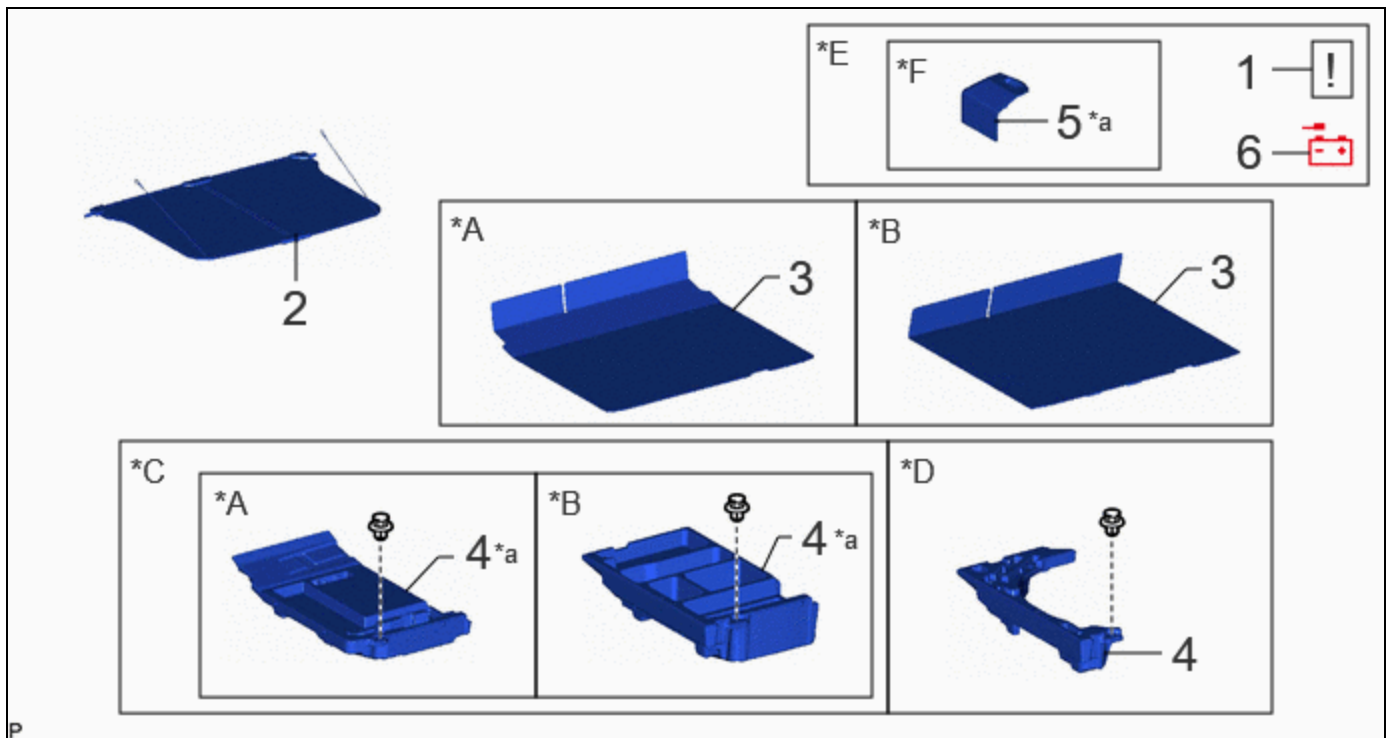
COMPONENTS (REMOVAL)

PROCEDURE	PART NAME CODE			
1 PRECAUTION	-	INFO	-	-
2 TONNEAU COVER ASSEMBLY	64910J	-	-	-

3	DECK BOARD ASSEMBLY	58410B	-	-	-
4	DECK FLOOR BOX LH	64997	-	-	-
5	BATTERY SERVICE HOLE COVER ASSEMBLY	58440	-	-	-
6	DISCONNECT CABLE FROM NEGATIVE AUXILIARY BATTERY TERMINAL	-	-	-	-

*A	for Type A	*B	for Type B
*C	w/o Spare Tire	*D	w/ Spare Tire
*E	w/ Rear Seat Side Airbag	*F	for M20A-FXS
*a	<p>HINT: As the illustration shown is an example, the actual details may differ.</p>	-	-

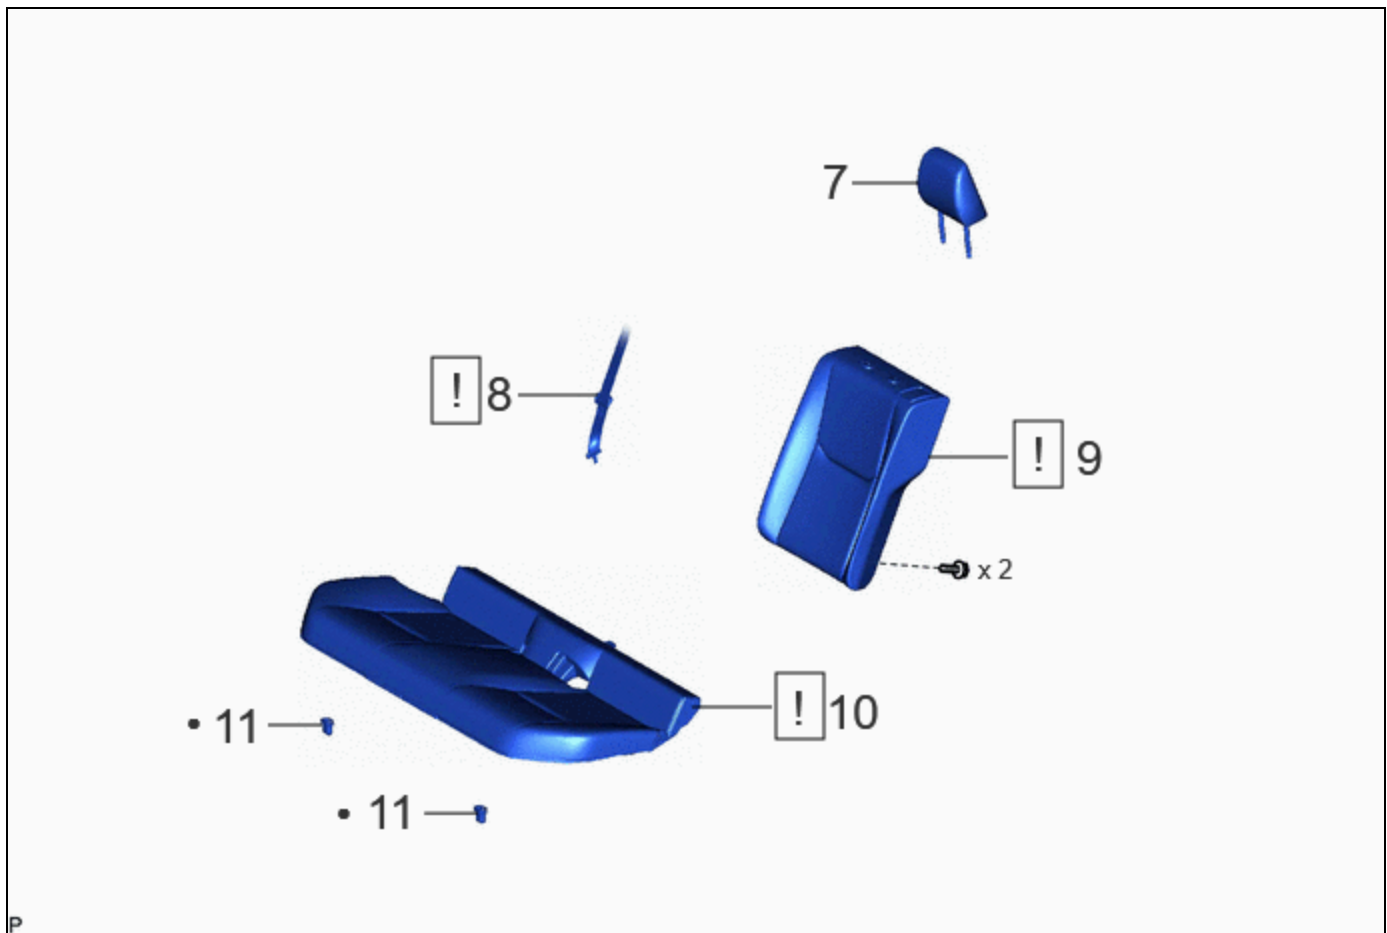
7	REAR SEAT HEADREST ASSEMBLY	71940A	-	-	-
8	REAR CENTER SEAT OUTER BELT ASSEMBLY	73350C	INFO	-	-
9	REAR SEATBACK ASSEMBLY LH	-	INFO	-	-
10	REAR SEAT CUSHION ASSEMBLY	-	INFO	-	-
11	REAR SEAT CUSHION LOCK HOOK	72693	-	-	-

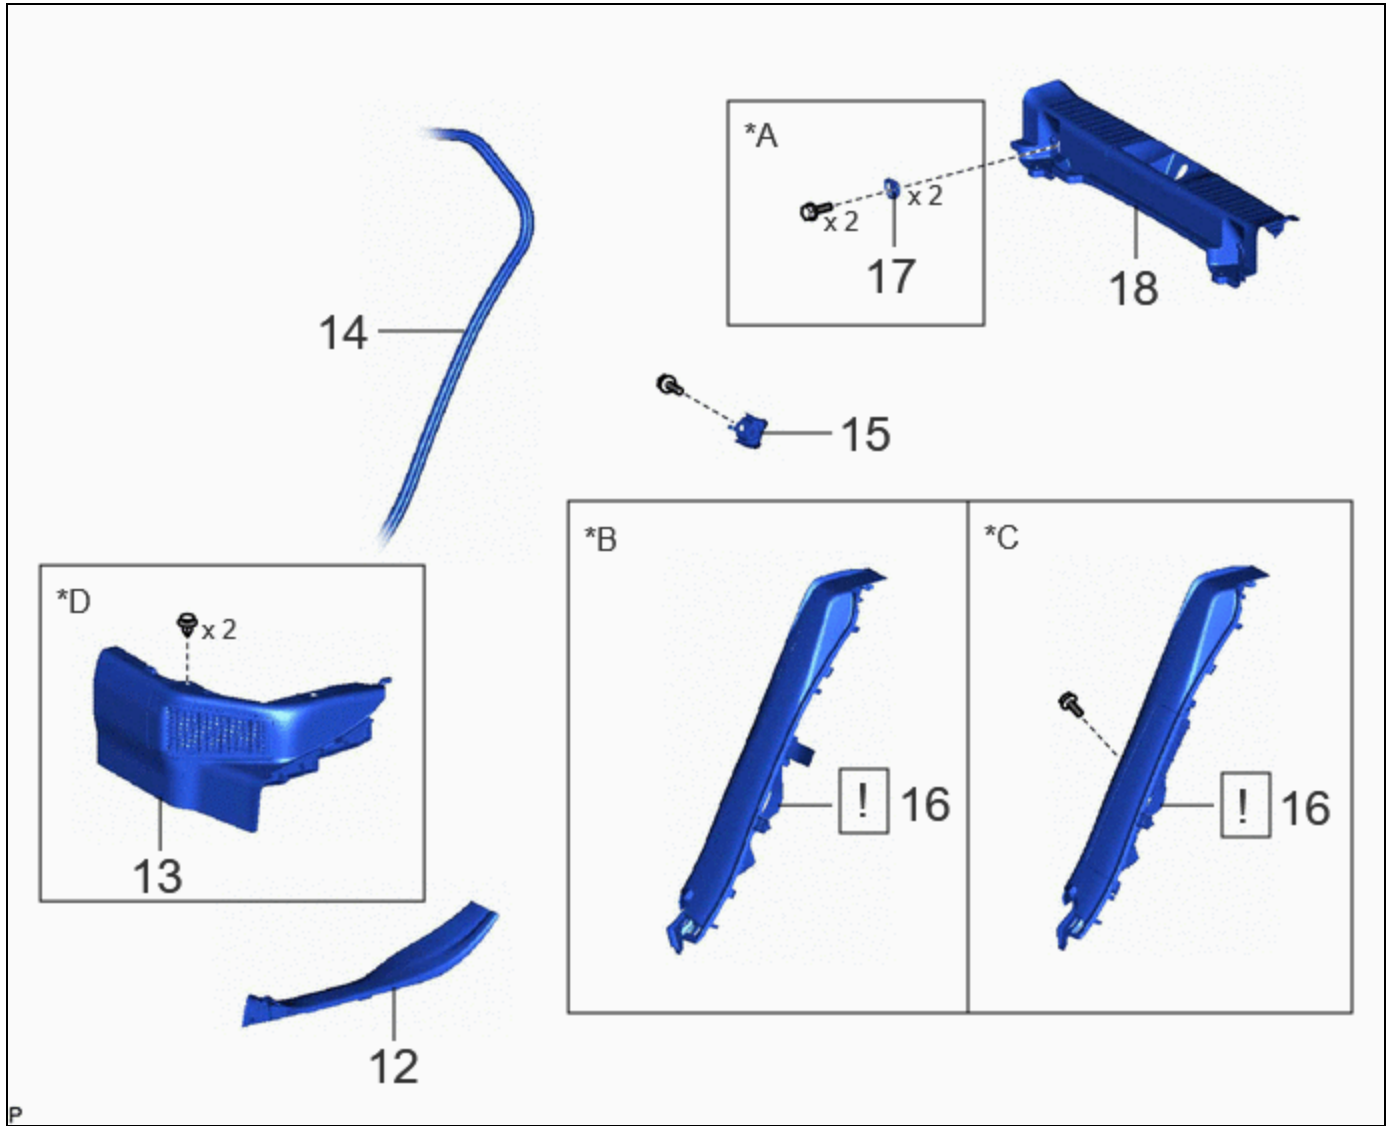
12	REAR DOOR SCUFF PLATE INSIDE LH	67918F	-	-	-
13	REAR UNDER SIDE COVER LH	76974E	-	-	-

14	REAR DOOR OPENING TRIM WEATHERSTRIP LH	62332A	-	-	-
15	REAR SEATBACK HINGE SUB-ASSEMBLY LH	71304C	-	-	-
16	REAR SEAT SIDE GARNISH LH	62552F	INFO	-	-
17	LUGGAGE HOLD BELT STRIKER ASSEMBLY	58460D	-	-	-
18	REAR DECK TRIM COVER	64716D	-	-	-

*A	for Rear Side	*B	w/o Rear Seat Side Airbag
*C	w/ Rear Seat Side Airbag	*D	for HEV Model

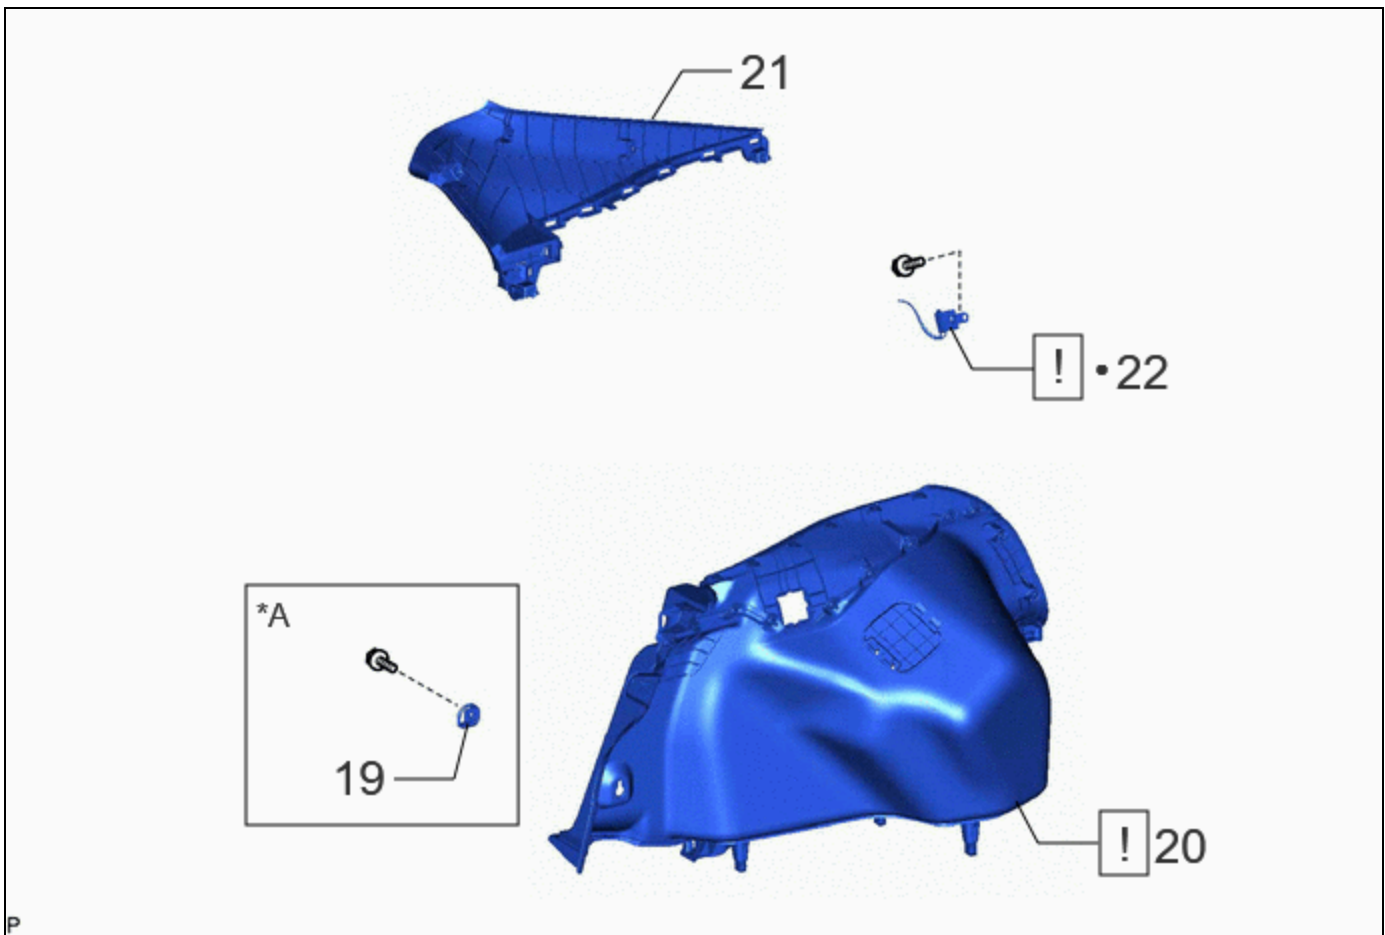
19	LUGGAGE HOLD BELT STRIKER ASSEMBLY	58460D	-	-	-
20	DECK TRIM SIDE PANEL ASSEMBLY LH	64740C	INFO	-	-
21	ROOF SIDE INNER GARNISH ASSEMBLY LH	62480A	-	-	-
22	RADIO SETTING CONDENSER	86011A	INFO	-	-

*A	for LH Side	•	Non-reusable part
----	-------------	---	-------------------

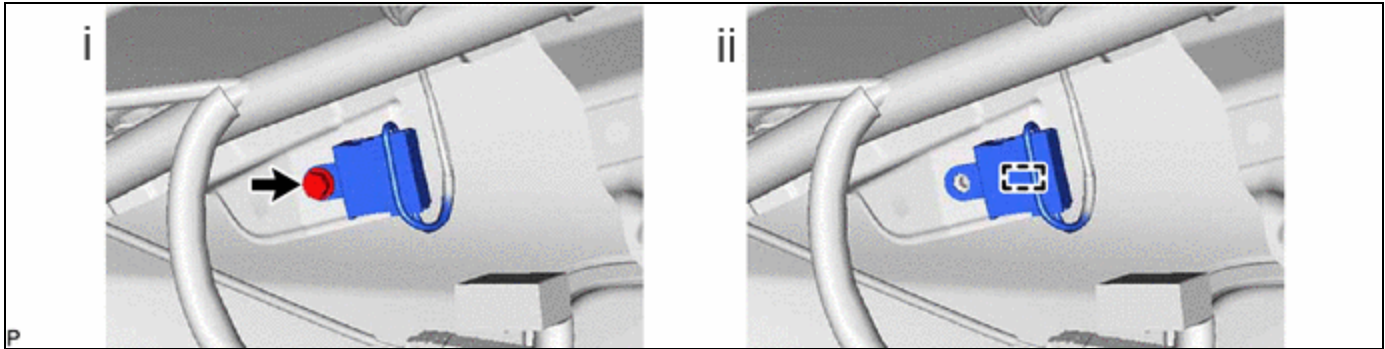
22. REMOVE RADIO SETTING CONDENSER

- (1) Remove the bolt.
- (2) Disengage the clamp and disconnect the radio setting condenser with wire harness from the vehicle body.

<p>NOTICE:</p> <p>When a terminal cover is removed, the radio setting condenser must be replaced because the terminal covers and condenser are supplied as a set.</p>
---	--

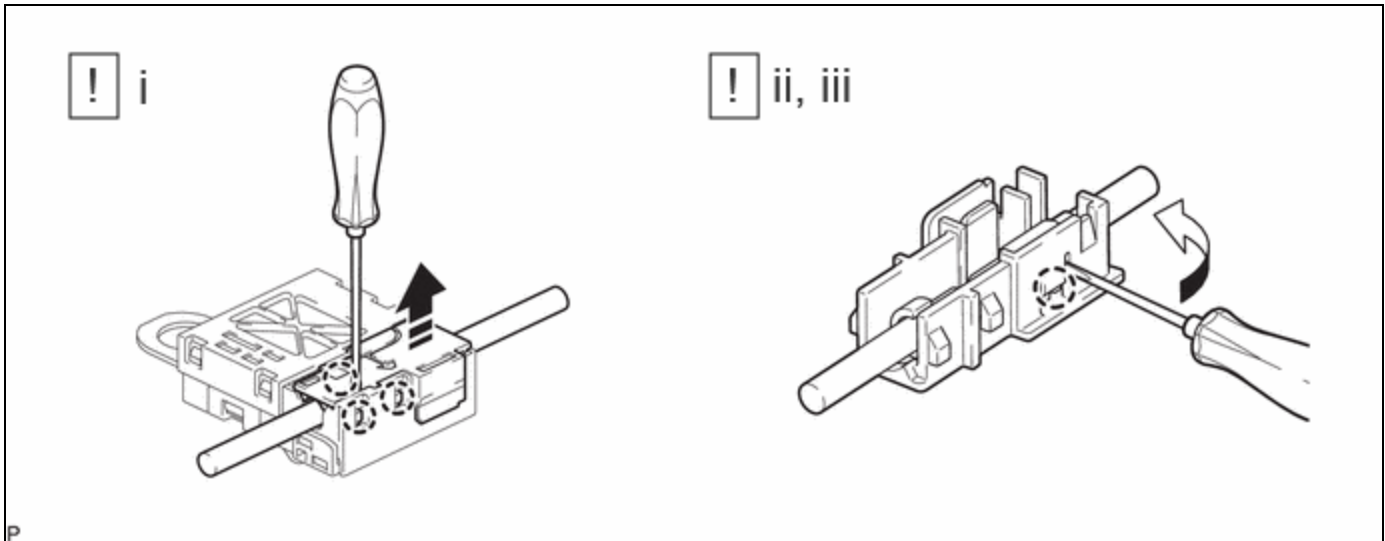
Remove in this Direction	-	-
---	--------------------------	---	---

- (1) Using a screwdriver, disengage the 3 claws and remove the terminal cover with wire harness from the condenser as shown in the illustration.
- (2) Using a screwdriver, bend back and break off the claw as shown in the illustration.
- (3) Remove the terminal cover from the wire harness.

- Make sure to hold the crimped side of the terminal when disconnecting the wire harness from the terminal cover.
- Make sure not to bend the exposed wire when disconnecting the wire harness from the terminal cover.
- Check for deformation of the terminal after the wire harness has been removed from the terminal cover.
