Last Modified: 12-04-2024	6.11:8.1.0	Doc ID: RM100000028VQX
Model Year Start: 2023	Model: Prius Prime	Prod Date Range: [12/2022 -]
Title: PARK ASSIST / MONITORING: INTUITIVE PARKING ASSIST SYSTEM: C1AE187; Ultrasonic Sensor (Front Left Corner) Missing Message; 2023 - 2024 MY Prius Prius Prime [12/2022 -]

DTC	C1AE187	Ultrasonic Sensor (Front Left Corner) Missing Message
------------	----------------	--

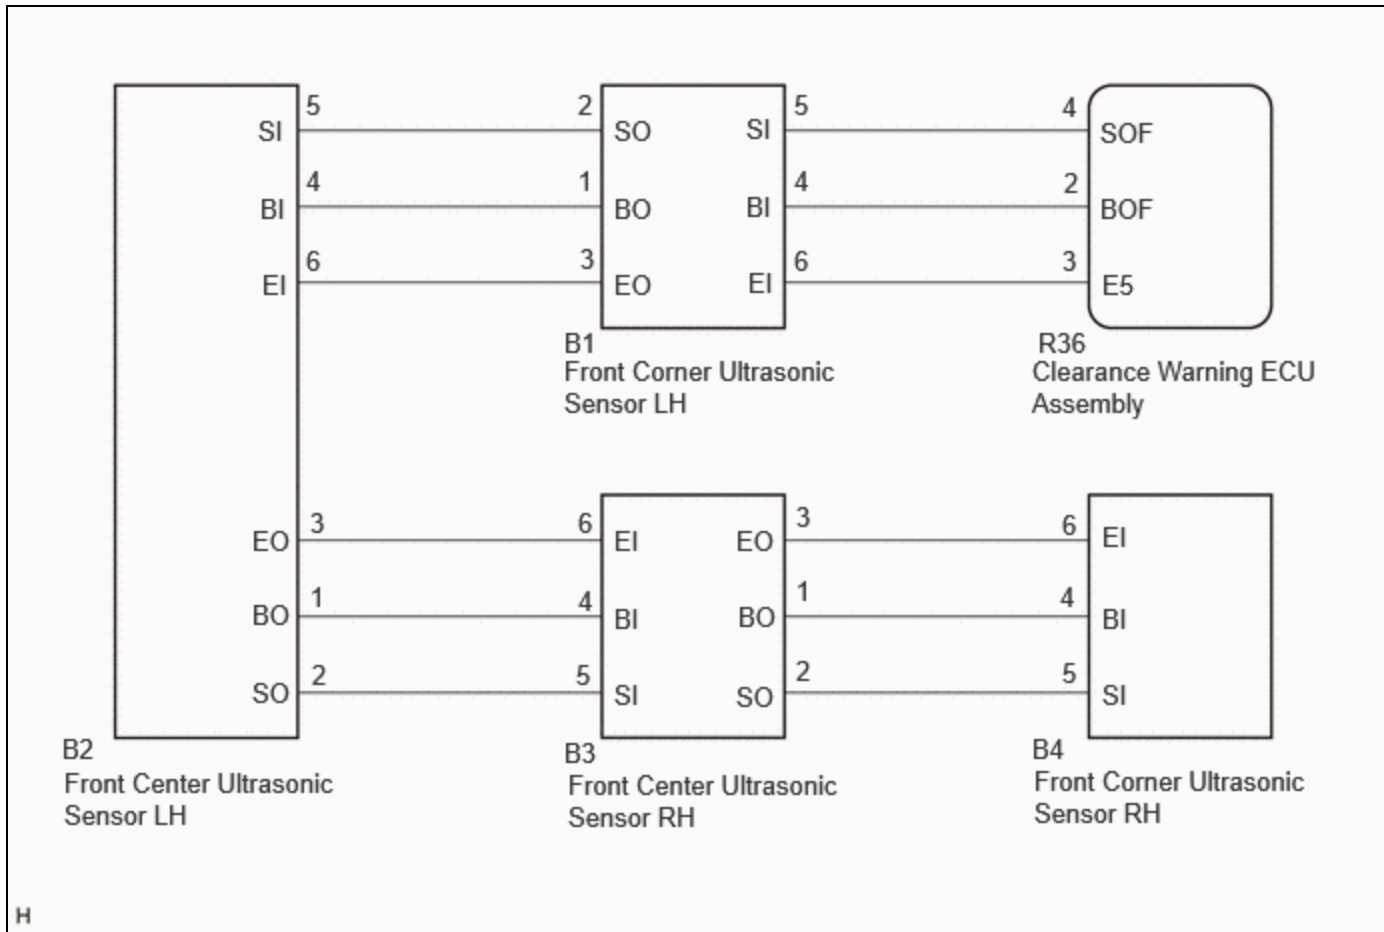
WIRING DIAGRAM

This DTC is stored when an open circuit or short occurs in the communication line between the front corner ultrasonic sensor LH and the clearance warning ECU assembly, or when a malfunction occurs in the front corner ultrasonic sensor LH.

- (a) Disconnect the R36 clearance warning ECU assembly connector.
- (b) Disconnect the B1 front corner ultrasonic sensor LH connector.

TESTER CONNECTION	CONDITION	SPECIFIED CONDITION	RESULT
R36-2 (BOF) - B1-4 (BI)	Always	Below 1 Ω	Ω
R36-4 (SOF) - B1-5 (SI)	Always	Below 1 Ω	Ω
R36-3 (E5) - B1-6 (EI)	Always	Below 1 Ω	Ω
R36-2 (BOF) or B1-4 (BI) - Body ground	Always	10 kΩ or higher	kΩ
R36-4 (SOF) or B1-5 (SI) - Body ground	Always	10 kΩ or higher	kΩ
R36-3 (E5) or B1-6 (EI) - Body ground	Always	10 kΩ or higher	kΩ
