Last Modified: 12-04-2024	6.11:8.1.0	Doc ID: RM1000000028XBH
Model Year Start: 2023	Model: Prius Prime	Prod Date Range: [12/2022 -]
Title: M20A-FXS (STARTING): POWER SWITCH: REMOVAL; 2023 - 2024 MY Prius Prius Prime [12/2022 -]

REMOVAL

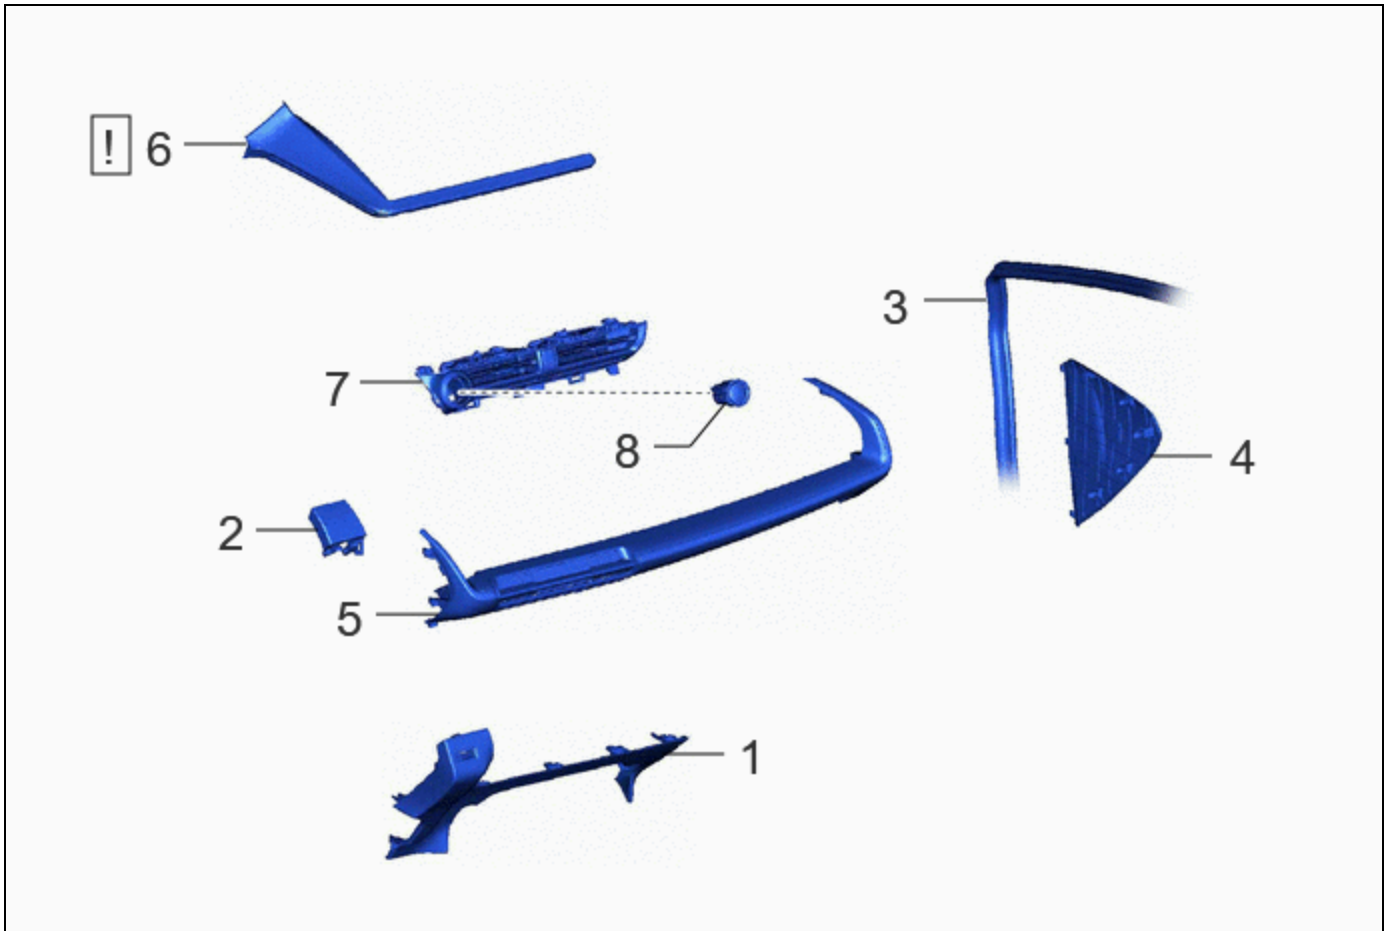
COMPONENTS (REMOVAL)

PROCEDURE		PART NAME CODE			
1	LOWER CENTER INSTRUMENT PANEL FINISH PANEL	55434B	-	-	-
2	LOWER CENTER INSTRUMENT CLUSTER FINISH PANEL SUB-ASSEMBLY	55406B	-	-	-
3	FRONT DOOR OPENING TRIM WEATHERSTRIP RH	62311B	-	-	-
4	INSTRUMENT SIDE PANEL	55317A	-	-	-
5	NO. 2 INSTRUMENT PANEL GARNISH SUB-ASSEMBLY WITH AIR CONDITIONING CONTROL ASSEMBLY	-	-	-	-

6	CENTER INSTRUMENT CLUSTER FINISH PANEL ASSEMBLY	55420A	INFO	-	-
7	NO. 3 INSTRUMENT PANEL REGISTER ASSEMBLY	55670	-	-	-
8	POWER SWITCH	89611	-	-	-

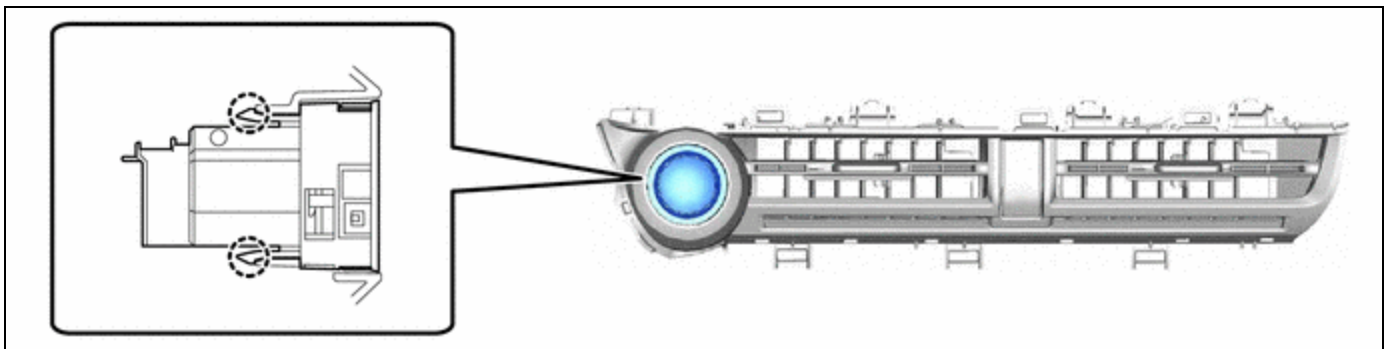
8. REMOVE POWER SWITCH
