Last Modified: 12-04-2024	6.11:8.1.0	Doc ID: RM10000002BI2E
Model Year Start: 2023	Model: Prius Prime	Prod Date Range: [03/2023 -]
Title: HYBRID / BATTERY CONTROL: HYBRID CONTROL SYSTEM (for PHEV Model): P0AD911; Hybrid/EV Battery Positive Contactor Circuit Short to Ground; 2023 - 2024 MY Prius Prime [03/2023 -]

DTC	P0AD911	Hybrid/EV Battery Positive Contactor Circuit Short to Ground
------------	----------------	---

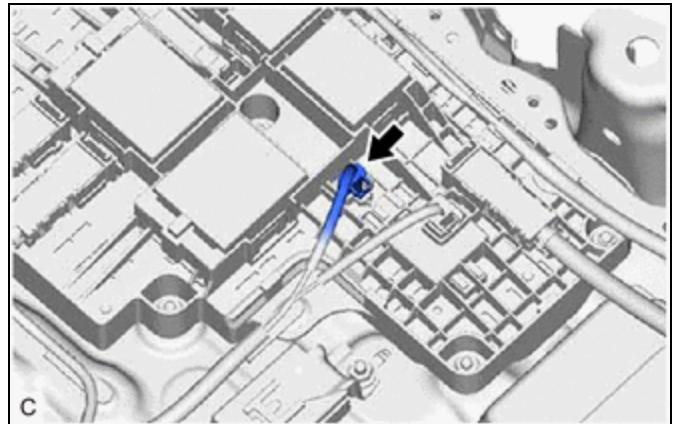
(c) Disconnect the No. 1 traction battery device box assembly connector.
