<b>Last Modified:</b> 12-04-2024	6.11:8.1.0	<b>Doc ID:</b> RM1000000029TL7
<b>Model Year Start:</b> 2023	<b>Model:</b> Prius	<b>Prod Date Range:</b> [12/2022 - ]
<b>Title:</b> MAINTENANCE: 2ZR-FXE SPARK PLUG: REMOVAL; 2023 - 2024 MY Prius [12/2022 - ]

## REMOVAL

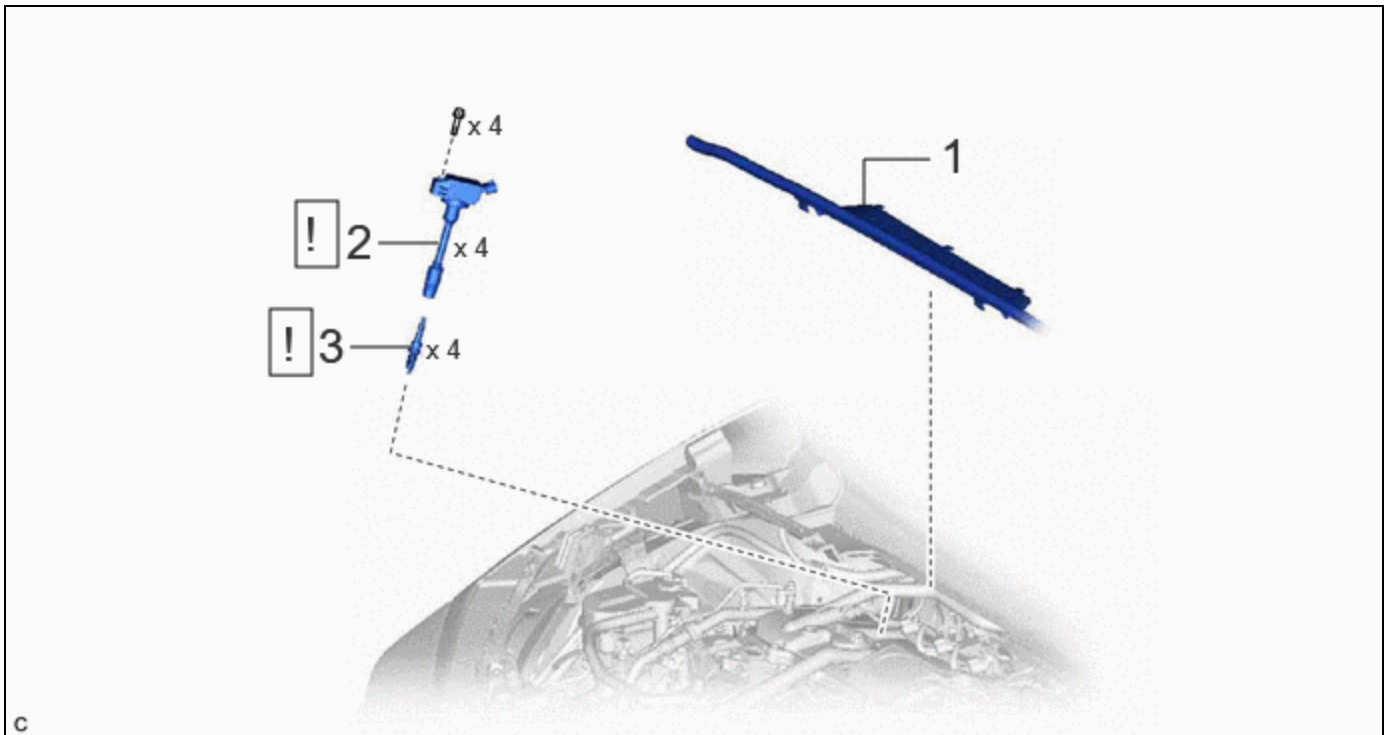
#### COMPONENTS (REMOVAL)

1	CENTER NO. 2 COWL TOP VENTILATOR LOUVER	55784B	-	-	-
2	IGNITION COIL ASSEMBLY	19500	<a href="#">INFO</a>	-	-
3	SPARK PLUG	19100P	<a href="#">INFO</a>	-	-

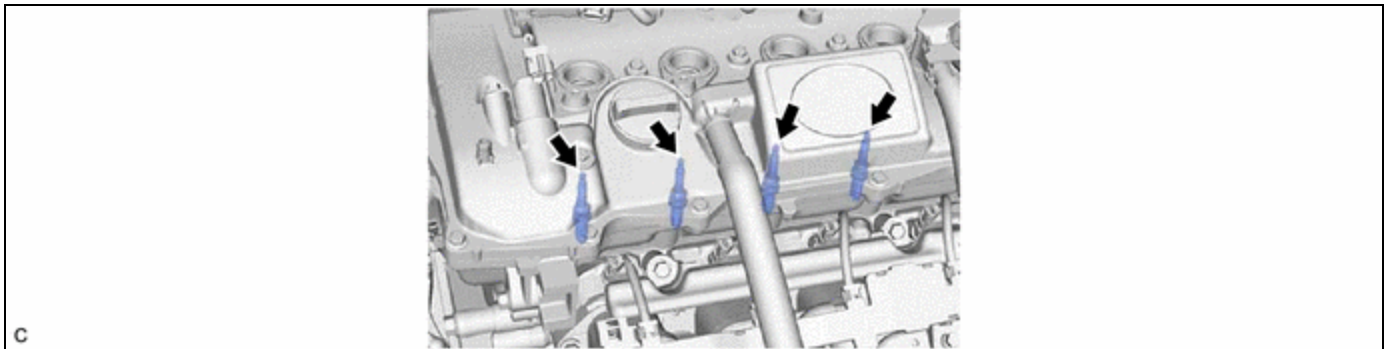
### 3. REMOVE SPARK PLUG

<p><b>NOTICE:</b></p> <p>If a spark plug has been struck or dropped, replace it.</p>
------------------------------------------------------------------------------------	--------------------------------------------------------------------------------------
