Last Modified: 12-04-2024	6.11:8.1.0	Doc ID: RM100000029GSU			
Model Year Start: 2023	Model: Prius	Prod Date Range: [12/2022 -]			
Title: NETWORKING: CAN COMMUNICATION SYSTEM (for HEV Model): Front Side Radar Sensor Communication					
Stop Mode; 2023 - 2024 MY Prius [12/2022 -]

Front Side Radar Sensor Communication Stop Mode

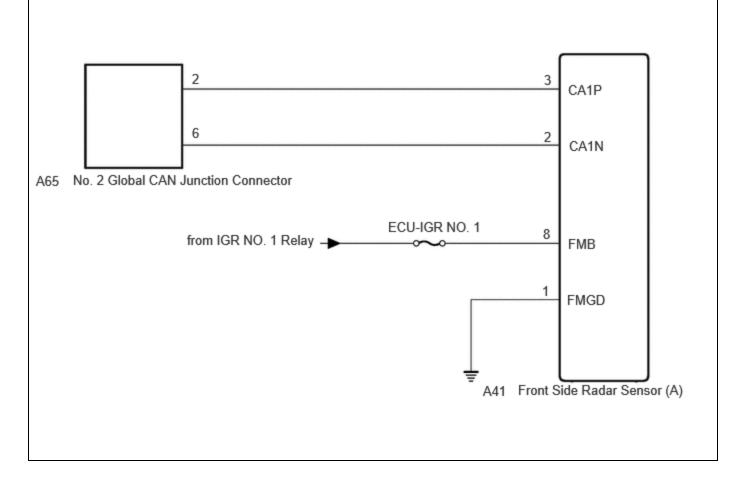
WIRING DIAGRAM

DETECTION ITEM	SYMPTOM	TROUBLE AREA
Front Side Radar Sensor Communication Stop Mode	Communication stop for "Front Side Radar "A"" is indicated on the "Communication Bus Check" screen of the GTS. Click here	 Front side radar sensor (A) branch line or connector Power source circuit of front side radar sensor (A) Front side radar sensor (A) ground circuit Front side radar sensor (A)

TESTER CONNECTION	CONDITION	SPECIFIED CONDITION
A41-3 (CA1P) - A41-2 (CA1N)	Cable disconnected from negative (-) auxiliary battery terminal	54 to 69 Ω

TESTER CONNECTION	CONDITION	SPECIFIED CONDITION
A41-1 (FMGD) - Body ground	Cable disconnected from negative (-) auxiliary battery terminal	Below 1 Ω

TESTER CONNECTION	CONDITION	SPECIFIED CONDITION
A41-8 (FMB) - Body ground	Ignition switch ON	11 to 14 V
