| Title: MAINTENANCE: FRONT LOWER BALL JOINT: ON-VEHICLE INSPECTION; 2023 - 2024 MY Prius Prius Prime [12/2022 -] | | |

ON-VEHICLE INSPECTION

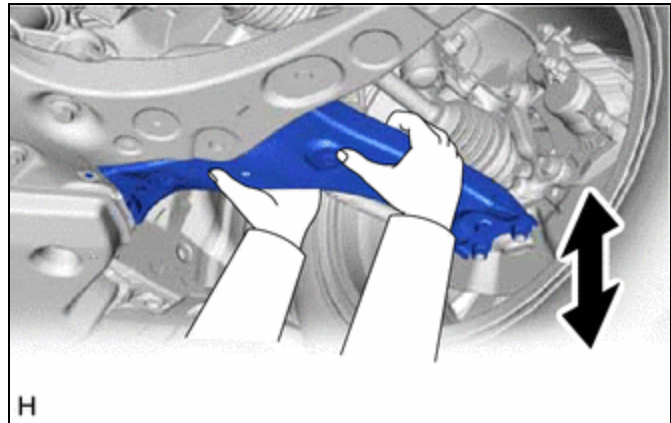
(2) Move the front lower No. 1 suspension arm sub-assembly up and down by hand with a force of 294 N (30 kgf) or more to check that there is no looseness at the front lower ball joint assembly.

If the front lower ball joint assembly is loose, replace it with a new one.
