Last Modified: 12-04-2024	6.11:8.1.0	Doc ID: RM10000000293TW
Model Year Start: 2023	Model: Prius Prime	Prod Date Range: [12/2022 -]
Title: HORN: HORN: INSPECTION; 2023 - 2024 MY Prius Prius Prime [12/2022 -]

1. INSPECT LOW PITCHED HORN ASSEMBLY

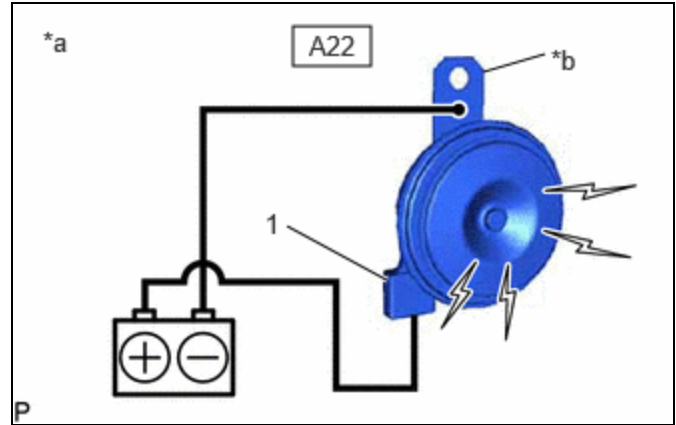
(a) Apply auxiliary battery voltage and check the operation of the low pitched horn assembly according to the table below.

TESTER CONNECTION	SPECIFIED CONDITION
A22-1 - Auxiliary battery positive (+) Body ground - Auxiliary battery negative (-)	Horn sounds

*a	Component without harness connected (Low Pitched Horn Assembly)
*b	Body Ground

If the result is not as specified, replace the low pitched horn assembly.
