Last Modified: 12-04-2024	6.11:8.1.0	Doc ID: RM10000000292L3
Model Year Start: 2023	Model: Prius Prime	Prod Date Range: [12/2022 -]
Title: LIGHTING (EXT): HAZARD WARNING SWITCH: REMOVAL; 2023 - 2024 MY Prius Prius Prime [12/2022 -]

REMOVAL

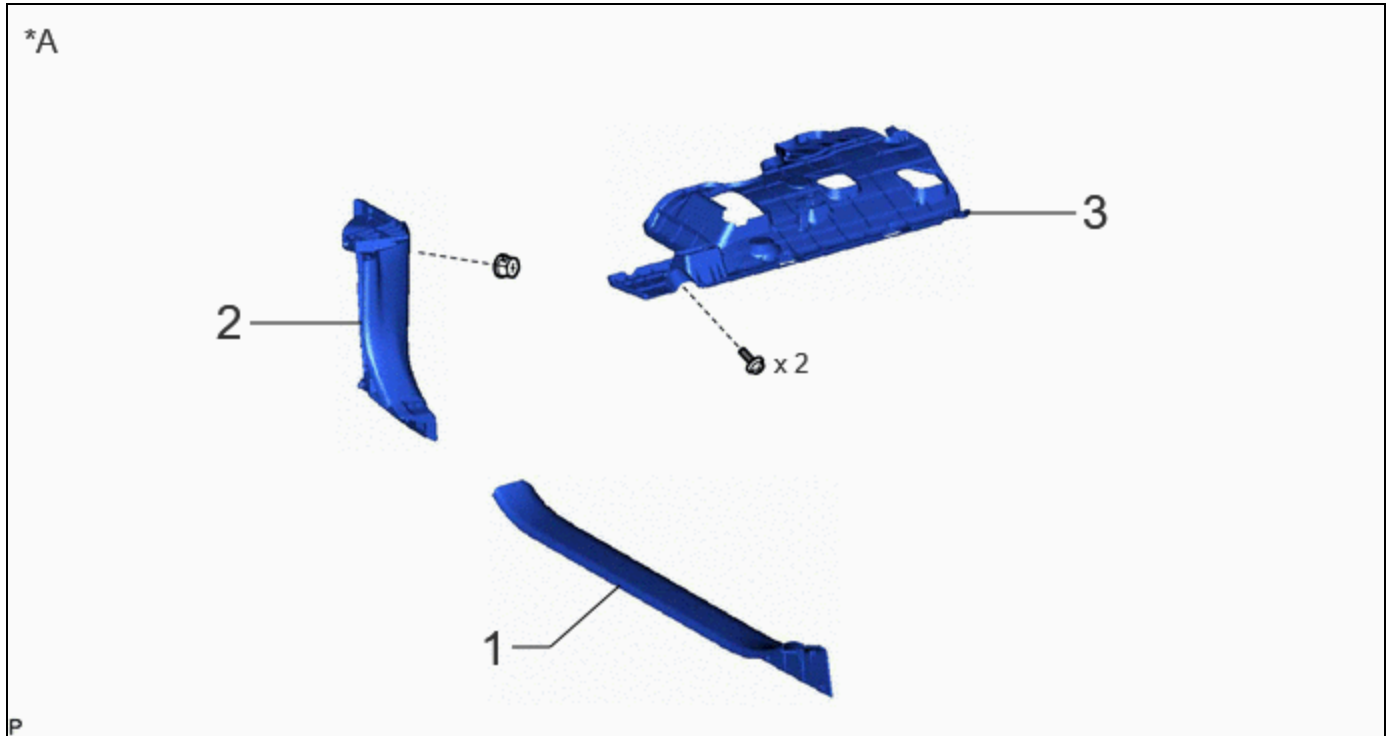
COMPONENTS (REMOVAL)

PROCEDURE	PART NAME CODE			
1	FRONT DOOR SCUFF PLATE LH	67914	-	-	-
2	COWL SIDE TRIM BOARD LH	62112	-	-	-
3	NO. 1 INSTRUMENT PANEL UNDER COVER SUB-ASSEMBLY	55606	-	-	-

*A	w/ Knee Airbag	-	-
----	----------------	---	---

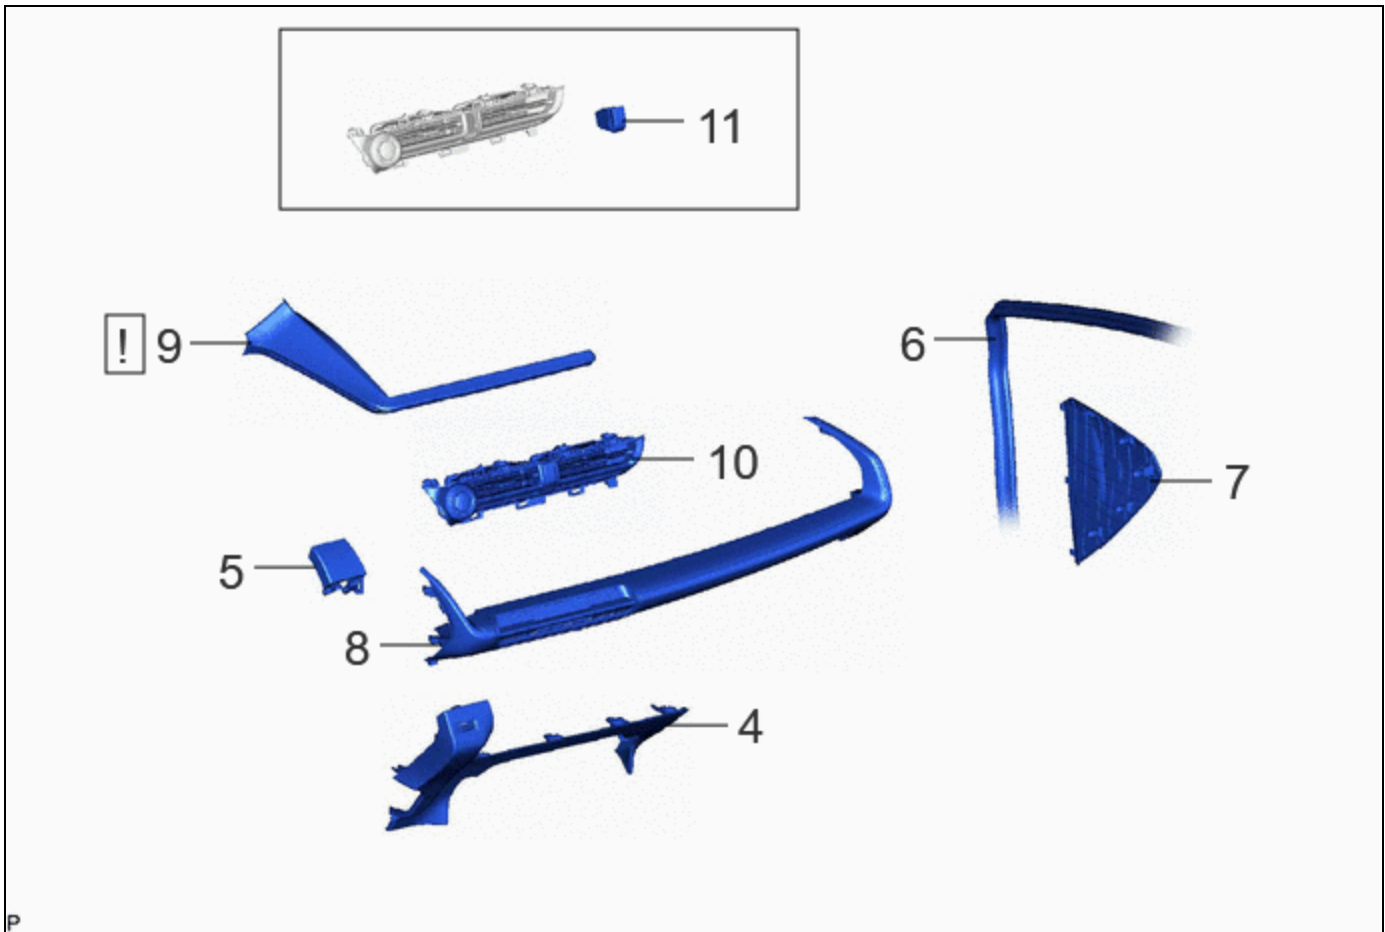
PROCEDURE	PART NAME CODE			
4 LOWER CENTER INSTRUMENT PANEL FINISH PANEL	55434B	-	-	-
5 LOWER CENTER INSTRUMENT CLUSTER FINISH PANEL SUB-ASSEMBLY	55406B	-	-	-
6 FRONT DOOR OPENING TRIM WEATHERSTRIP	62311B	-	-	-
7 INSTRUMENT SIDE PANEL	55317A	-	-	-
8 NO. 2 INSTRUMENT PANEL GARNISH SUB-ASSEMBLY WITH AIR CONDITIONING CONTROL ASSEMBLY	-	-	-	-
9 CENTER INSTRUMENT CLUSTER FINISH PANEL ASSEMBLY	55420A	INFO	-	-
10 NO. 3 INSTRUMENT PANEL REGISTER ASSEMBLY	55670	-	-	-
11 HAZARD WARNING SIGNAL SWITCH ASSEMBLY	84330	-	-	-

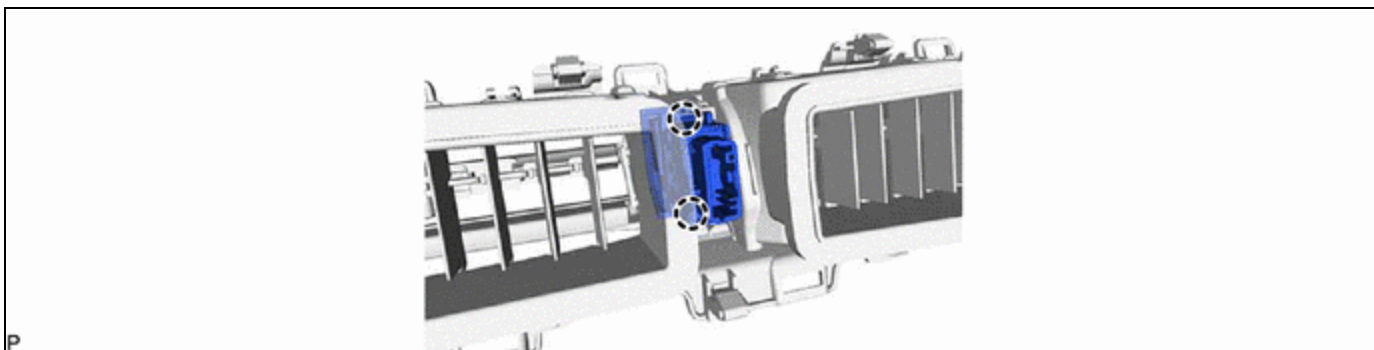
11. REMOVE HAZARD WARNING SIGNAL SWITCH ASSEMBLY
