SUPPLEMENTAL RESTRAINT SYSTEMS: OCCUPANT CLASSIFICATION SYSTEM: B00C286; Passenger Seat Occupant Clas...

Last Modified: 12-04-2024	6.11:8.1.0	Doc ID: RM100000028UZ4	
Model Year Start: 2023	Model: Prius Prime	Prod Date Range: [12/2022 -]	
Title: SUPPLEMENTAL RESTRAINT SYSTEMS: OCCUPANT CLASSIFICATION SYSTEM: B00C286; Passenger Seat			
Occupant Classification Sensor "C" Signal (some circuit quantity, reported via serial data) Invalid; 2023 - 2024 MY			
Prius Prius Prime [12/2022 -]

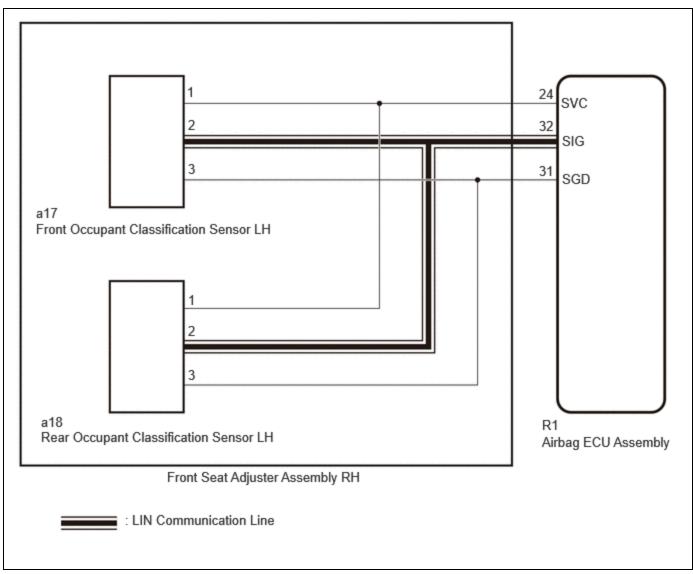
WIRING DIAGRAM

DTC NO.	DETECTION ITEM	DTC DETECTION CONDITION	TROUBLE AREA	DTC OUTPUT FROM	PRIORITY
B00C286	Passenger Seat Occupant Classification Sensor "C" Signal (some circuit quantity, reported via serial data) Invalid	Either of following conditions is met: • The airbag ECU assembly detects a line short, short to ground or +B in the rear occupant classification sensor LH circuit. • Rear occupant classification sensor LH malfunction • Airbag ECU assembly malfunction	 Harness or connector Front seat adjuster assembly RH (rear occupant classification sensor LH) Airbag ECU assembly 	SRS Airbag	A

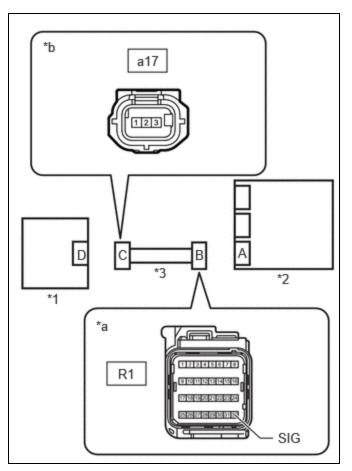
(a) Measure the resistance according to the value(s) in the table below.

TESTER CONNECTION	CONDITION	SPECIFIED CONDITION	RESULT
R1-32 (SIG) - a17-2	Always	Below 1 Ω	Ω

*1	Front Seat Adjuster Assembly RH
*2	Airbag ECU Assembly
*3	Wire Harness
*а	Front view of wire harness connector (to Airbag ECU Assembly)
*b	Front view of wire harness connector (to Front Seat Adjuster Assembly RH (Front Occupant Classification Sensor LH))

OK > REPLACE FRONT SEAT ADJUSTER ASSEMBLY RH

NG REPAIR OR REPLACE HARNESS OR CONNECTOR

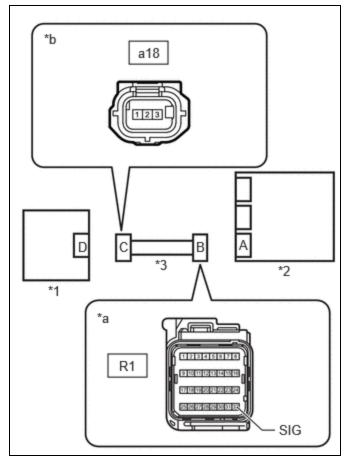
(a) Measure the resistance according to the value(s) in the table below.

TESTER CONNECTION	CONDITION	SPECIFIED CONDITION	RESULT
R1-32 (SIG) - a18-2	Always	Below 1 Ω	Ω

*1	Front Seat Adjuster Assembly RH
*2	Airbag ECU Assembly
*3	Wire Harness
*а	Front view of wire harness connector (to Airbag ECU Assembly)
*b	Front view of wire harness connector (to Front Seat Adjuster Assembly RH (Rear Occupant Classification Sensor LH))

OK > REPLACE FRONT SEAT ADJUSTER ASSEMBLY RH

NG REPAIR OR REPLACE HARNESS OR CONNECTOR

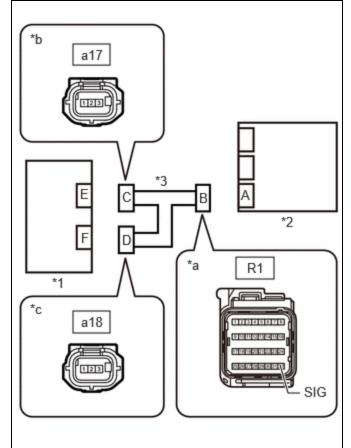
(a) Measure the resistance according to the value(s) in the table below.

TESTER CONNECTION	CONDITION	SPECIFIED CONDITION	RESULT
R1-32 (SIG) - Other terminals and body ground	Always	10 kΩ or higher	kΩ
a17-2 - Other terminals and body ground	Always	10 kΩ or higher	kΩ
a18-2 - Other terminals and body ground	Always	10 kΩ or higher	kΩ

*1	Front Seat Adjuster Assembly RH
*2	Airbag ECU Assembly
*3	Wire Harness
*а	Front view of wire harness connector (to Airbag ECU Assembly)
*b	Front view of wire harness connector (to Front Seat Adjuster Assembly RH (Front Occupant Classification Sensor LH))
*с	Front view of wire harness connector (to Front Seat Adjuster Assembly RH (Rear Occupant Classification Sensor LH))

NG REPAIR OR REPLACE HARNESS OR CONNECTOR

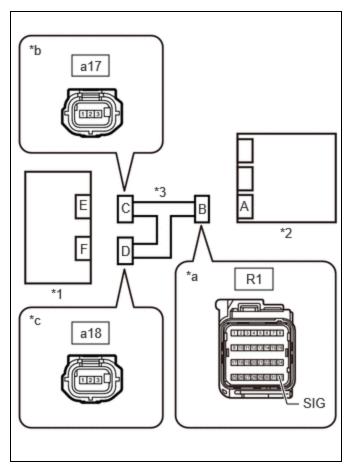
(c) Measure the voltage according to the value(s) in the table below.

TESTER CONNECTION	CONDITION	SPECIFIED CONDITION	RESULT
R1-32 (SIG) - Body ground	Ignition switch ON	Below 1 V	V
a17-2 - Body ground	Ignition switch ON	Below 1 V	V
a18-2 - Body ground	Ignition switch ON	Below 1 V	V

*1	Front Seat Adjuster Assembly RH
*2	Airbag ECU Assembly
*3	Wire Harness
*а	Front view of wire harness connector (to Airbag ECU Assembly)
*b	Front view of wire harness connector (to Front Seat Adjuster Assembly RH (Front Occupant Classification Sensor LH))
*с	Front view of wire harness connector (to Front Seat Adjuster Assembly RH (Rear Occupant Classification Sensor LH))

NG REPAIR OR REPLACE HARNESS OR CONNECTOR
