<b>Last Modified:</b> 12-04-2024	6.11:8.1.0	<b>Doc ID:</b> RM10000002BEM4
<b>Model Year Start:</b> 2023	<b>Model:</b> Prius Prime	<b>Prod Date Range:</b> [03/2023 - ]
<b>Title:</b> HEATING / AIR CONDITIONING: AIR CONDITIONING SYSTEM (for PHEV Model): B140287; Lost Communication with Front Air Outlet Damper Control Servo Motor LIN Missing Message; 2023 - 2024 MY Prius Prime [03/2023 - ]

<b>DTC</b>	<b>B140287</b>	<b>Lost Communication with Front Air Outlet Damper Control Servo Motor LIN Missing Message</b>
------------	----------------	--

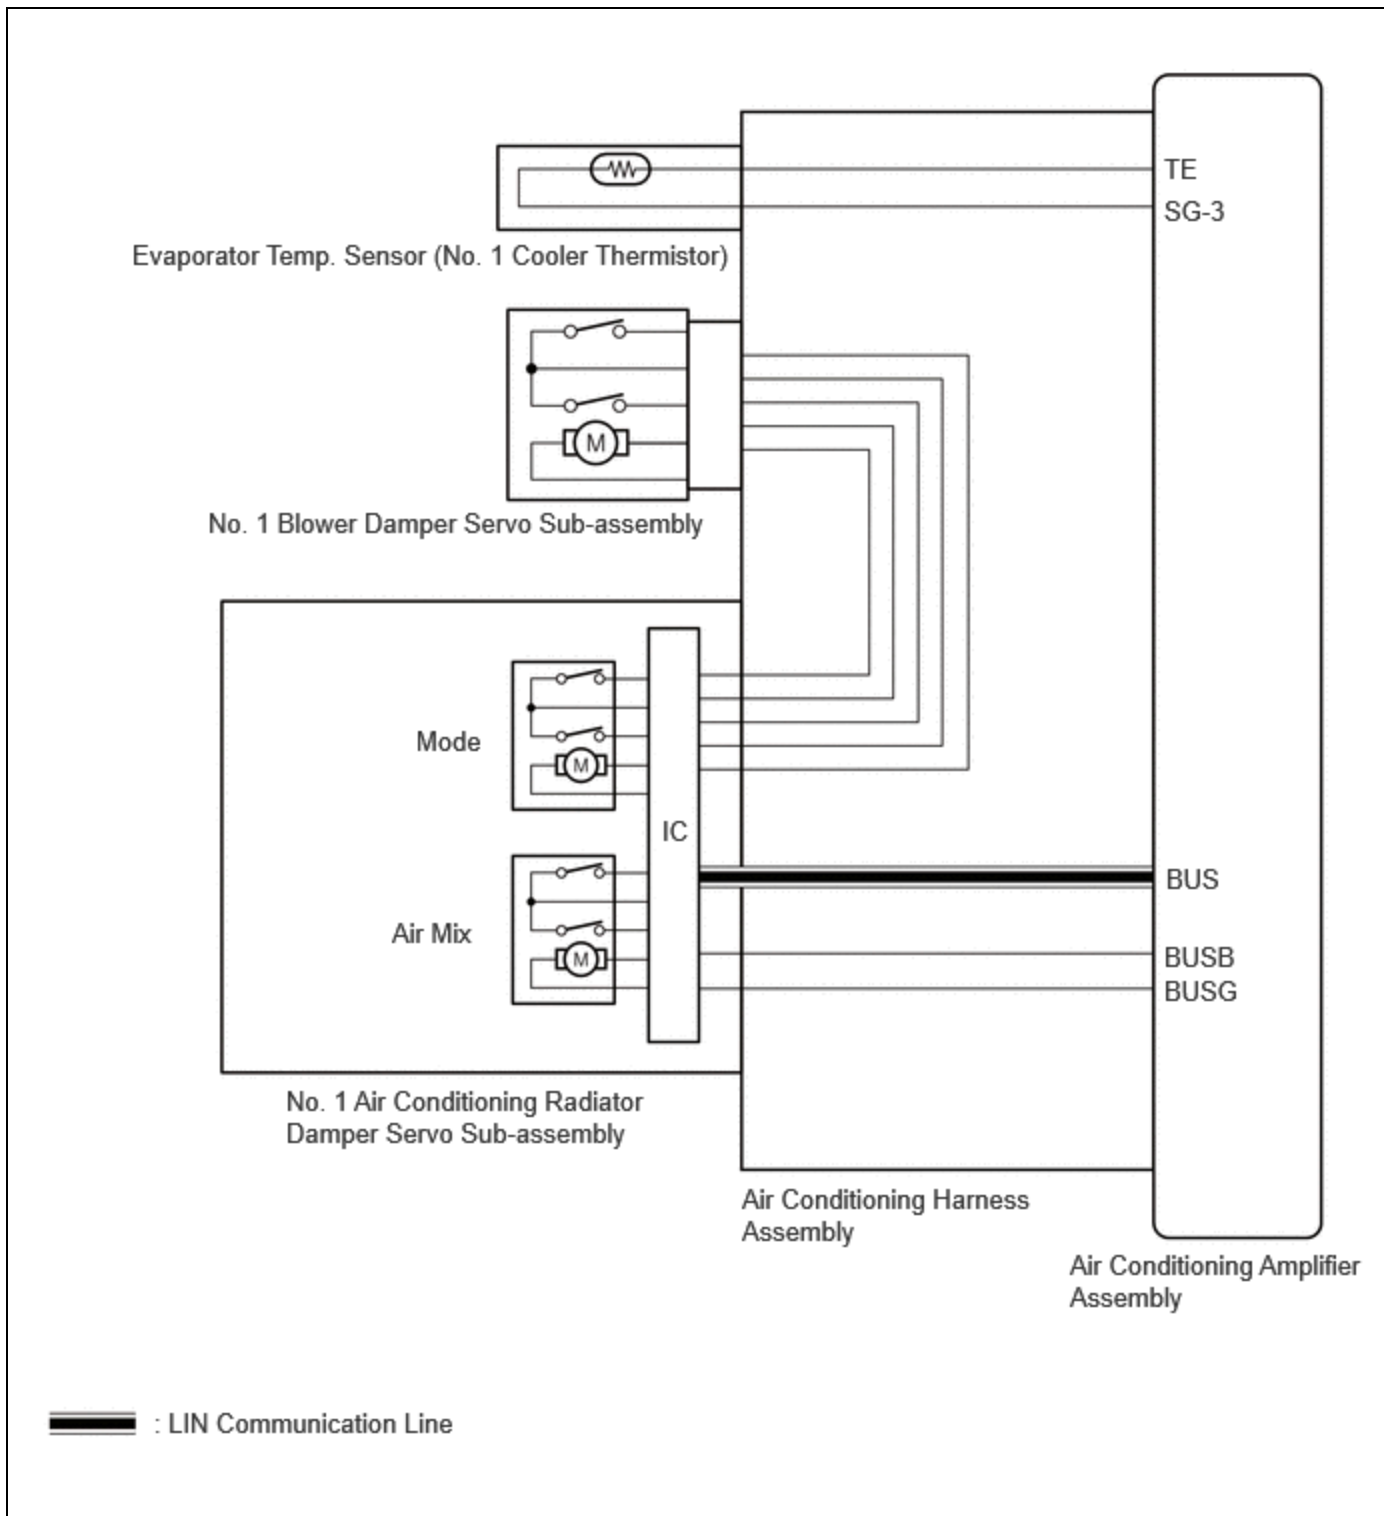
**WIRING DIAGRAM**

The air conditioning harness assembly connects the air conditioning amplifier assembly and No. 1 air conditioning radiator damper servo sub-assembly.

The No. 1 air conditioning radiator damper servo sub-assembly sends damper position information to the air conditioning amplifier assembly.
