Last Modified: 12-04-2024	6.11:8.1.0	Doc ID: RM100000029ZW3
Model Year Start: 2023	Model: Prius Prime	Prod Date Range: [12/2022 -]
Title: HEATING / AIR CONDITIONING: ROOM TEMPERATURE SENSOR: REMOVAL; 2023 - 2024 MY Prius Prius Prime [12/2022 -]

REMOVAL

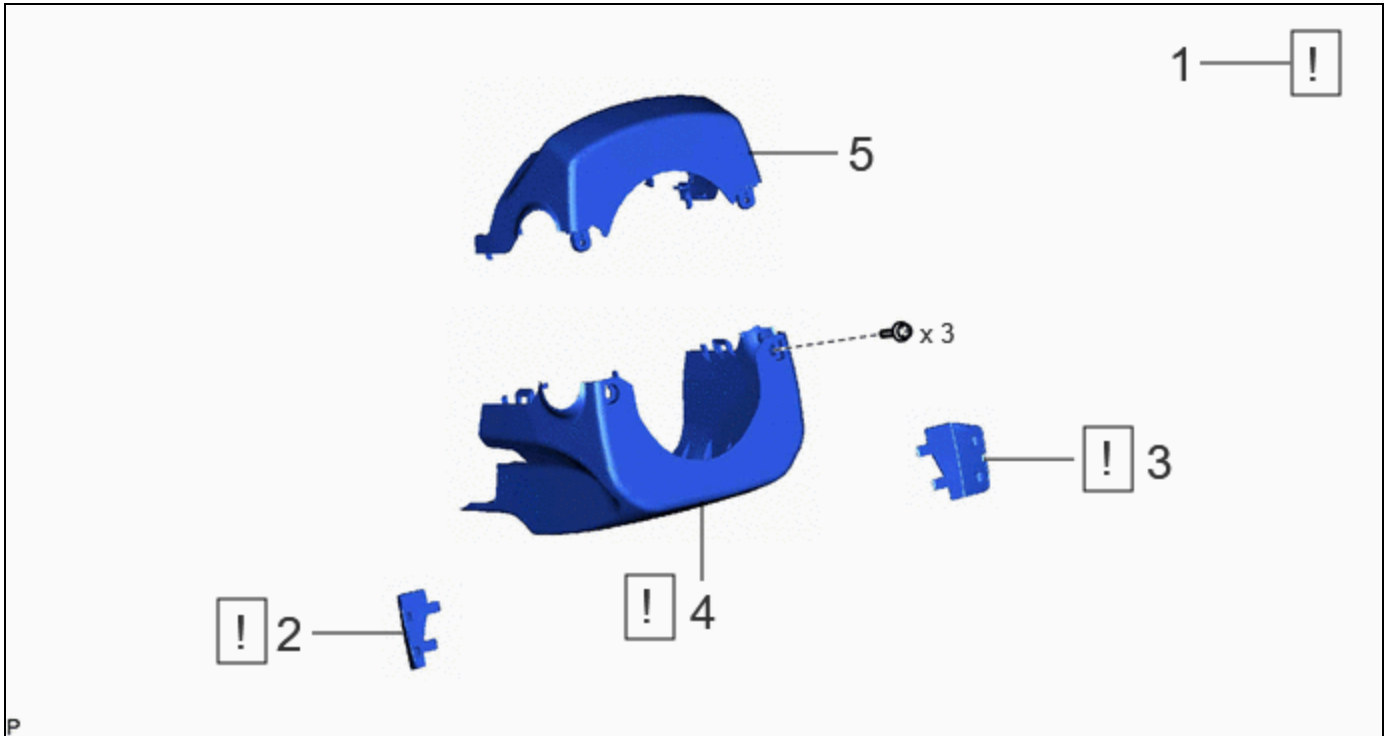
COMPONENTS (REMOVAL)

PROCEDURE	PART NAME CODE			
1	STEERING WHEEL POSITION	-	INFO	-	-
2	NO. 3 STEERING WHEEL LOWER COVER	45187	INFO	-	-
3	NO. 2 STEERING WHEEL LOWER COVER	45186	INFO	-	-
4	LOWER STEERING COLUMN COVER	45287	INFO	-	-
5	UPPER STEERING COLUMN COVER	45286B	-	-	-

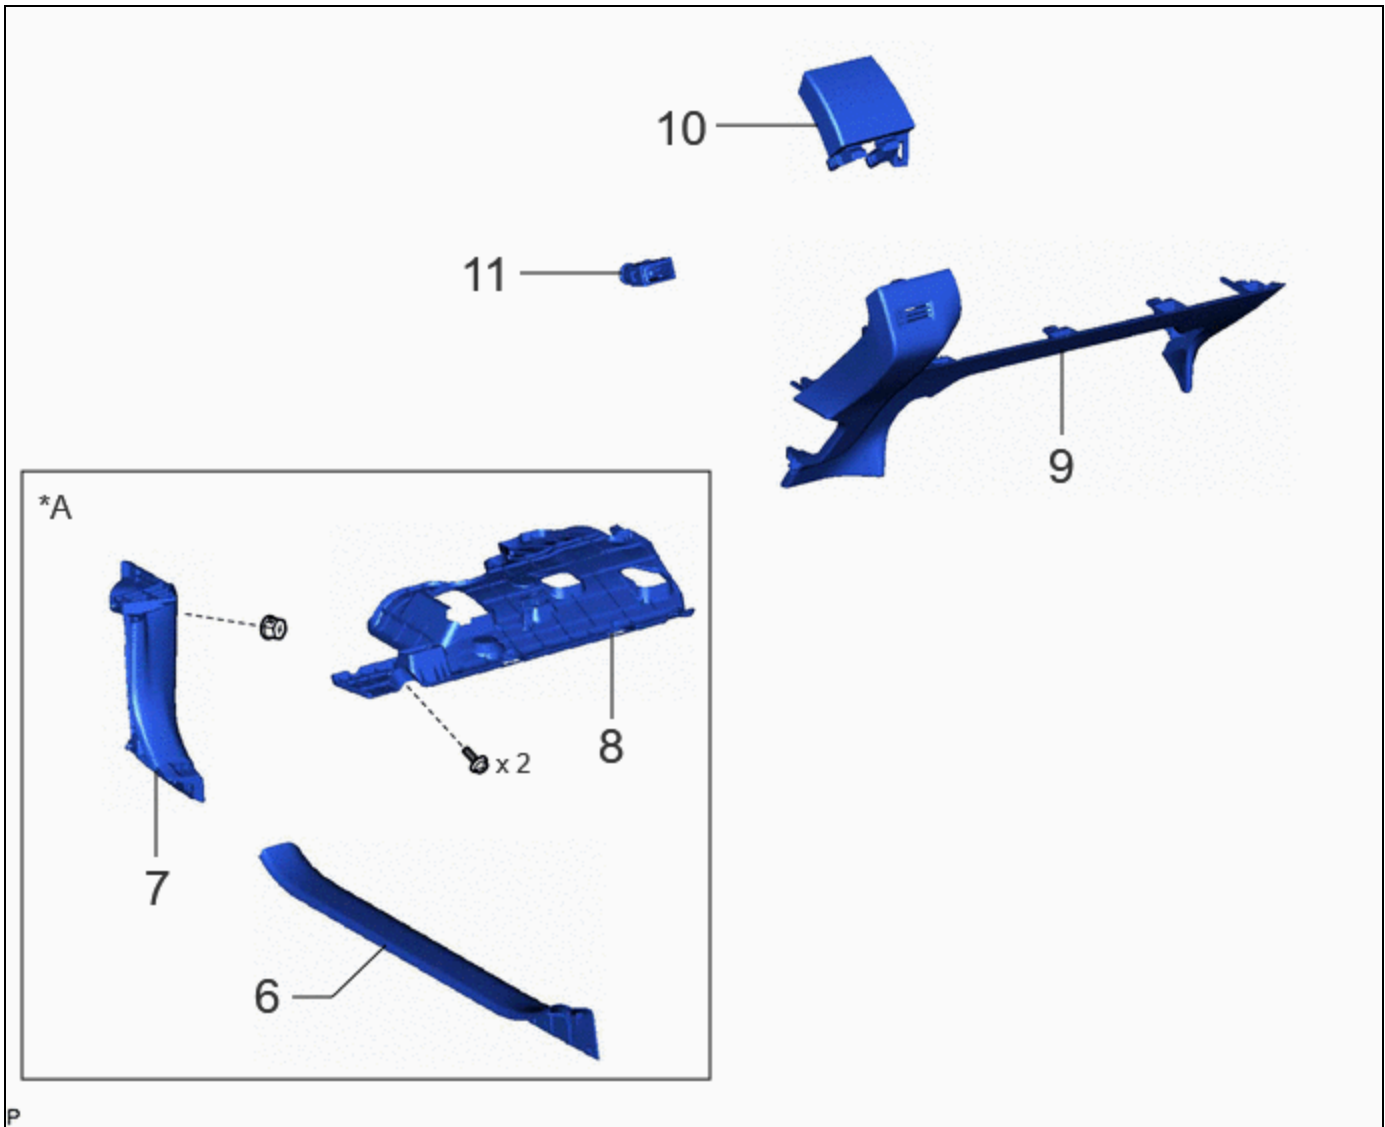
6	FRONT DOOR SCUFF PLATE LH	67914	-	-	-
7	COWL SIDE TRIM BOARD LH	62112	-	-	-
8	NO. 1 INSTRUMENT PANEL UNDER COVER SUB-ASSEMBLY	55606	-	-	-
9	LOWER CENTER INSTRUMENT PANEL FINISH PANEL	55434B	-	-	-
10	LOWER CENTER INSTRUMENT CLUSTER FINISH PANEL SUB-ASSEMBLY	55406B	-	-	-
11	COOLER (ROOM TEMP. SENSOR) THERMISTOR	88625Q	-	-	-

*A	w/ Knee Airbag	-	-
----	----------------	---	---

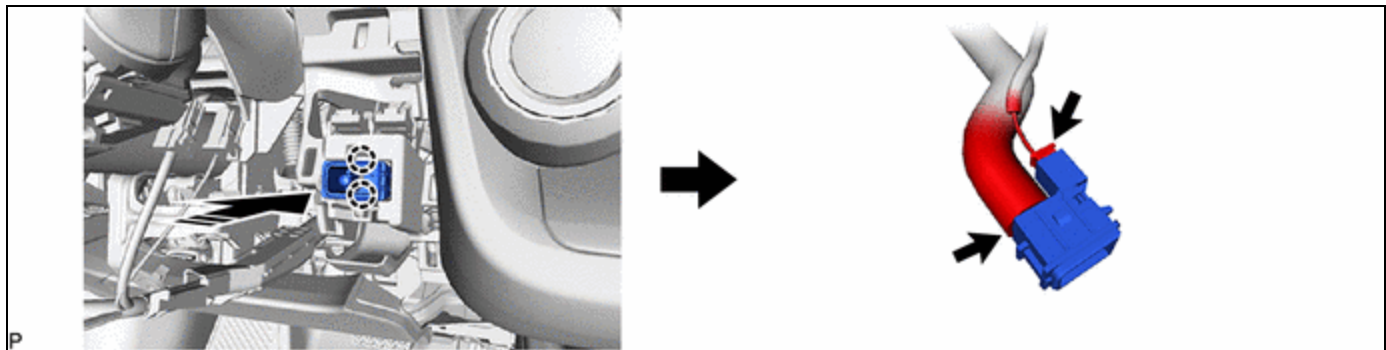
11. REMOVE COOLER (ROOM TEMP. SENSOR) THERMISTOR

Remove in this Direction	-	-
---	--------------------------	---	---
