<b>Last Modified:</b> 12-04-2024	6.11:8.1.0	<b>Doc ID:</b> RM1000000029QFD
<b>Model Year Start:</b> 2023	<b>Model:</b> Prius Prime	<b>Prod Date Range:</b> [12/2022 - ]
<b>Title:</b> EXTERIOR PANELS / TRIM: QUARTER GARNISH: REMOVAL; 2023 - 2024 MY Prius Prius Prime [12/2022 - ]

## REMOVAL

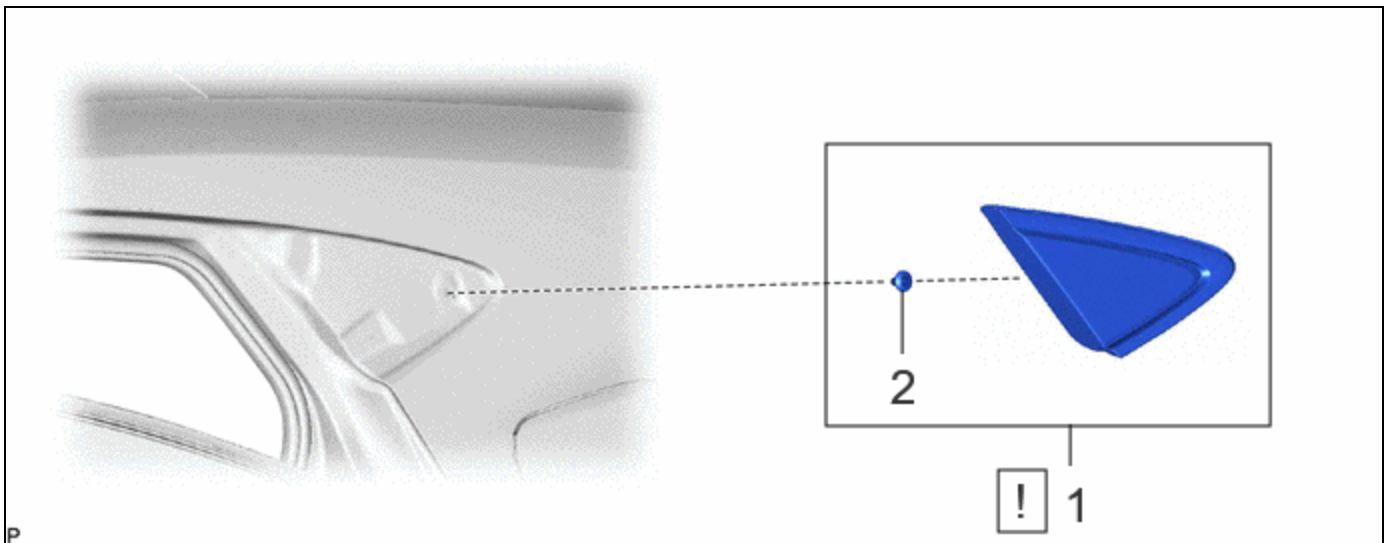
#### COMPONENTS (REMOVAL)

PROCEDURE	PART NAME CODE			
1	QUARTER PILLAR COVER SUB-ASSEMBLY	62506C	INFO	-	-
2	DOOR TRIM RETAINER CAP	-	-	-	-

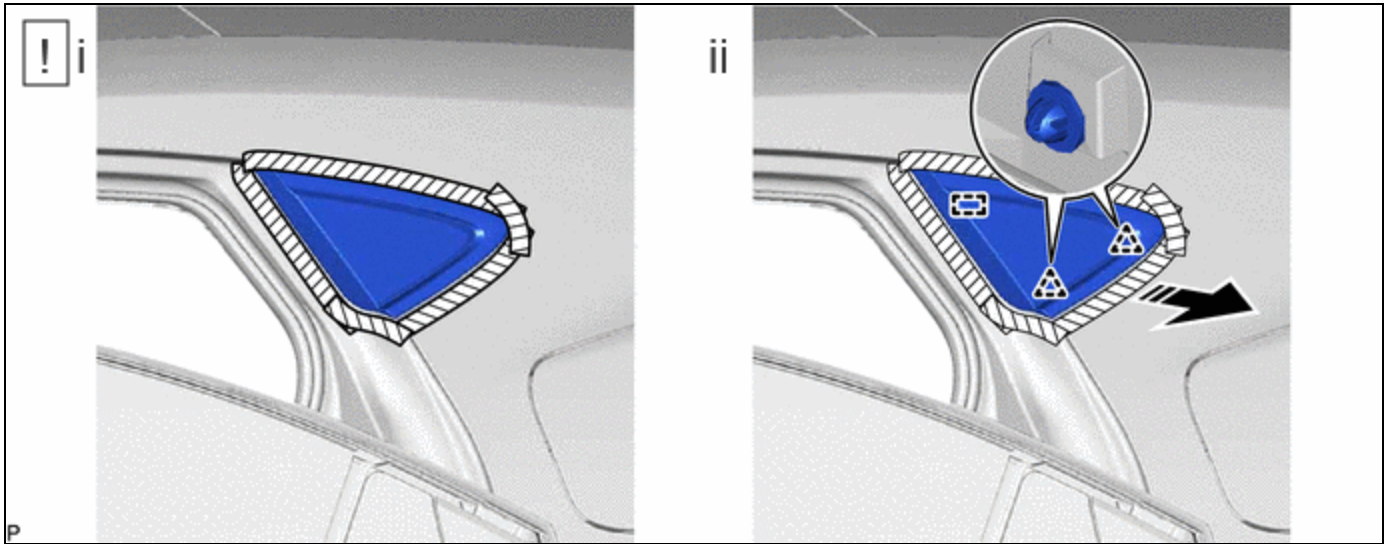
### 1. REMOVE QUARTER PILLAR COVER SUB-ASSEMBLY

Remove in this Direction	-	-
---	--------------------------	---	---

- (1) Apply protective tape around the quarter pillar cover sub-assembly as shown in the illustration.
- (2) Disengage the 2 clips and pin to remove the quarter pillar cover sub-assembly as shown in the illustration.

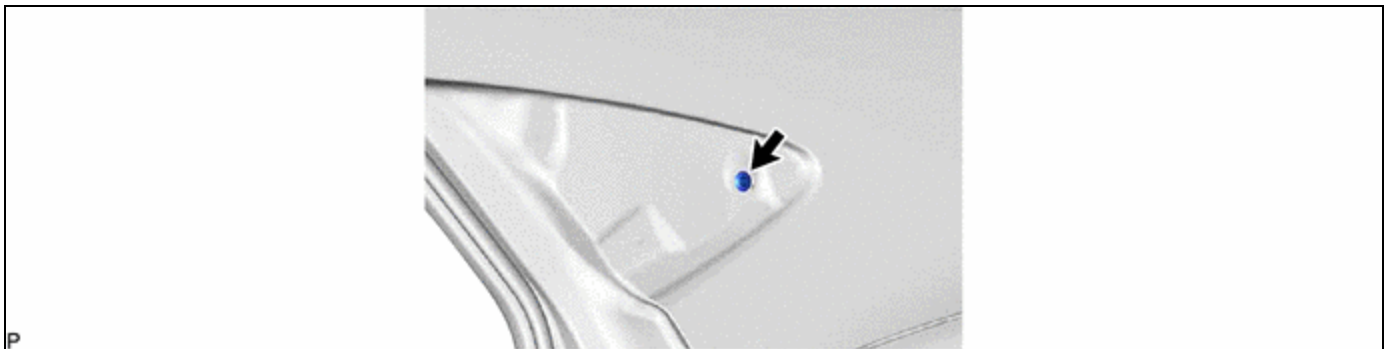
**2. REMOVE DOOR TRIM RETAINER CAP**

(a) When reusing the quarter pillar cover sub-assembly:
