## 2006 HONDA

## Insight

## BUZZERS, RELAYS &amp; TIMERS

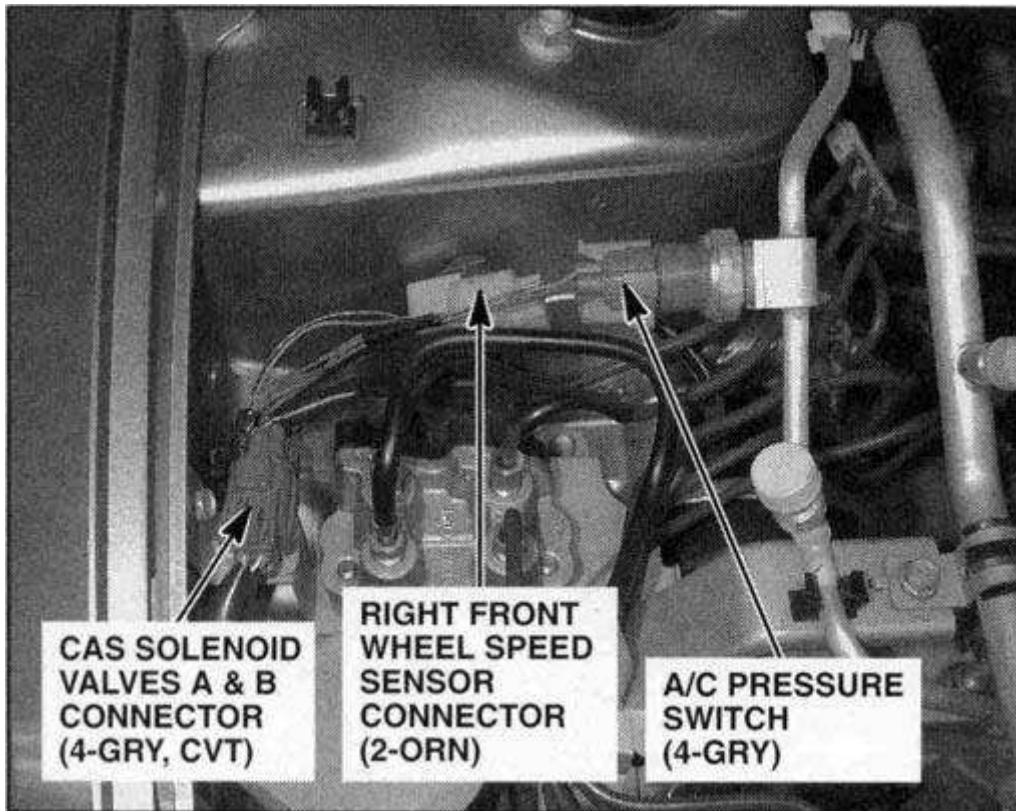
G00288317

**Fig. 1: Right Side Of Engine Compartment**  
**Courtesy of AMERICAN HONDA MOTOR CO., INC.**

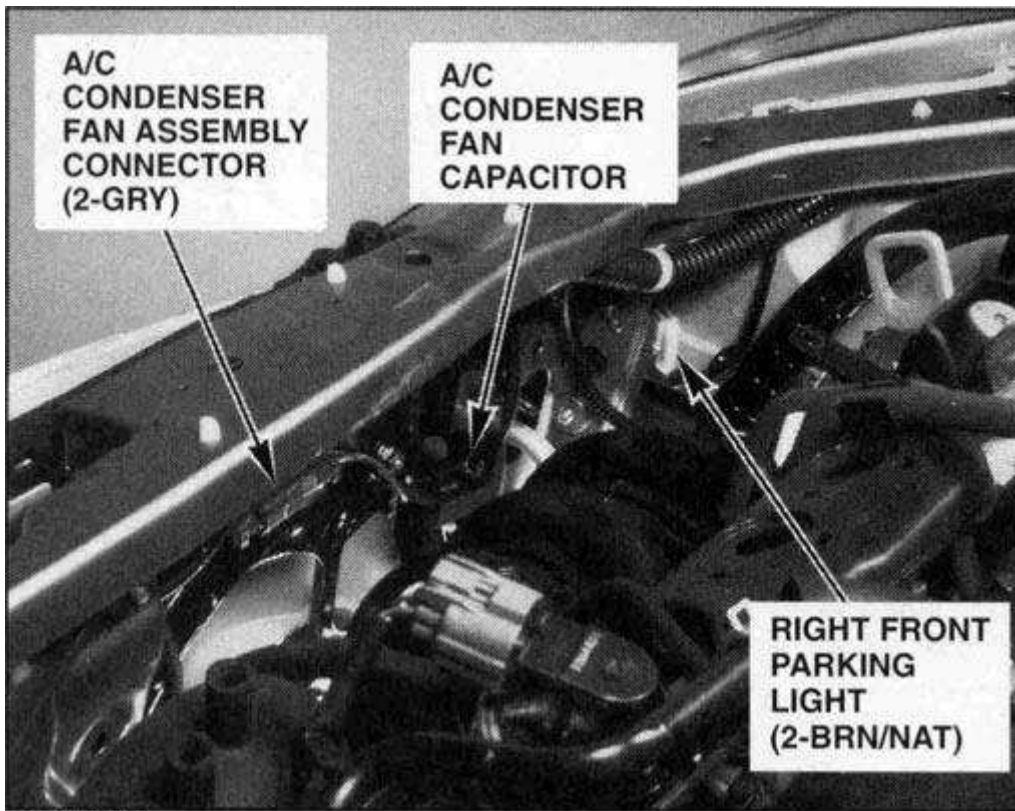
G00288319

**Fig. 3: Right Front Of Engine Compartment**  
**Courtesy of AMERICAN HONDA MOTOR CO., INC.**

| <b>Component</b> | <b>Location</b> |
|---|---|
| A/C Condenser Fan Capacitor | Right front of engine compartment.<br>See <b>Fig. 3</b> . |

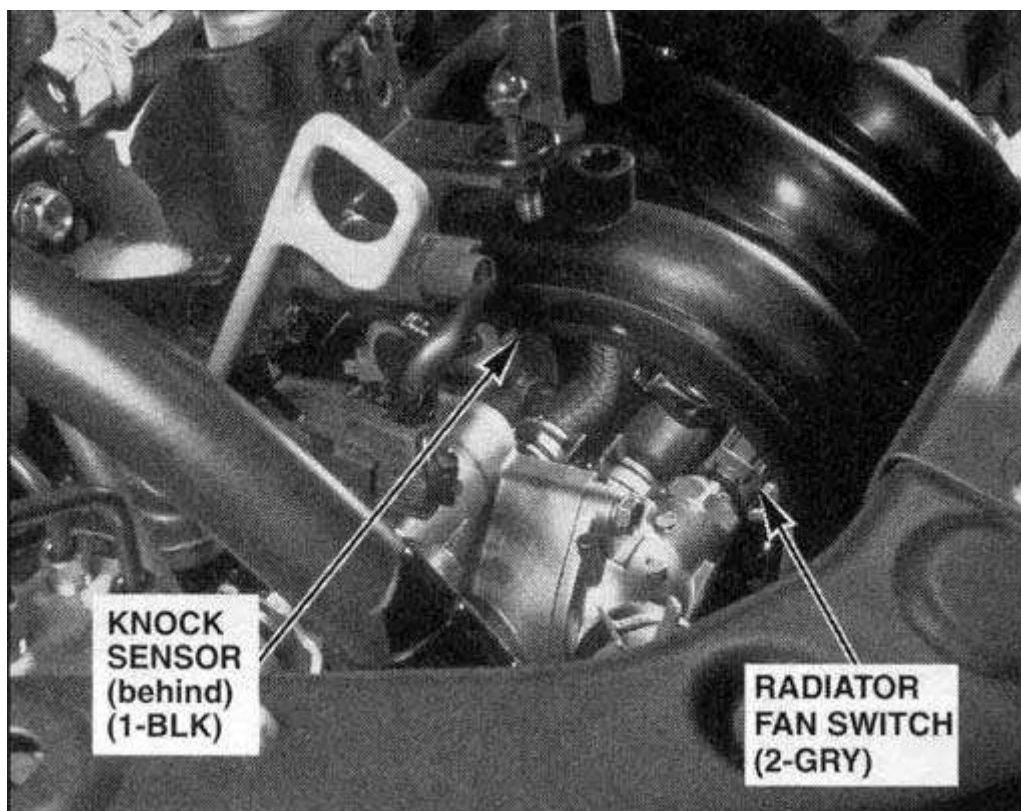
G00288323

**Fig. 5: Front Of Engine**

| <b>Component</b> | <b>Location</b> |
|---|---|
| Radiator Fan Switch | At front of engine compartment. See <b>Fig. 5</b> . |

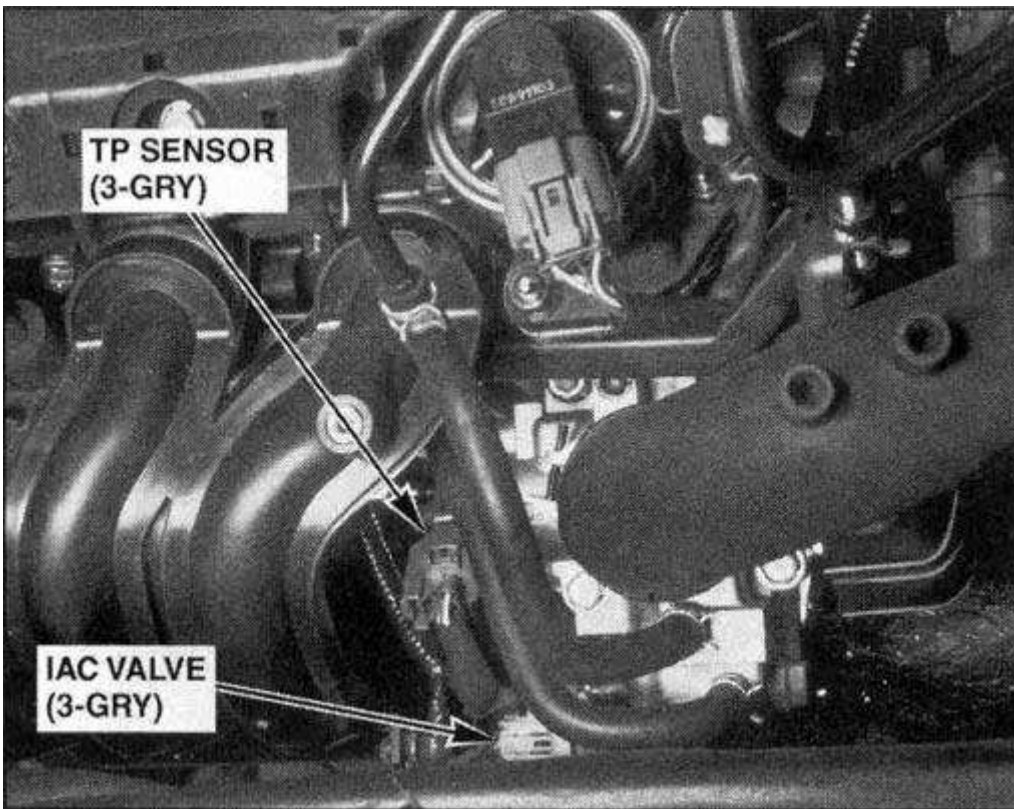
G00288325

**Fig. 7: Front Of Engine**

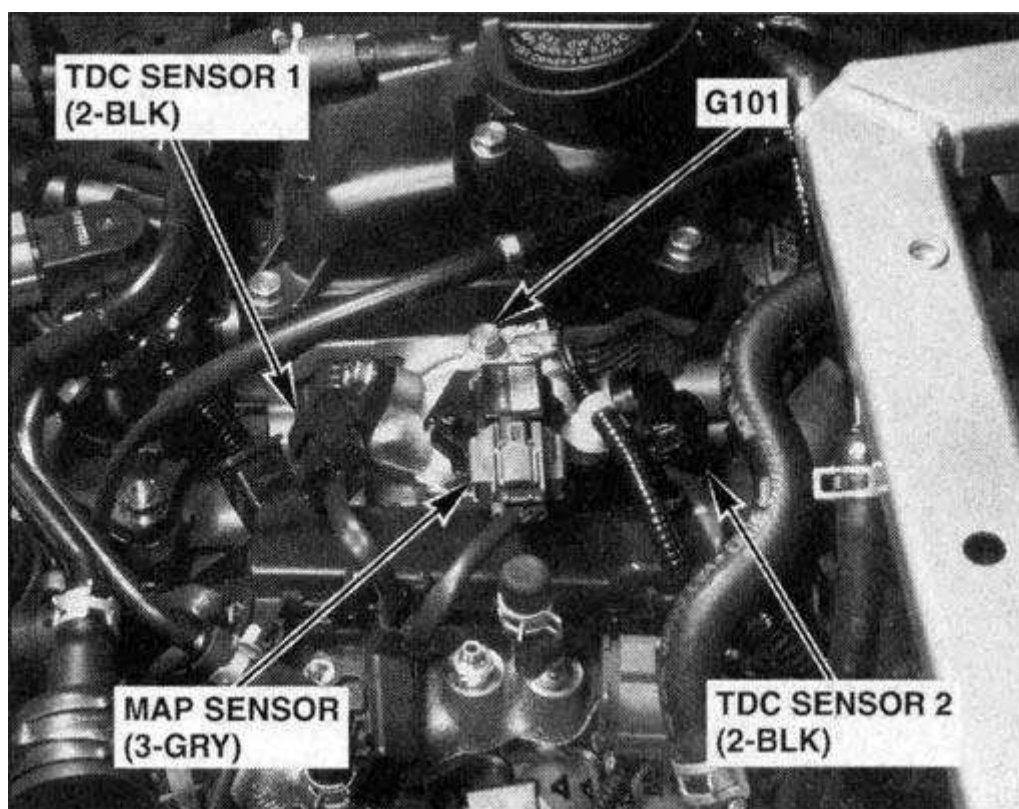
G00288327

**Fig. 9: Middle Of Engine**

| G101 | At top rear of engine. See <b>Fig. 9</b> . |

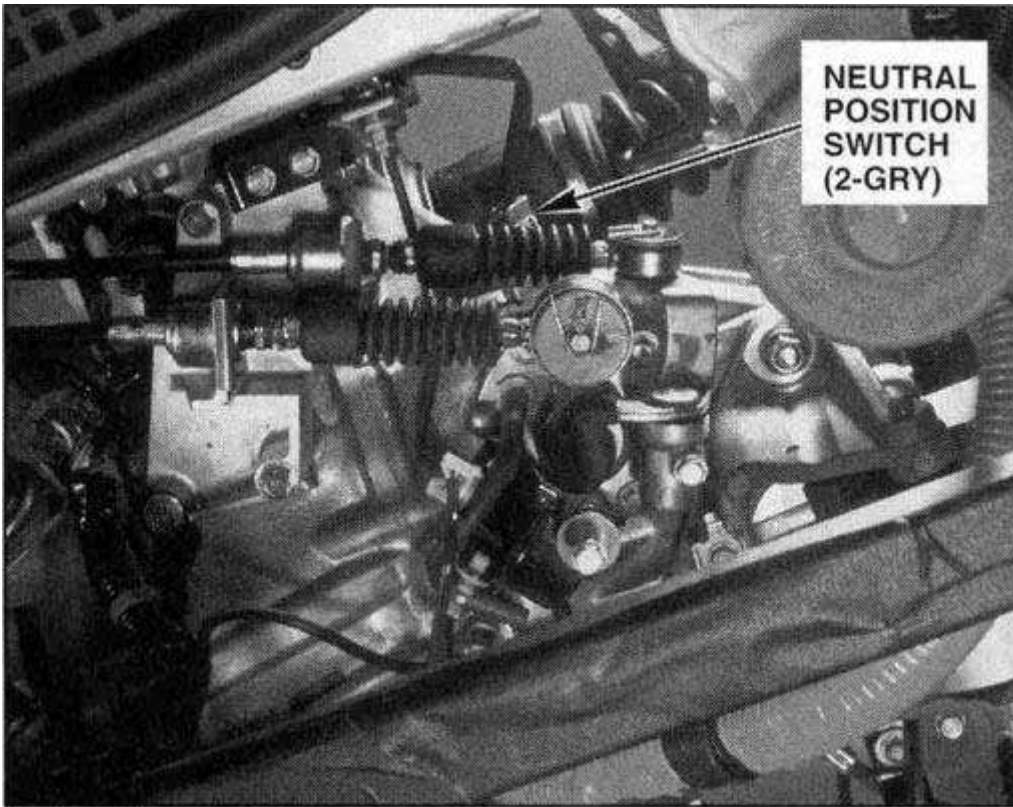
G00288334

**Fig. 15: Rear Of Transmission (M/T)**

| <b>Component</b> | <b>Location</b> |
|---|---|
| Neutral Position Switch | Rear of transmission. See <b>Fig. 15</b> . |

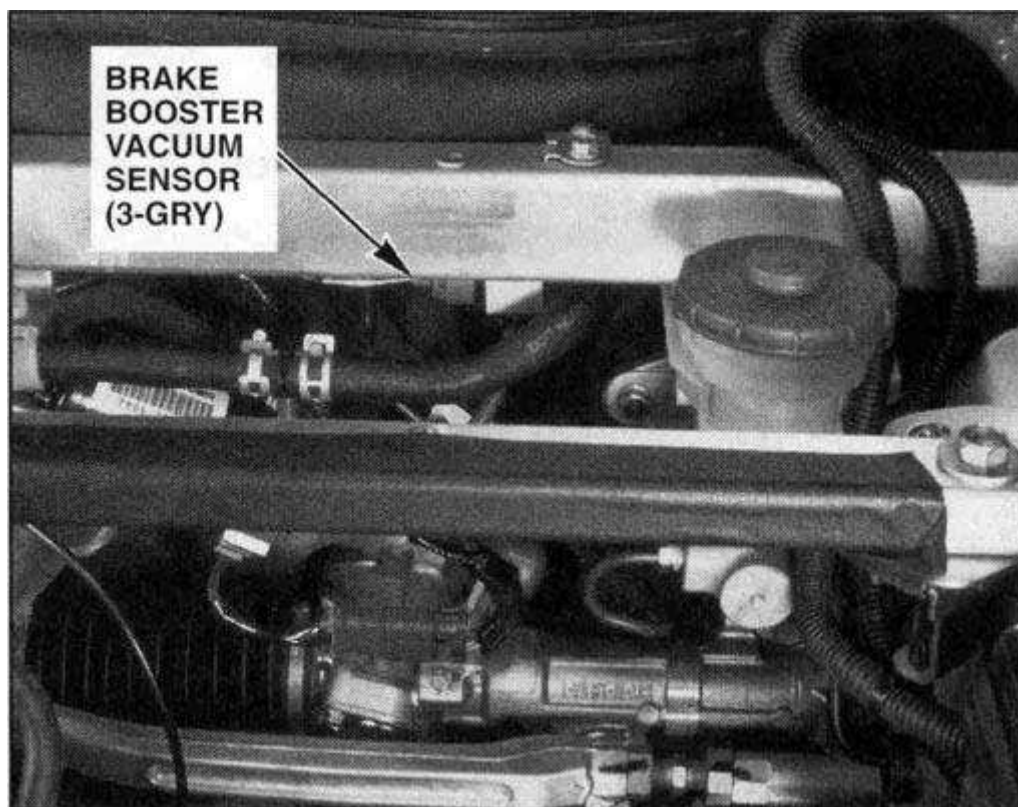
G00288337

**Fig. 18: Left Rear Of Engine Compartment**  
**Courtesy of AMERICAN HONDA MOTOR CO., INC.**

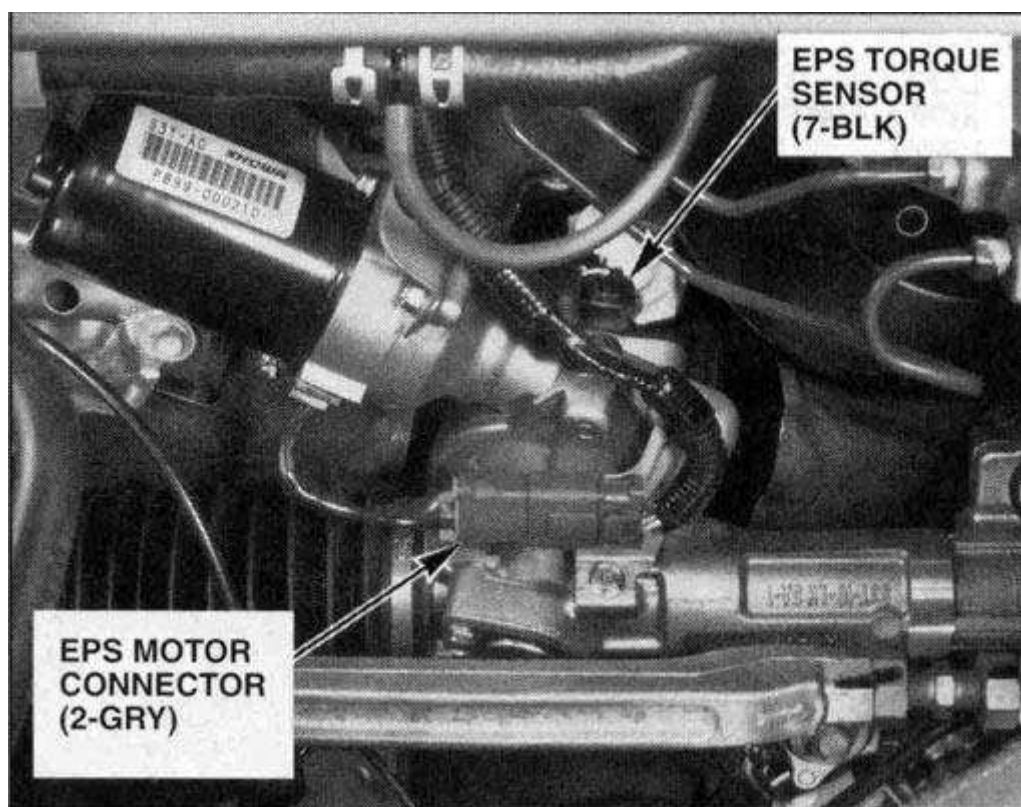
G00288338

**Fig. 19: Left Rear Of Engine Compartment**  
**Courtesy of AMERICAN HONDA MOTOR CO., INC.**

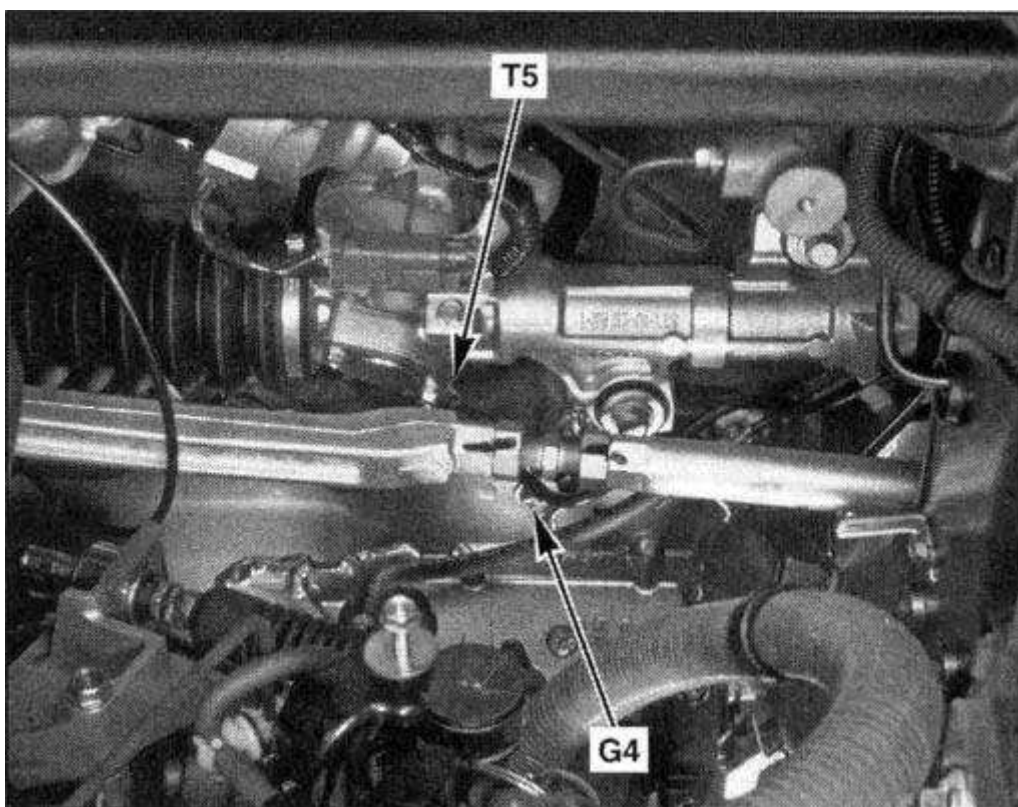
G00288339

**Fig. 20: Left Rear Of Engine Compartment**  
**Courtesy of AMERICAN HONDA MOTOR CO., INC.**

| G4 | At left side of engine compartment.<br>See <b>Fig. 20</b> . |

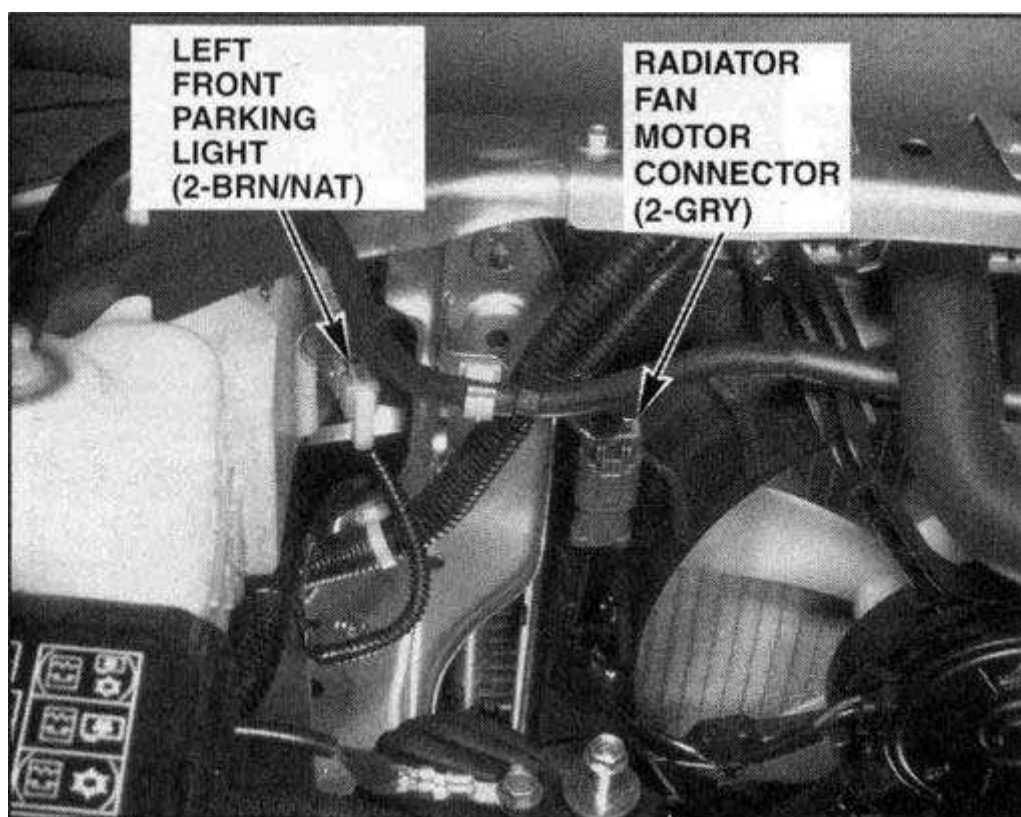
G00288340

**Fig. 21: Left Front Of Engine Compartment**  
**Courtesy of AMERICAN HONDA MOTOR CO., INC.**

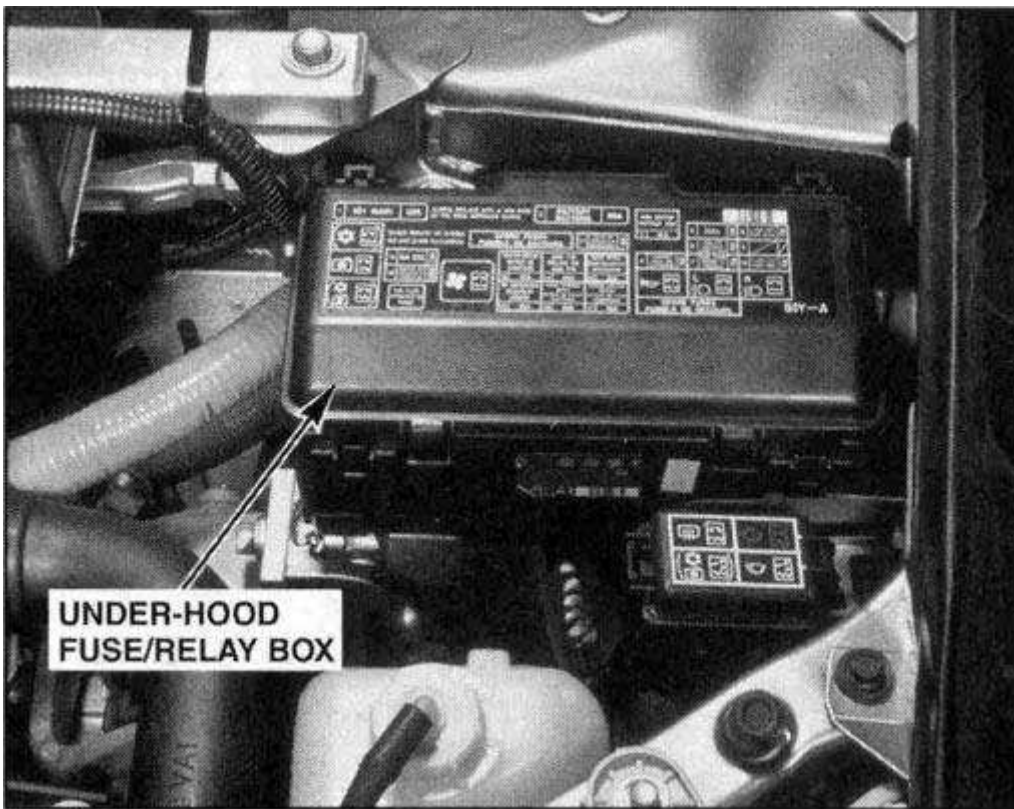
G00288342

**Fig. 23: Left Front Side Of Engine Compartment**  
**Courtesy of AMERICAN HONDA MOTOR CO., INC.**

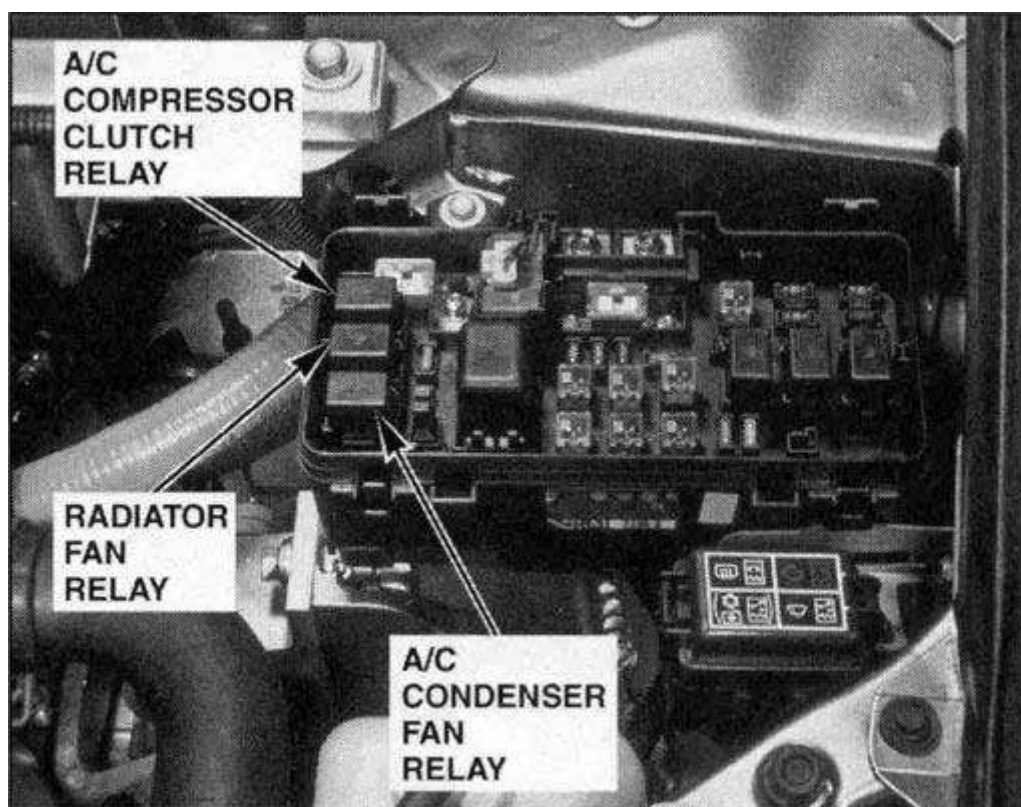
G00288344

**Fig. 25: Left Front Side Of Engine Compartment**  
**Courtesy of AMERICAN HONDA MOTOR CO., INC.**

| Component | Location |
|---|---|
| A/C Compressor Clutch Relay | In under-hood fuse/relay box. See <b>Fig. 25</b> . |
| A/C Condenser Fan Relay | In under-hood fuse/relay box. See <b>Fig. 25</b> . |

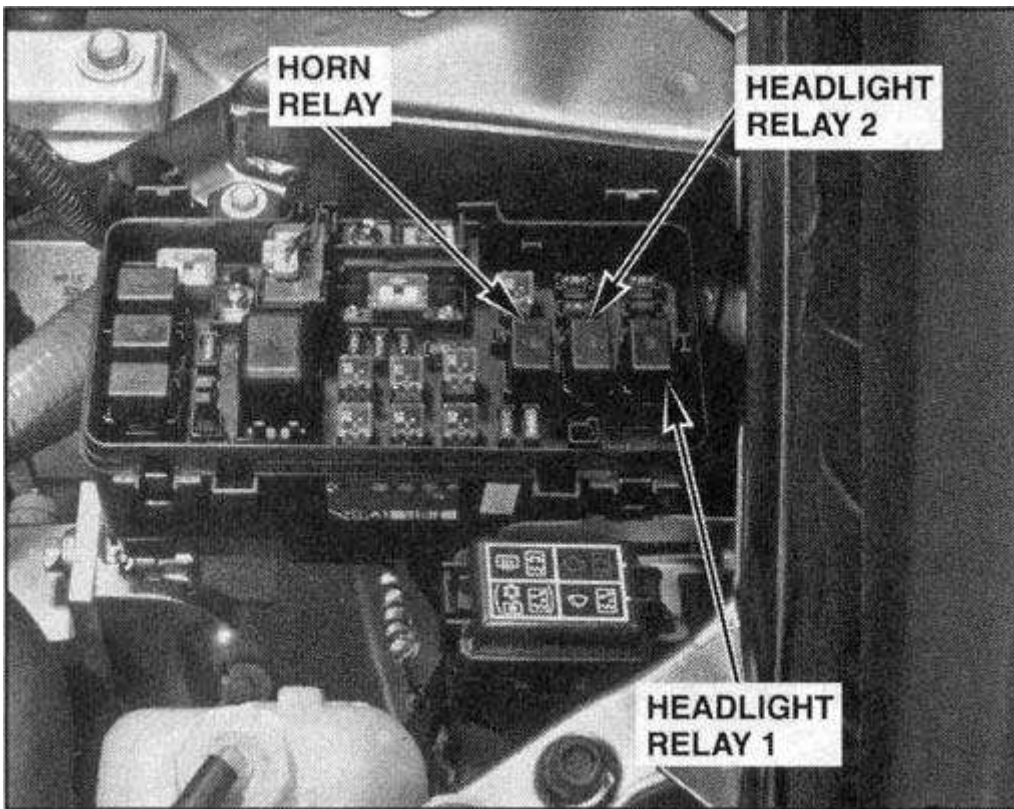
G00288346

**Fig. 27: Left Front Side Of Engine Compartment**  
**Courtesy of AMERICAN HONDA MOTOR CO., INC.**

| Component | Location |
|---|---|
| Headlight Relay 1 | In under-hood fuse/relay box. See <b>Fig. 27</b> . |
| Headlight Relay 2 | In under-hood fuse/relay box. See <b>Fig. 27</b> . |

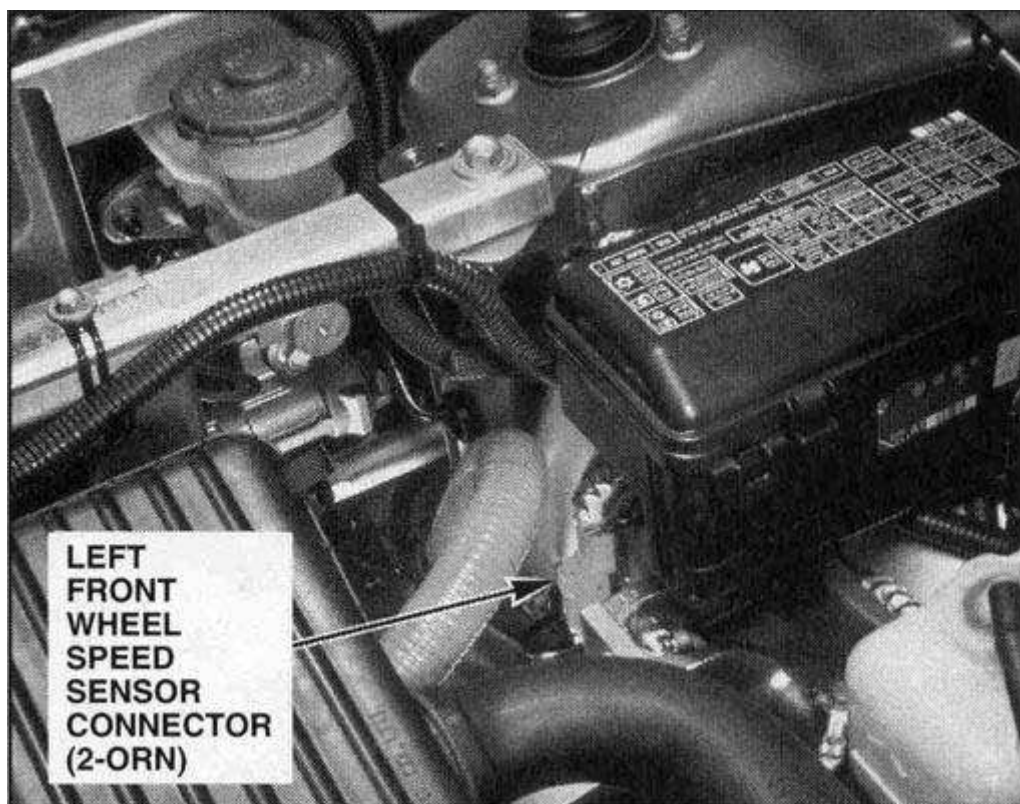
G00288347

**Fig. 28: Left Side Of Engine Compartment**  
**Courtesy of AMERICAN HONDA MOTOR CO., INC.**

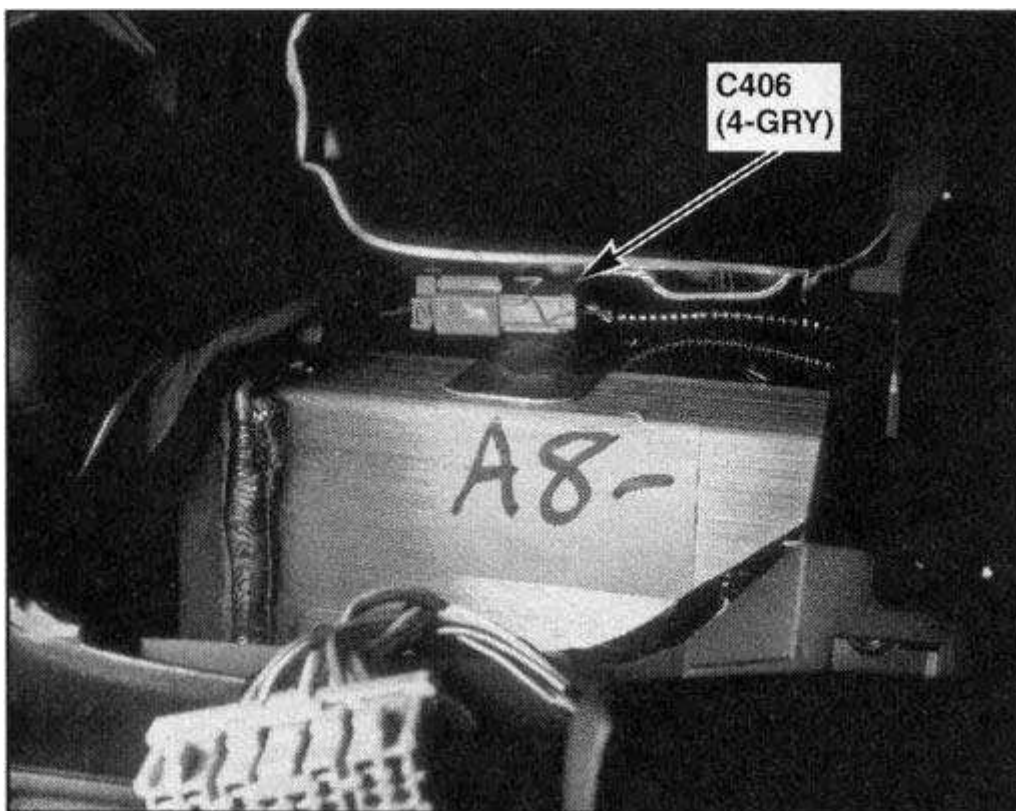
G00288350

**Fig. 30: Left Side Of Dash**

| Component | Location |
|---|---|
| C406 (Gray, 4 Pin) | Under left side of dash. See <b>Fig. 30</b> . |

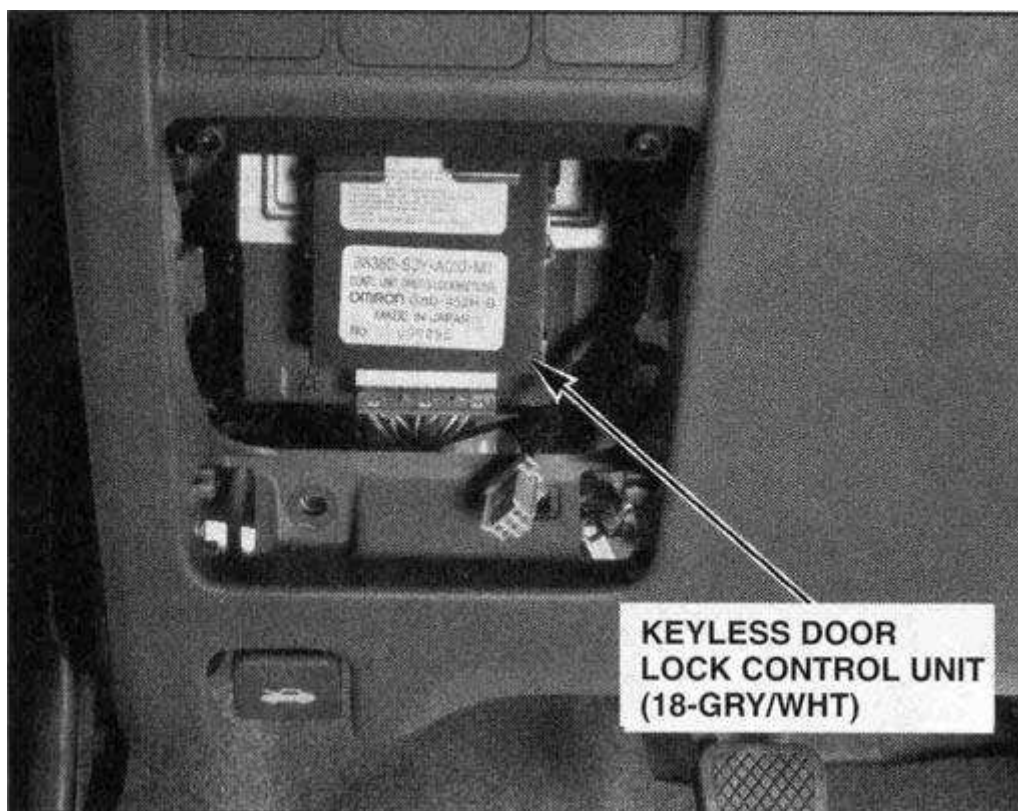
G00288351

**Fig. 31: Under Left Side Of Dash**  
**Courtesy of AMERICAN HONDA MOTOR CO., INC.**

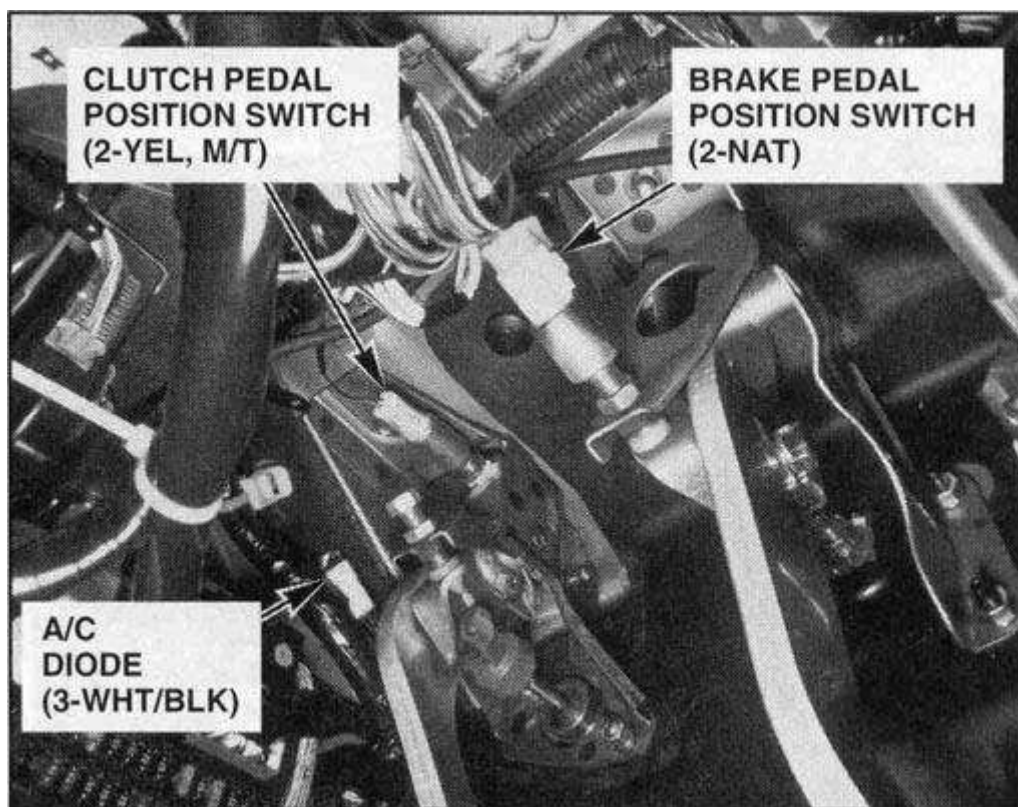
G00288353

**Fig. 33: Under Left Side Of Dash**

| <b>Component</b> | <b>Location</b> |
|---|---|
| Brake Pedal Position Switch | Under left side of dash. See <b>Fig. 33</b> . |
| Clutch Pedal Position Switch | Under left side of dash. See <b>Fig. 33</b> . |

| <b>Component</b> | <b>Location</b> |
|---|---|
| A/C Diode | Under left side of dash. See <b>Fig. 33</b> . |

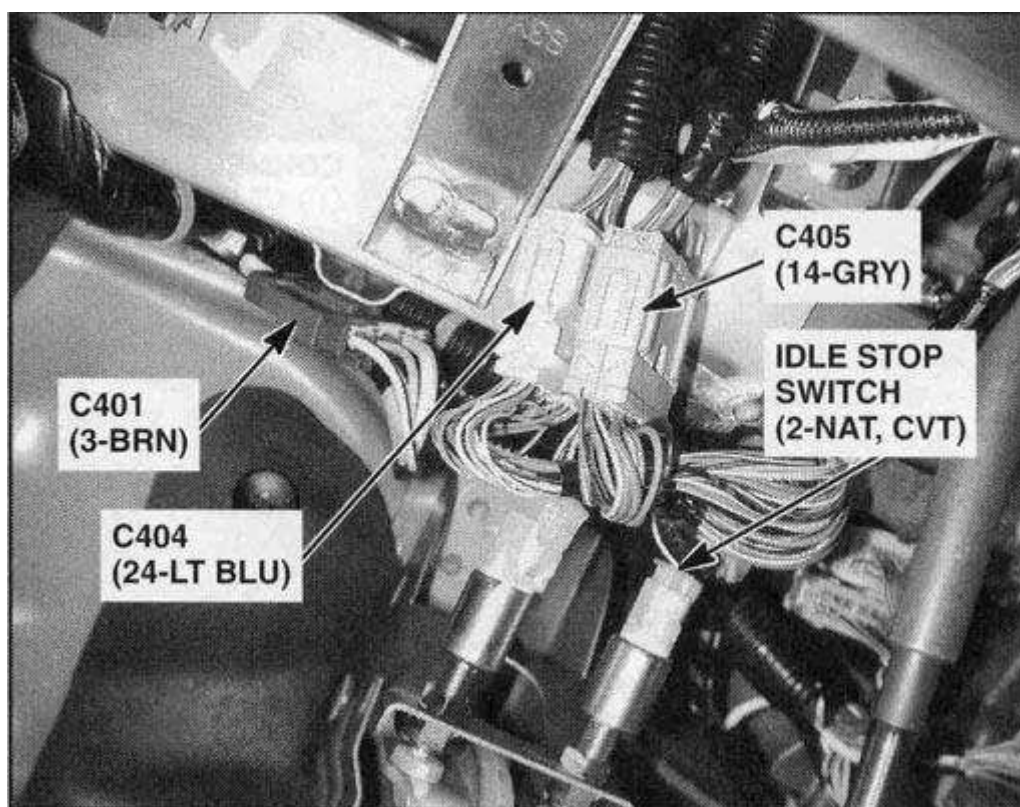
G00288354

**Fig. 34: Under Left Side Of Dash**

| <b>Component</b> | <b>Location</b> |
|---|---|
| Idle Stop Switch | Under left side of dash. See <b>Fig. 34</b> . |

| Component | Location |
|---|---|
| C401 (Brown, 3 Pin) | Under left side of dash. See <b>Fig. 34</b> . |
| C404 (Light Blue, 24 Pin) | Under left side of dash. See <b>Fig. 34</b> . |
| C405 (Gray, 14 Pin) | Under left side of dash. See <b>Fig. 34</b> . |

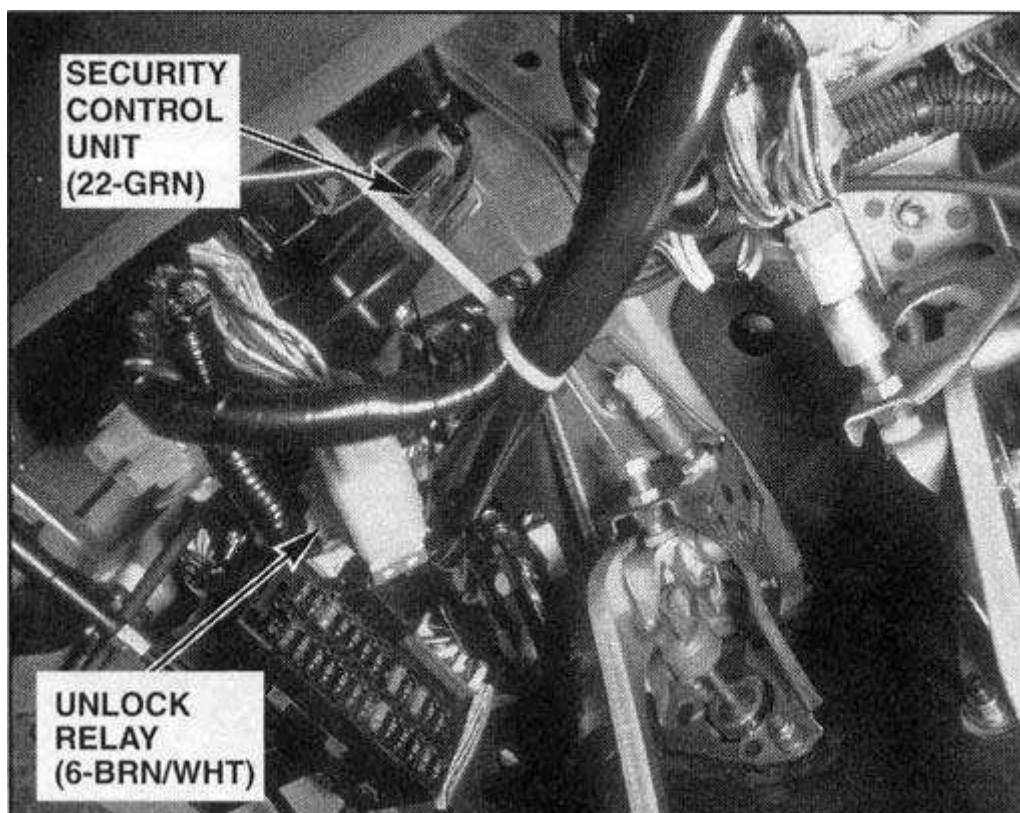
**Fig. 35: Under Left Side Of Dash (Honda Accessory)**  
**Courtesy of AMERICAN HONDA MOTOR CO., INC.**

| <b>Component</b> | <b>Location</b> |
|---|---|
| In-Line Fuse A | Left side of dash. See <b>Fig. 35 .</b> |
| In-Line Fuse B | Left side of dash. See <b>Fig. 35 .</b> |

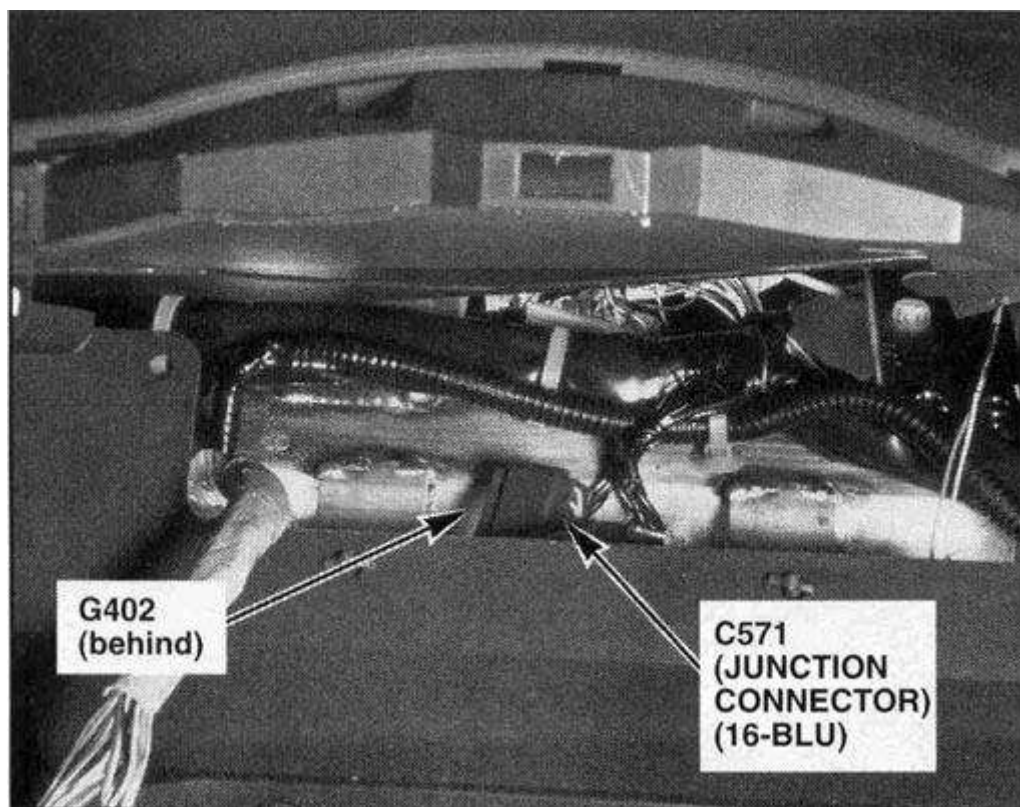
G00288357

**Fig. 37: Left Side Of Dash**

| Junction Connector C571 | Under left side of dash. See <b>Fig. 37 .</b> |

| G402 | Behind left side of dash. See <b>Fig. 37</b> . |

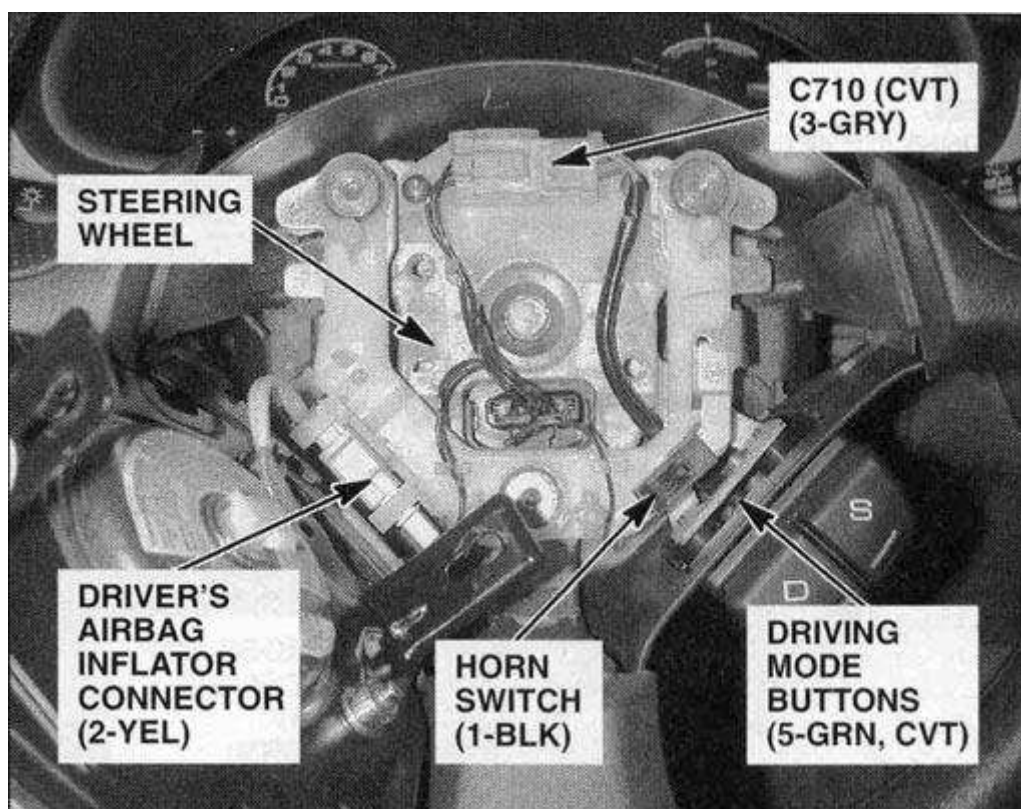
G00288358

**Fig. 38: Steering Wheel (Airbag Removed)**  
**Courtesy of AMERICAN HONDA MOTOR CO., INC.**

| C710 (CVT) (Gray, 3 Pin) | In steering wheel. See <b>Fig. 38 .</b> |

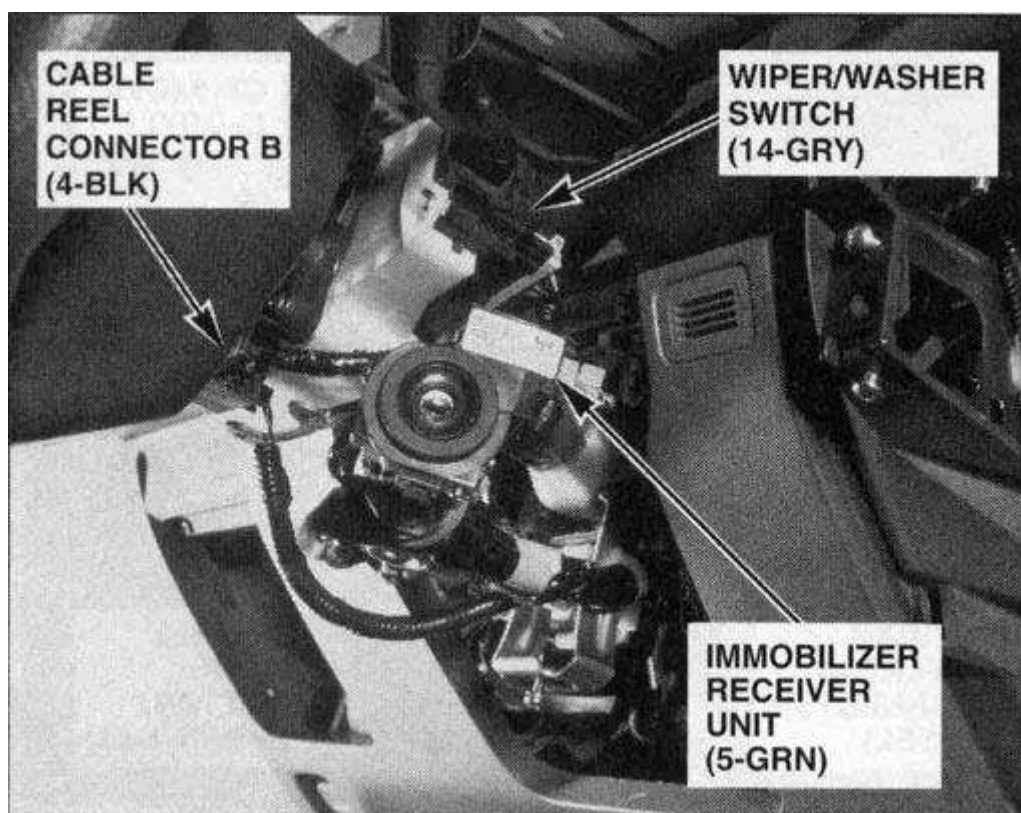
G00288360

**Fig. 39: Right Side Of Steering Column**

| Cable Reel Connector B | On steering column. See <b>Fig. 39 .</b> |

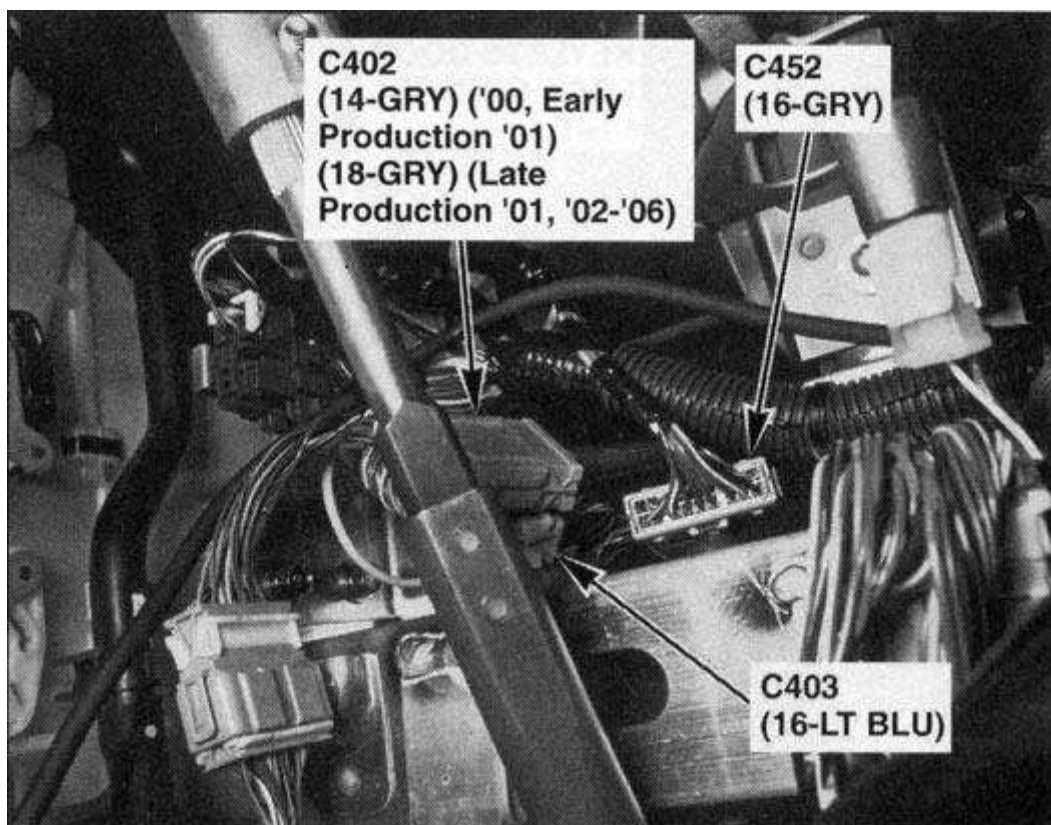
| Component | Location |
|---|---|
| Immobilizer Receiver Unit | Under left side of dash, right of steering column. See <b>Fig. 39</b> . |

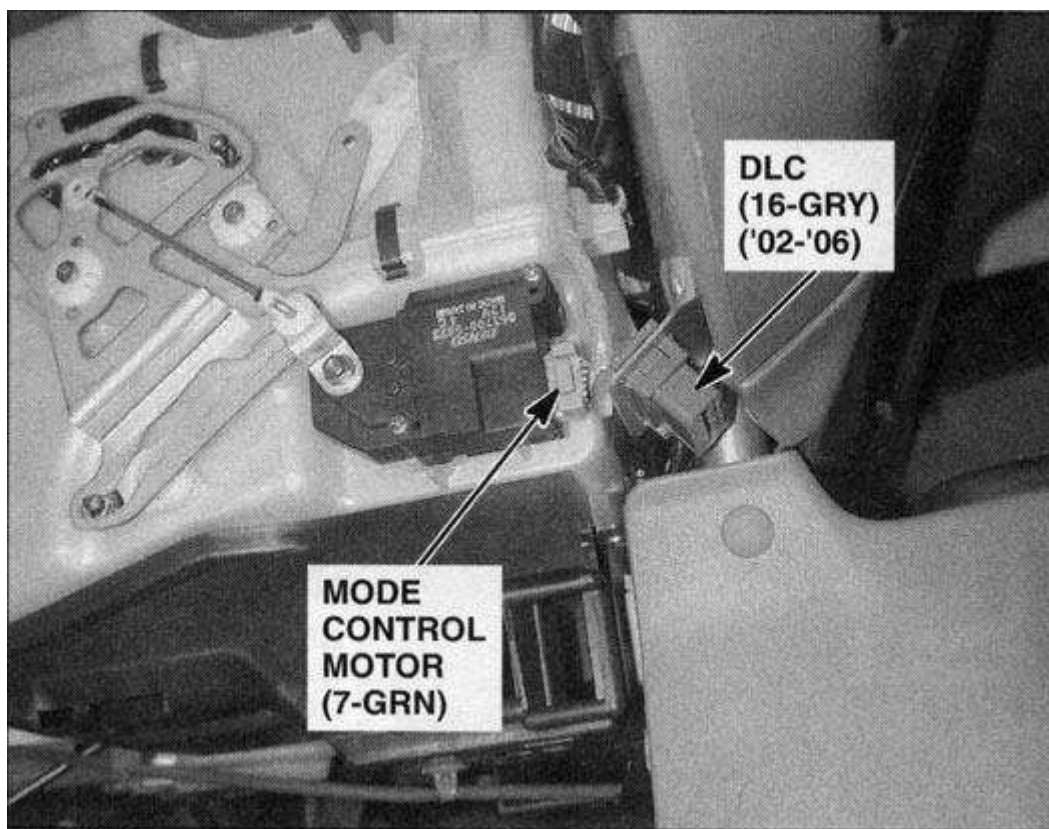
G00421163

**Fig. 41: Under Middle Of Dash**  
**Courtesy of AMERICAN HONDA MOTOR CO., INC.**

| DLC (Data Link Connector) | Behind center of dash. See <b>Fig. 41 .</b> |

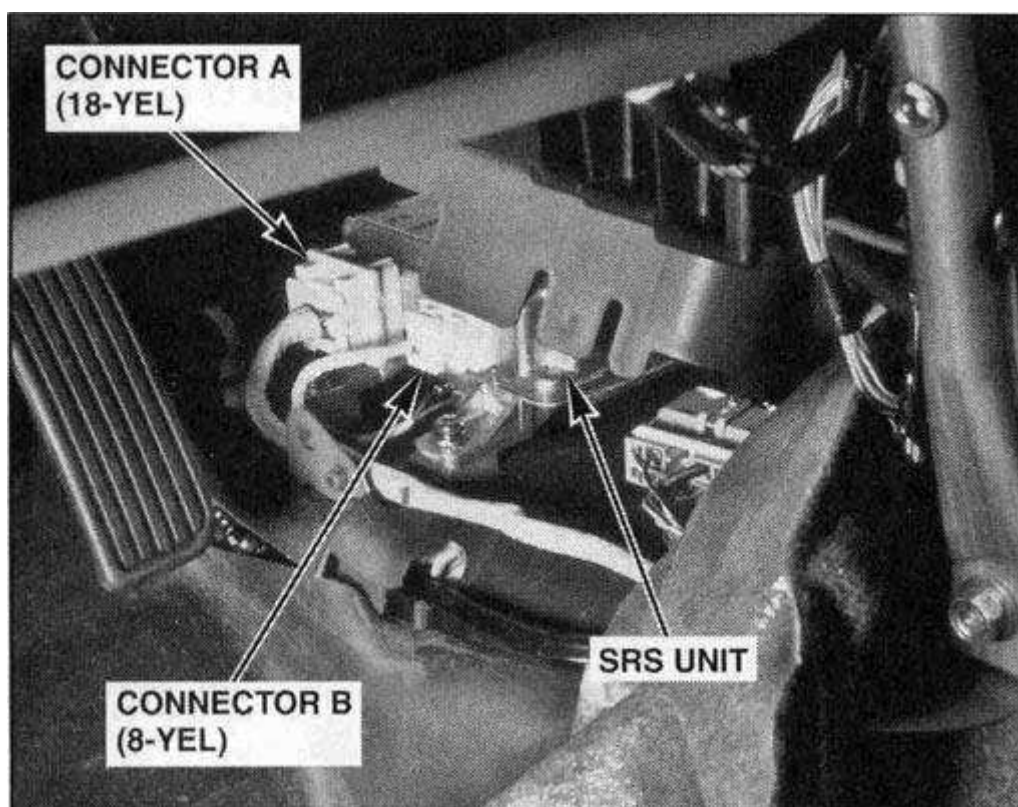
G00288364

**Fig. 42: Under Middle Of Dash**

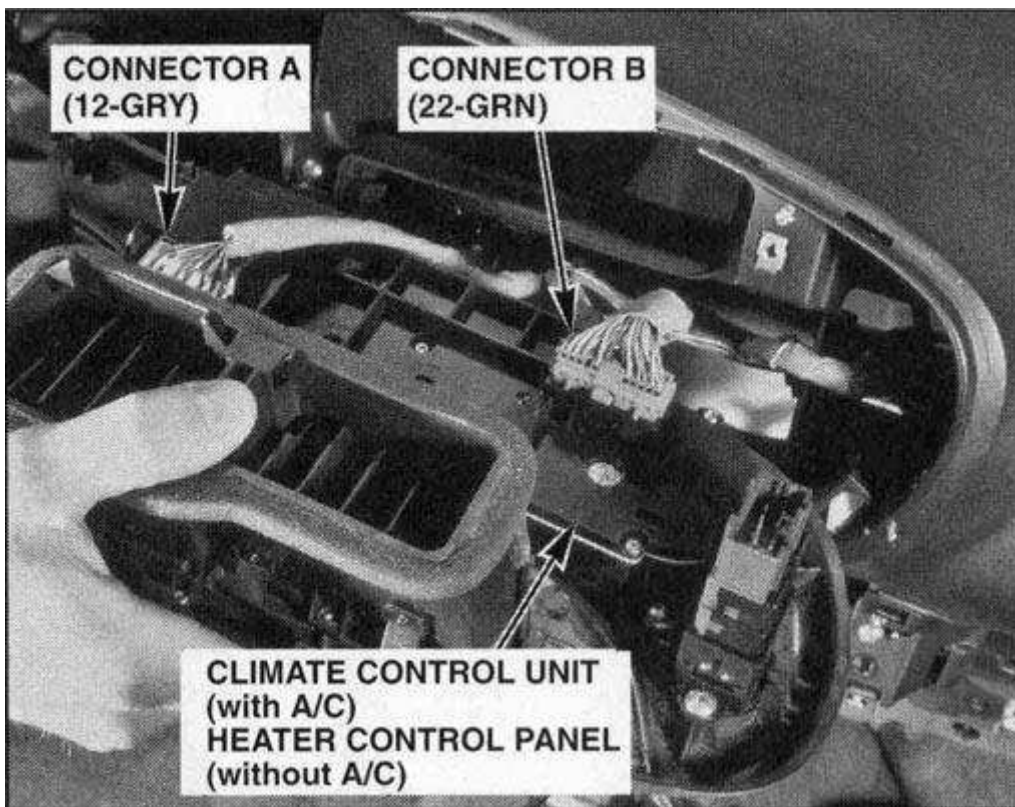
G00291988

**Fig. 44: Middle Of Dash**
