## 2006 HONDA

## Insight

## BUZZERS, RELAYS &amp; TIMERS

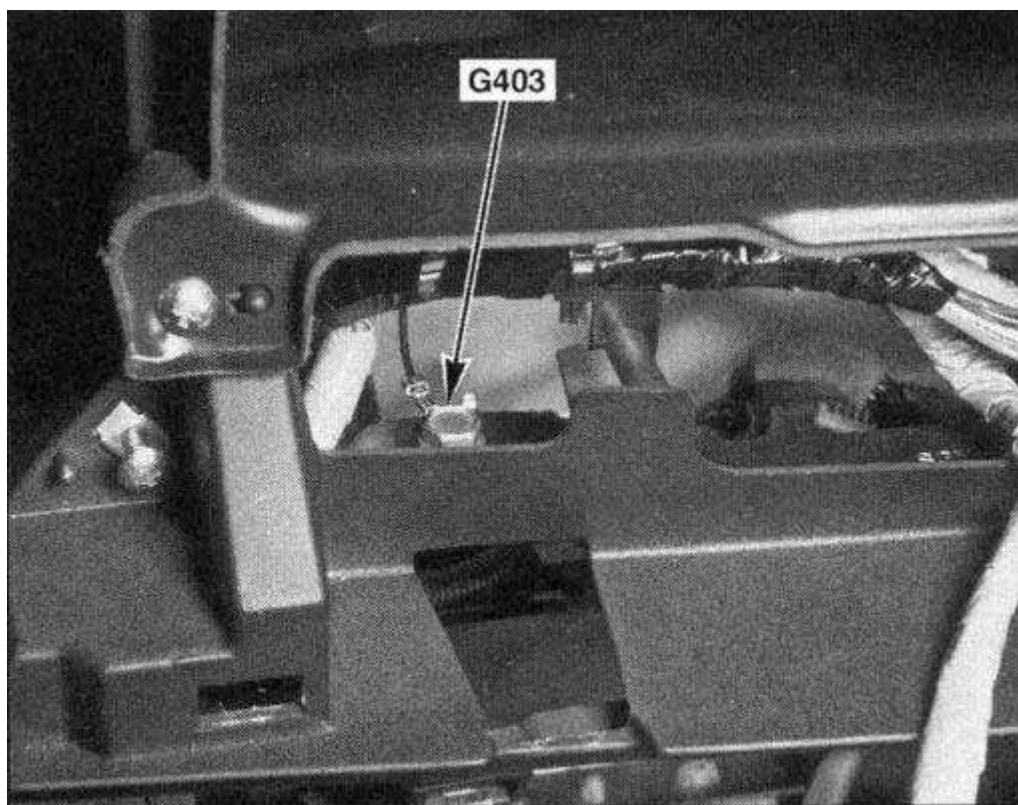
G00288366

**Fig. 45: Middle Of Dash**

| G403 | Behind center of dash. See <b>Fig. 45</b> . |

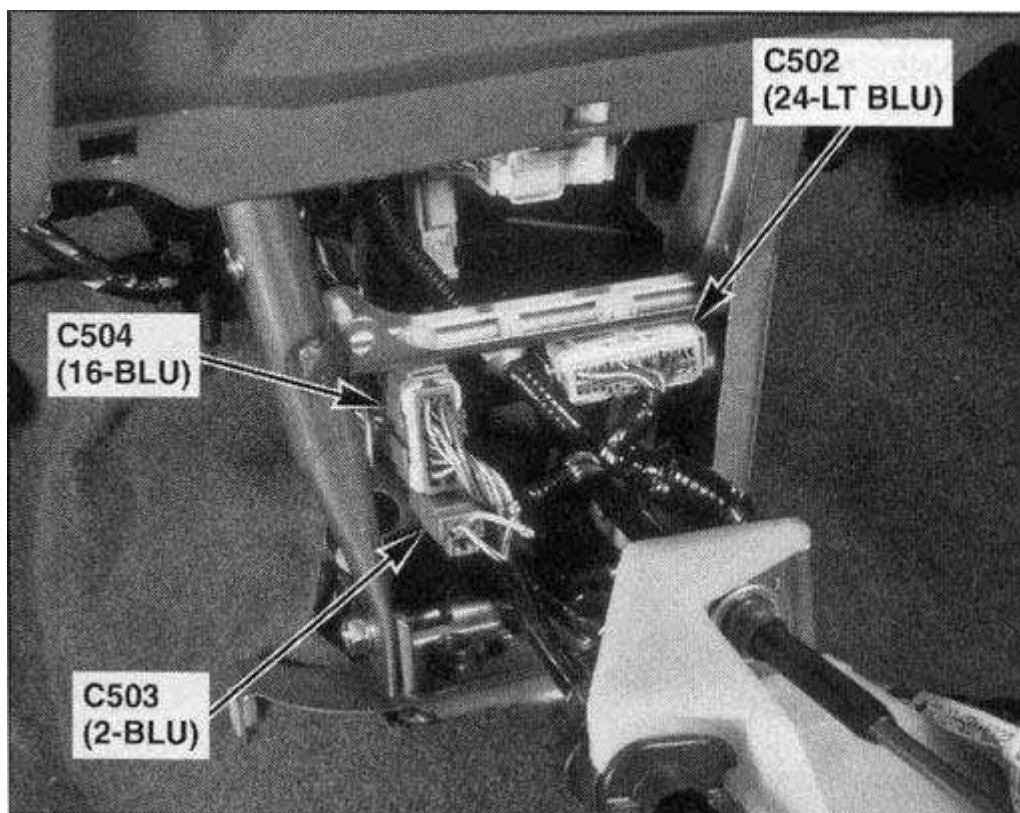
G00288368

**Fig. 46: Behind Center Lower Cover**

| C502 (Light Blue, 24 Pin) | Behind center lower cover. See <b>Fig. 46 .</b> |
| C503 (Blue, 2 Pin) | Behind center lower cover. See <b>Fig. 46 .</b> |
| C504 (Blue, 16 Pin) | Behind center lower cover. See <b>Fig. 46 .</b> |

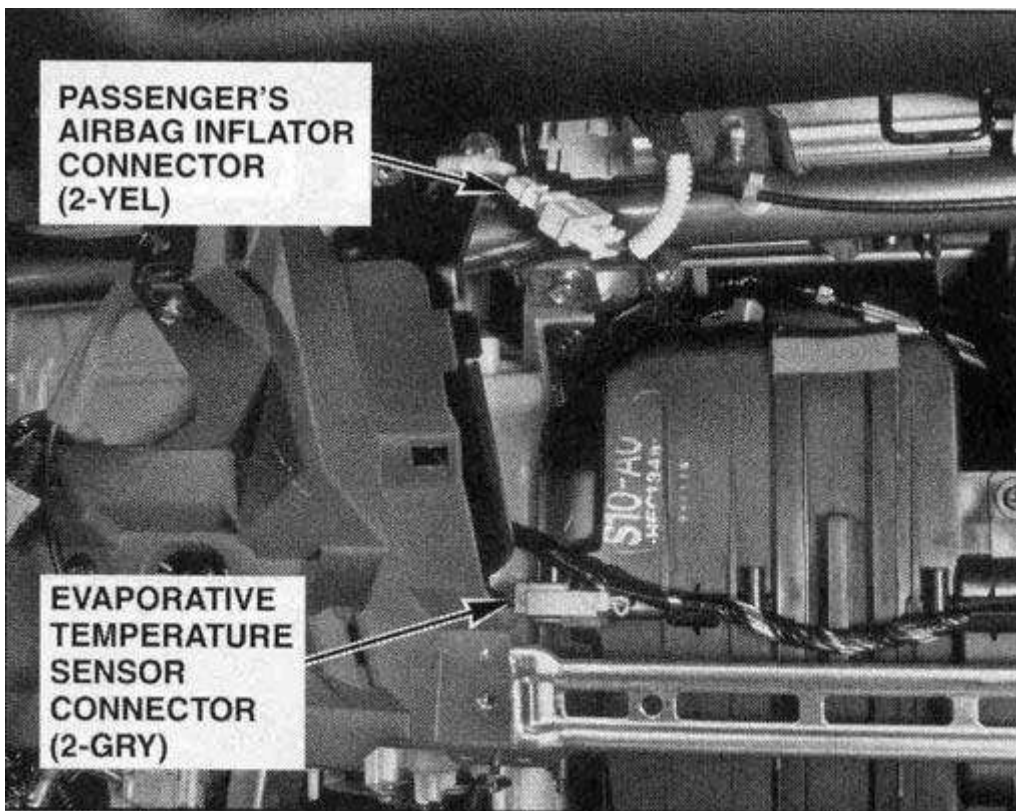
G00288369

**Fig. 47: Behind Glove Box**

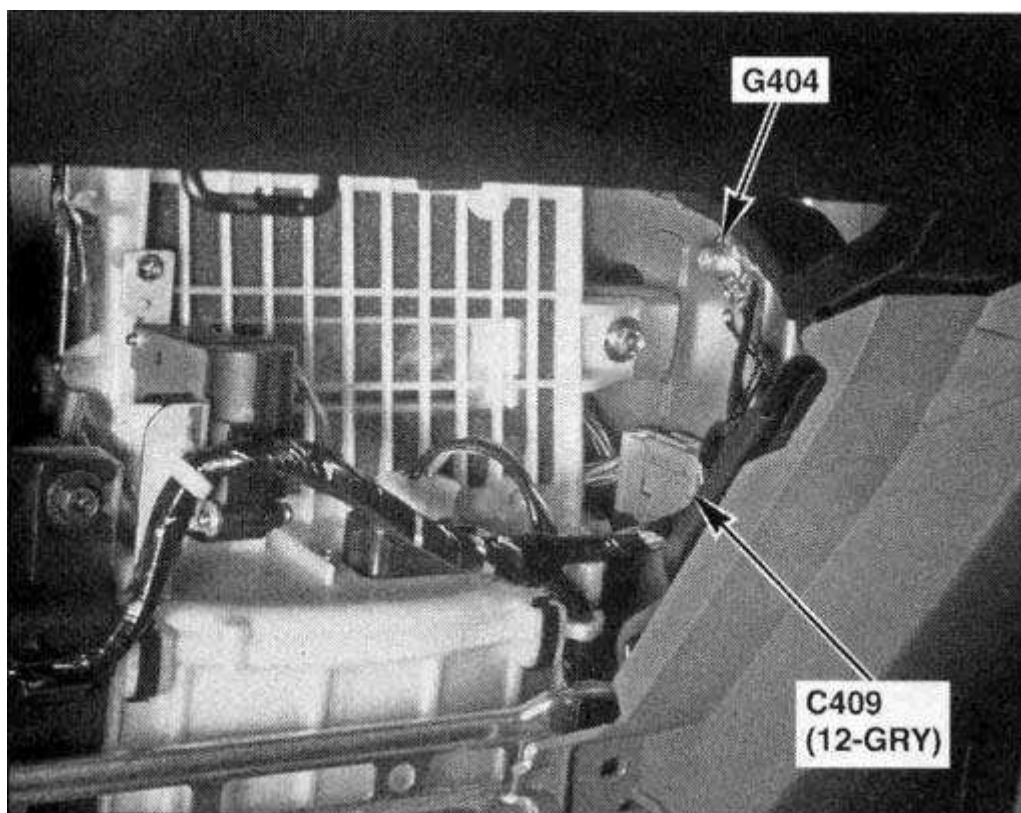
**Fig. 48: Behind Glove Box**

| Component | Location |
|---|---|
| Recirculation Control Motor | Behind glove box. See <b>Fig. 48</b> . |

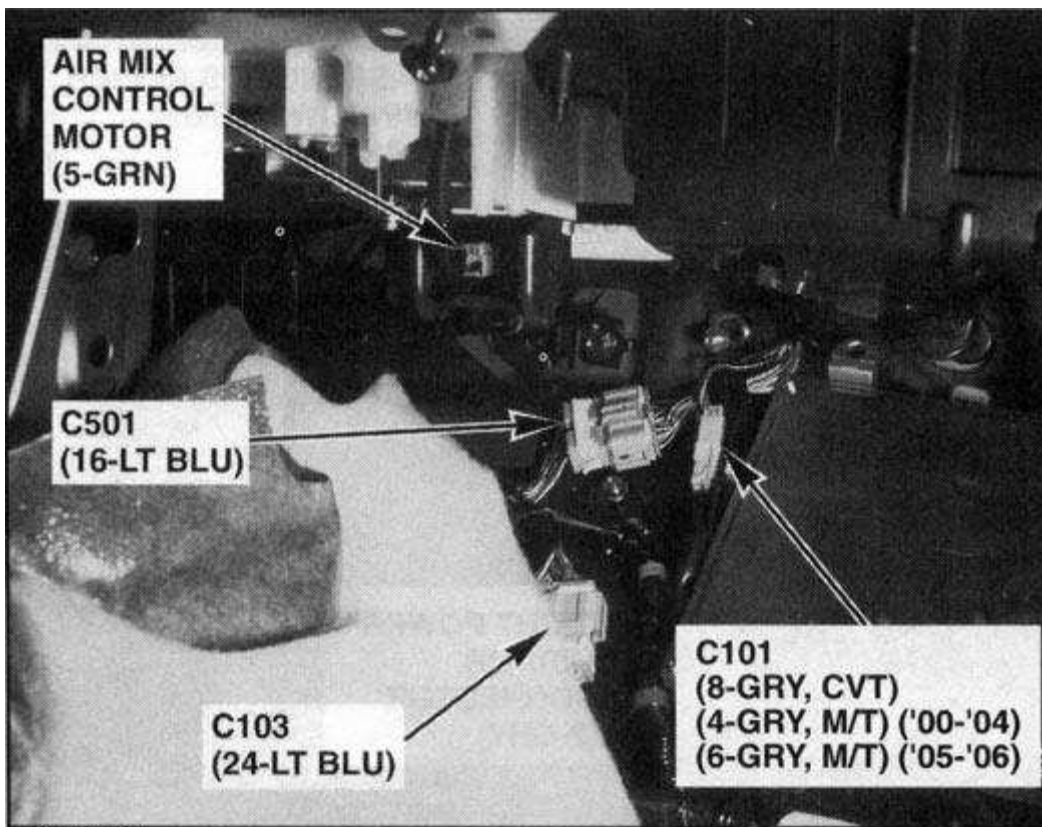
G00421165

**Fig. 50: Under Middle Of Dash**

| Component | Location |
|---|---|
| C101 (CVT) (Gray, 8 Pin) | Under center of dash. See <b>Fig. 50</b> . |
| C101 (M/T) (Gray, 6 Pin) | Under center of dash. See <b>Fig. 50</b> . |
| C103 (Light Blue, 24 Pin) | Under center of dash. See <b>Fig. 50</b> . |

| C501 (Light Blue, 16 Pin) | Under center of dash. See <b>Fig. 50 .</b> |

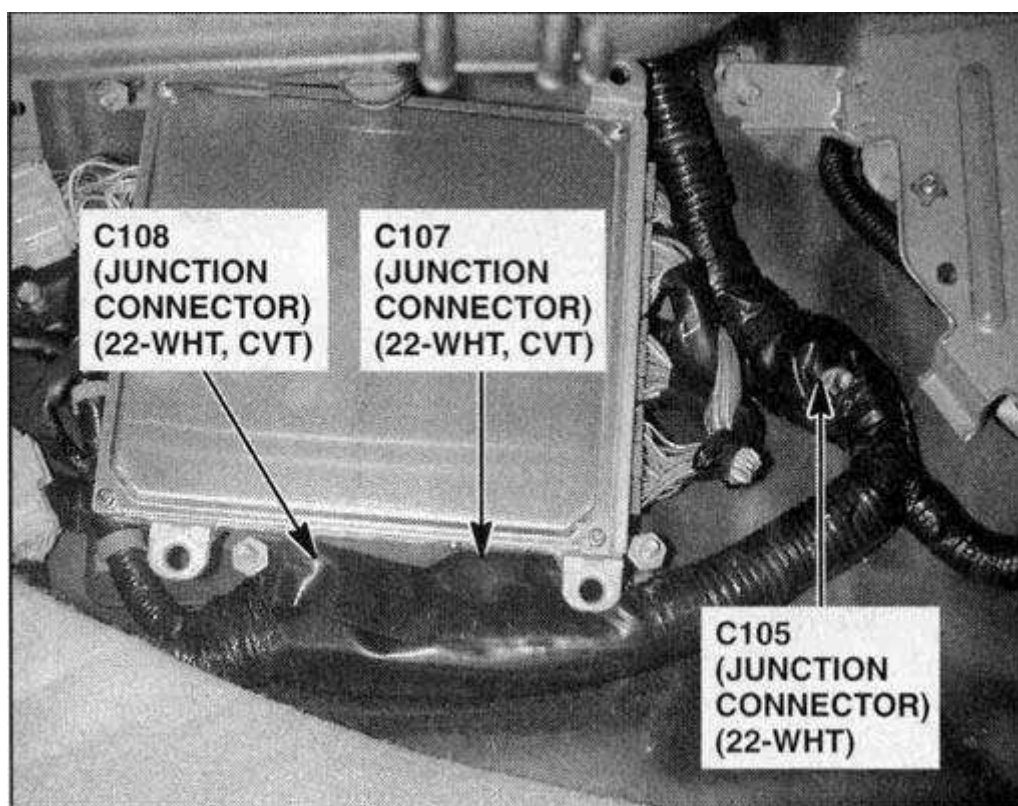
G00288375

**Fig. 52: Right Side Of Floor**

| Junction Connector C105 | At right side of floor. See <b>Fig. 52 .</b> |
| Junction Connector C107 | Under center of dash. See <b>Fig. 52 .</b> |
| Junction Connector C108 | Under center of dash. See <b>Fig. 52 .</b> |

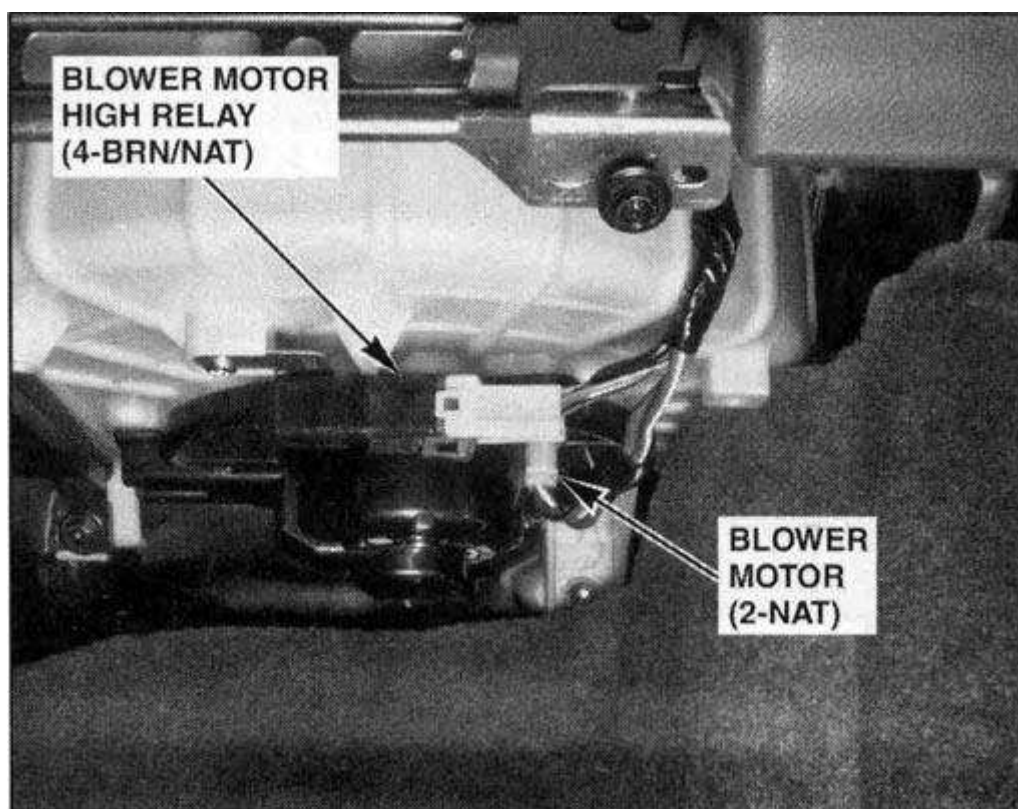
G00288376

**Fig. 53: Under Right Side Of Dash**

| Component | Location |
|---|---|
| Blower Motor High Relay | Behind glove box. See <b>Fig. 53</b> . |

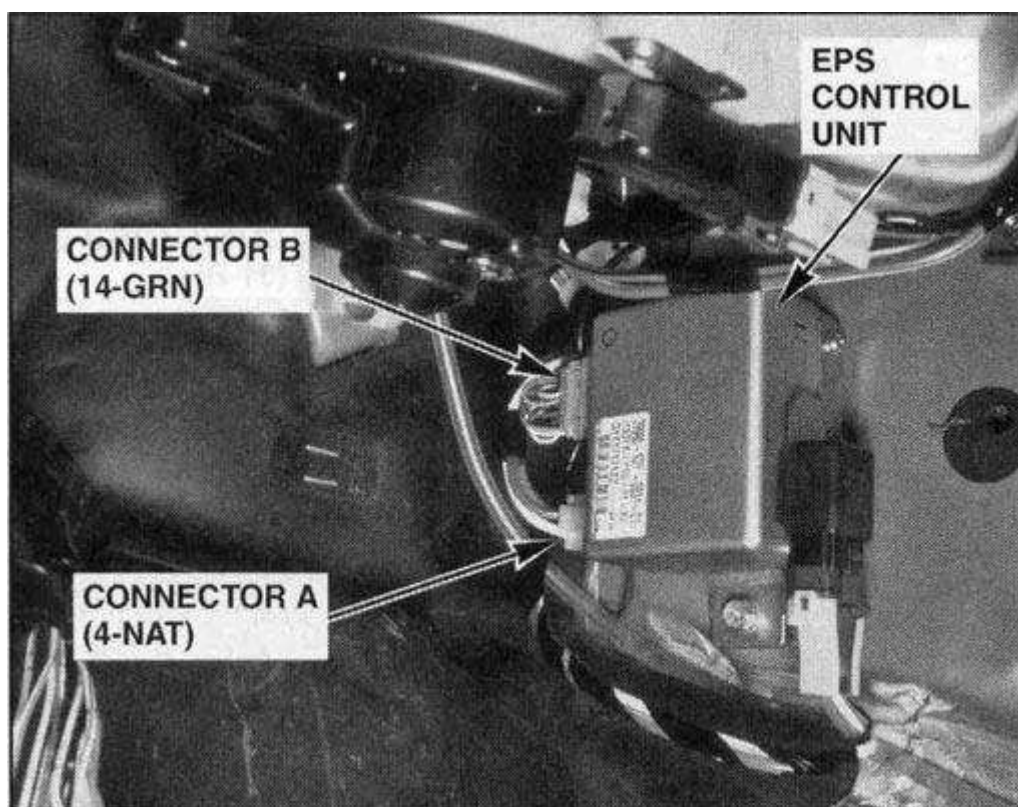
G00288377

**Fig. 54: Under Right Side Of Kick Panel (M/T)**  
**Courtesy of AMERICAN HONDA MOTOR CO., INC.**

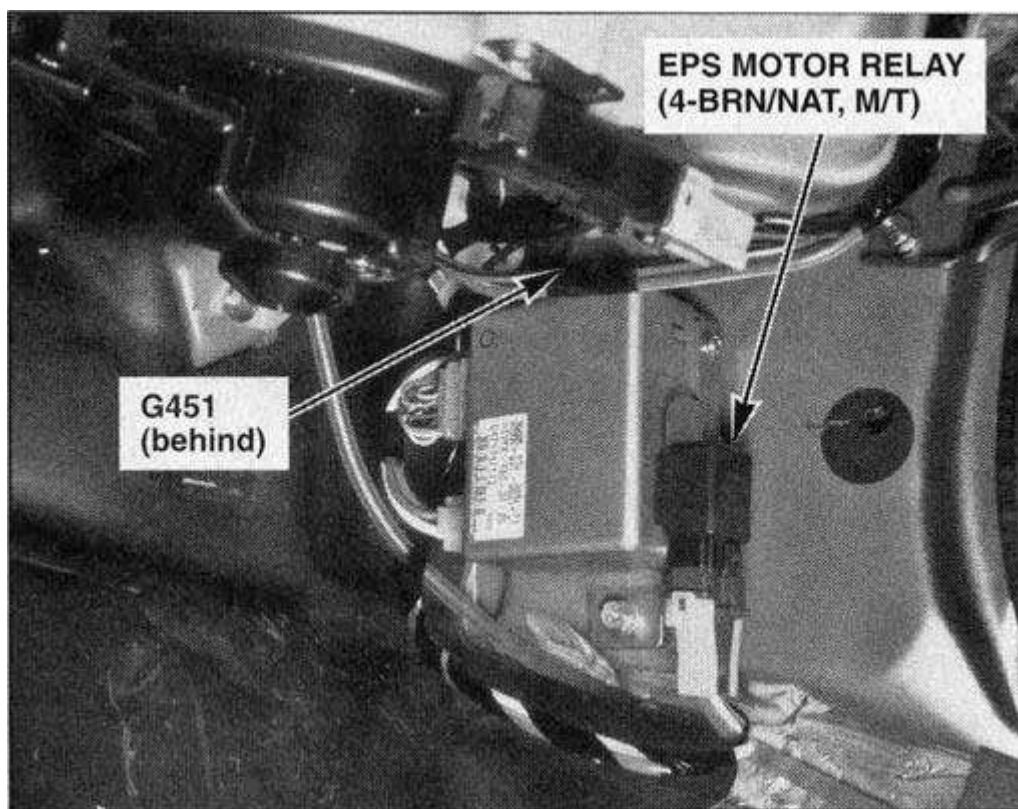
G00288378

**Fig. 55: Under Right Side Of Kick Panel**  
**Courtesy of AMERICAN HONDA MOTOR CO., INC.**

| Component | Location |
|---|---|
| EPS Motor Relay (M/T) | Under right kick panel. See <b>Fig. 55</b> . |

| G451 | Behind right kick panel. See <b>Fig. 55</b> . |

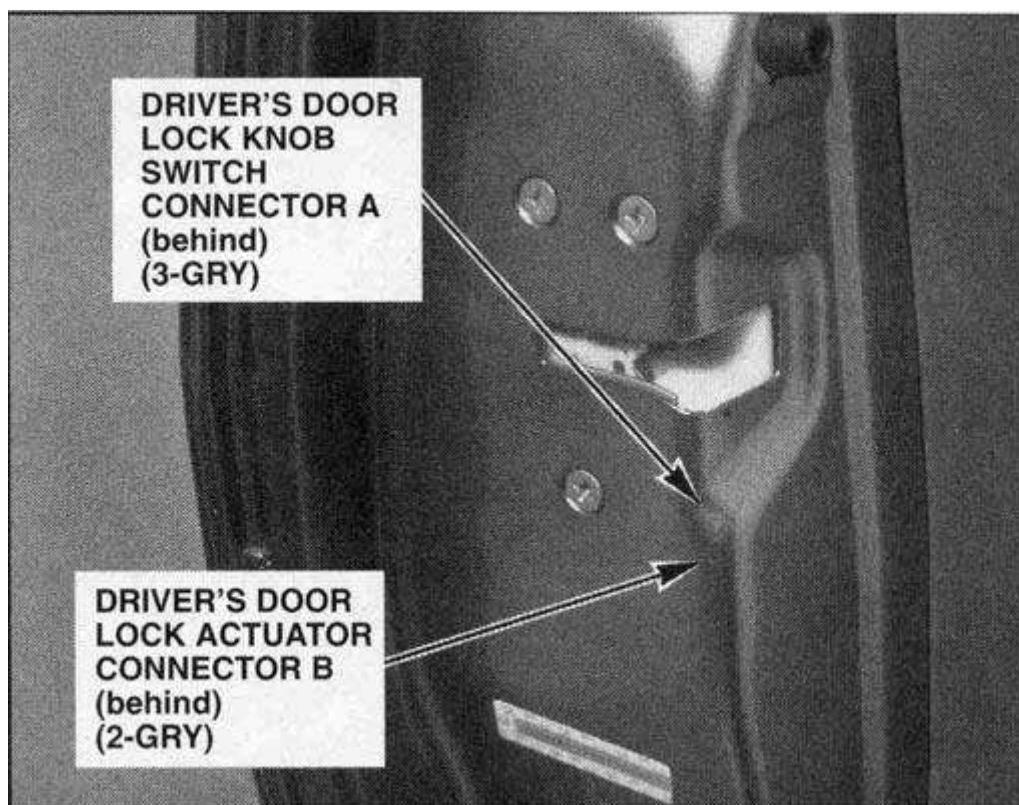
G00291989

**Fig. 56: Rear Of Driver's Door**

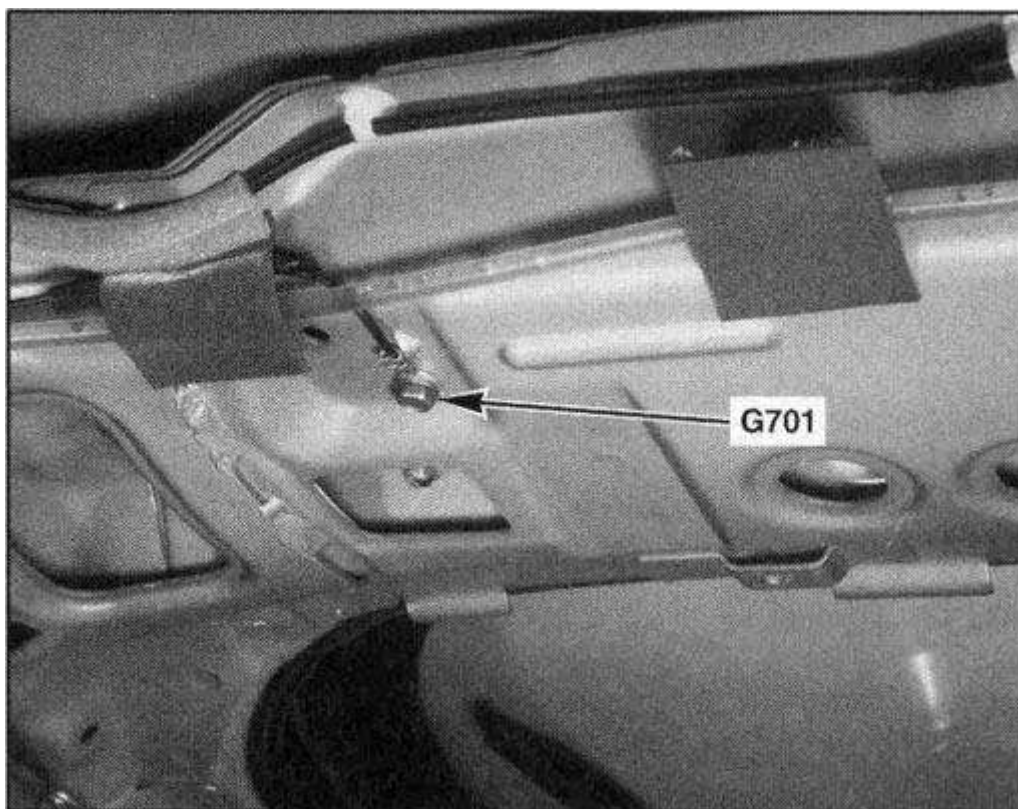
G00288380

**Fig. 58: Middle Rear Of Roof**

| G701 | At center rear of roof. See <b>Fig. 58</b> . |

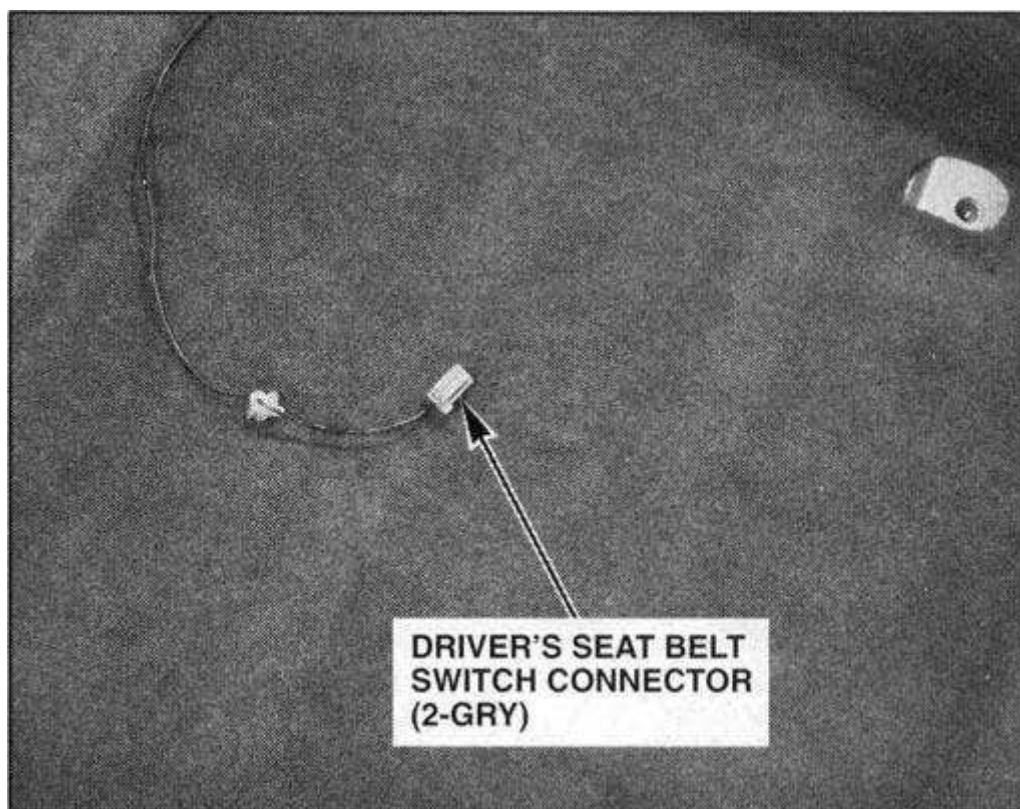
G00288381

**Fig. 59: Under Driver's Seat**

| <b>Component</b> | <b>Location</b> |
|---|---|
| Driver's Seat Belt Switch Connector | Under driver's seat. See <b>Fig. 59</b> . |

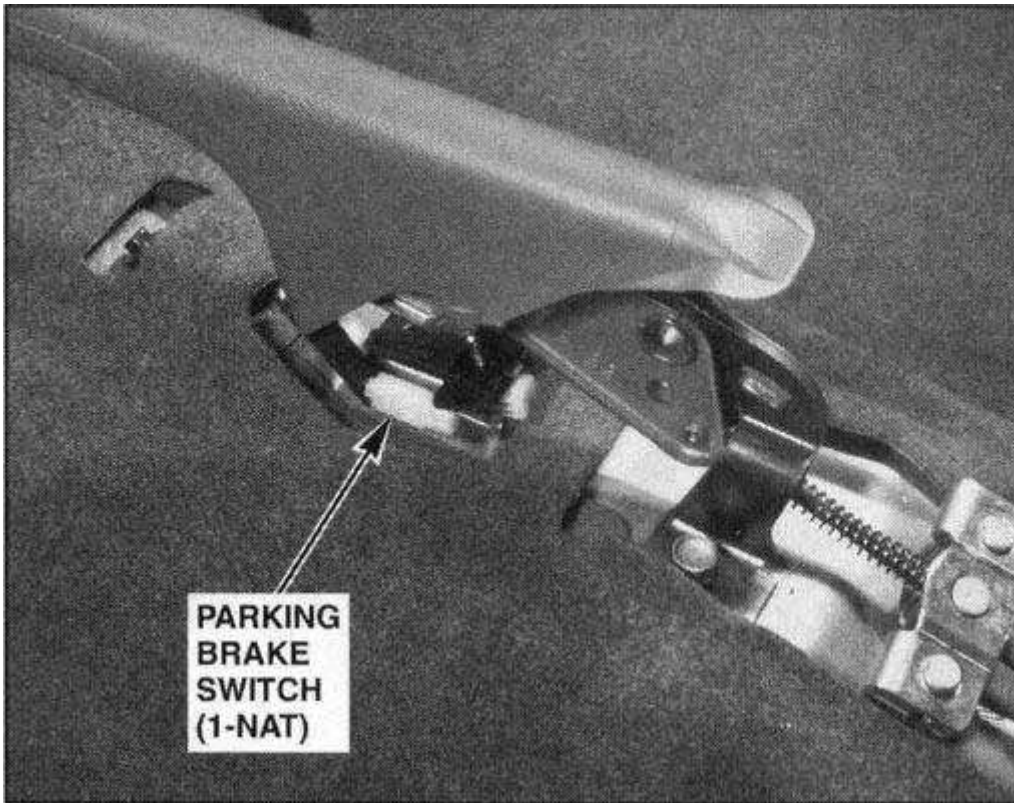
G00288382

**Fig. 60: Middle Of Floor**

| <b>Component</b> | <b>Location</b> |
|---|---|
| Parking Brake Switch | At base of parking brake lever. See <b>Fig. 60</b> . |

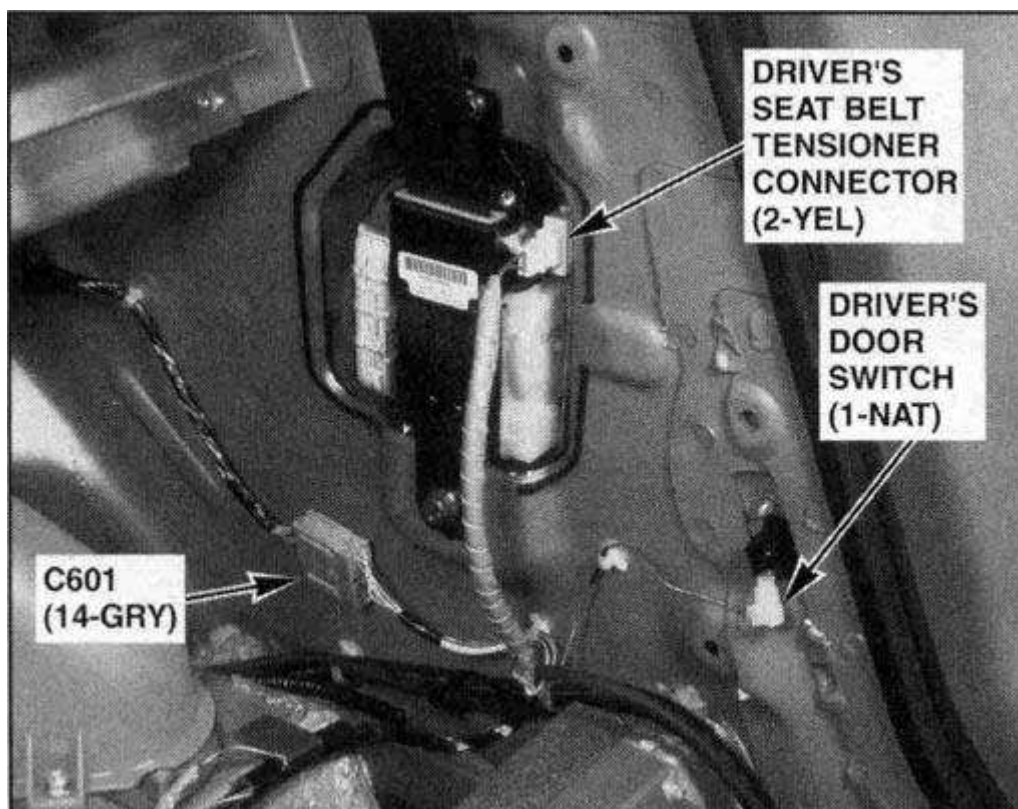
G00288383

**Fig. 61: Left "B" Pillar**

| Driver's Seat Belt Tensioner Connector | At left "B" pillar. See <b>Fig. 61 .</b> |

| C601 (Gray, 14 Pin) | At left "B" pillar. See <b>Fig. 61 .</b> |

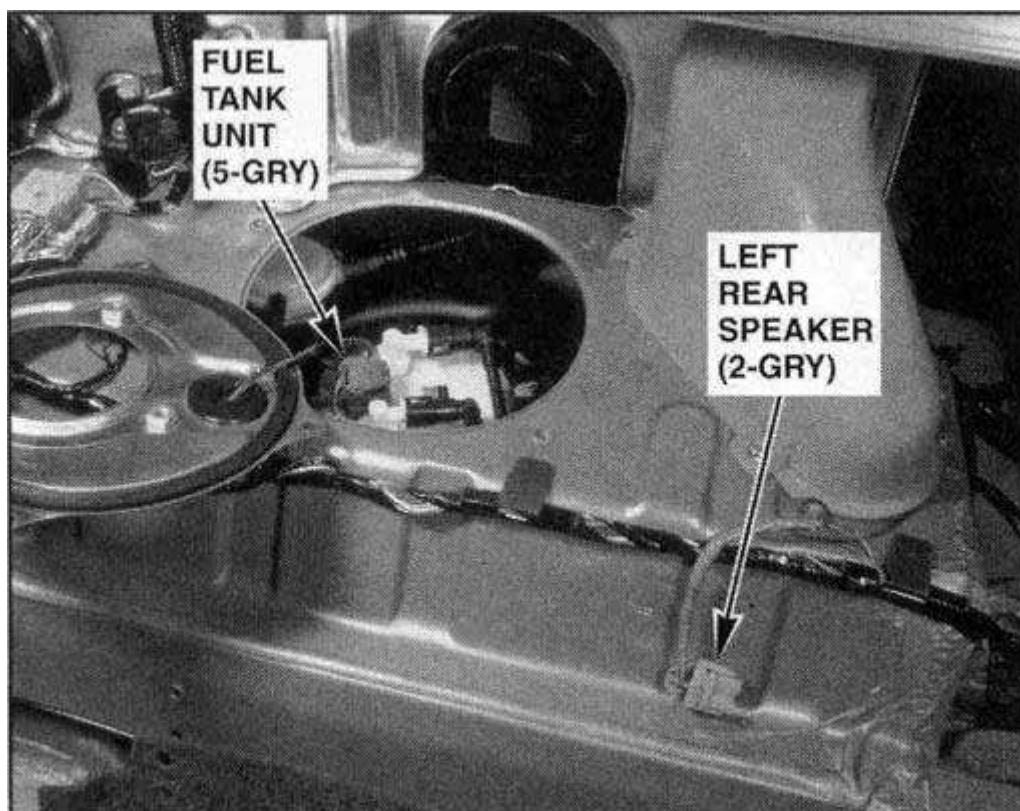
G00288384

**Fig. 62: Behind Seat, Middle Of Floor**

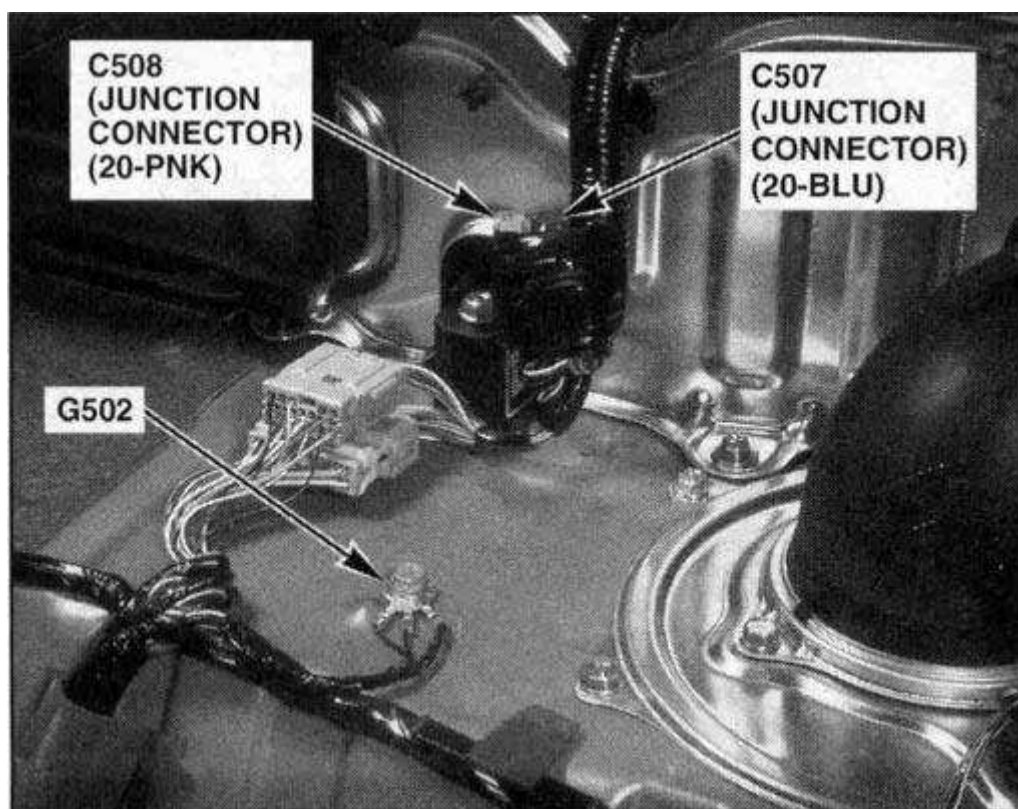
G00288385

**Fig. 63: Behind Seat, Middle Of Floor**

| Junction Connector C507 | Behind rear seats, at center of floor. See <b>Fig. 63 .</b> |
| Junction Connector C508 | Behind rear seats, at center of floor. See <b>Fig. 63 .</b> |

| G502 | Behind rear seats, at center of floor.<br>See <b>Fig. 63</b> . |

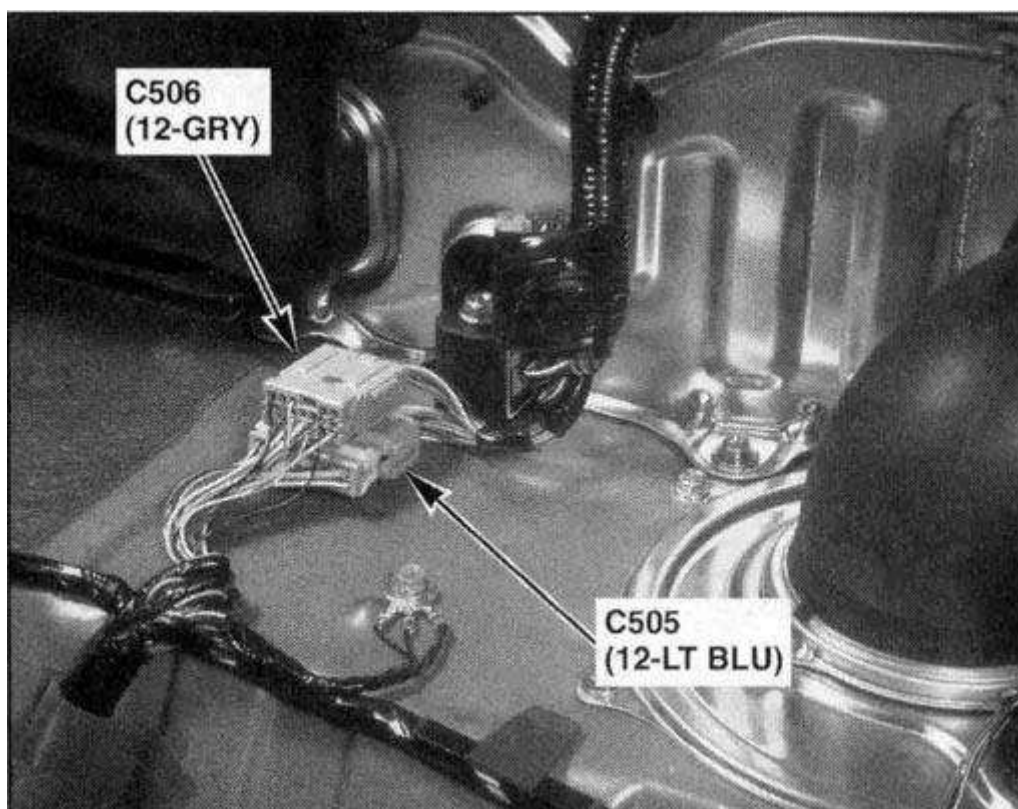
G00288386

**Fig. 64: Behind Seat, Middle Of Floor**

| C505 (Light Blue, 12 Pin) | Behind rear seats, at center of floor.<br>See <b>Fig. 64 .</b> |
| C506 (Gray, 12 Pin) | Behind rear seats, at center of floor.<br>See <b>Fig. 64 .</b> |

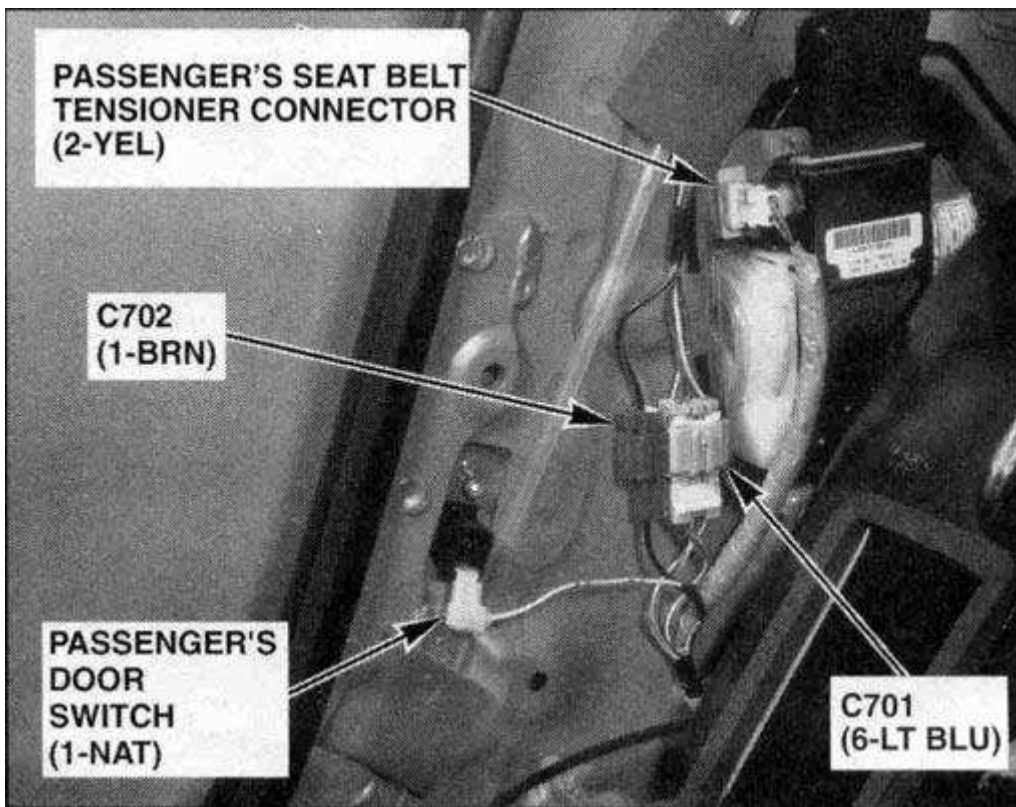
**Fig. 65: Behind Passenger's Seat**

| Noise Condenser Connector | Behind passenger's seat. See <b>Fig. 65</b> . |

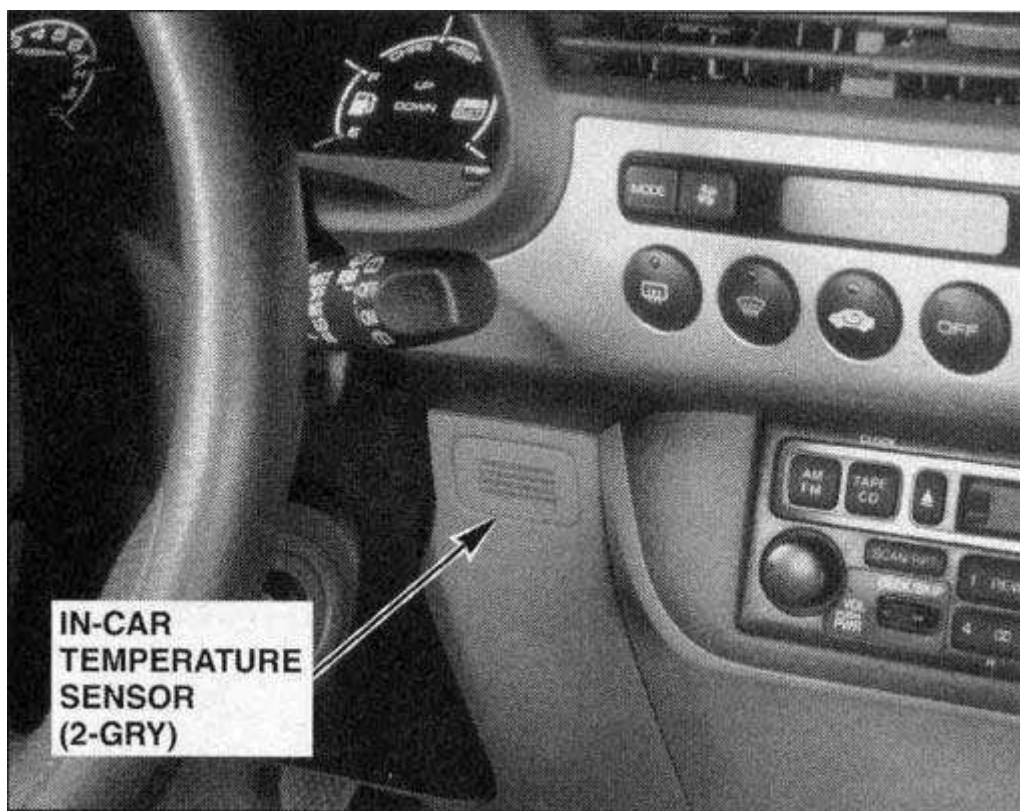
**Fig. 97: Upper Left Kick Panel Area**

| Component | Location |
|---|---|
| A/F Sensor Relay | Behind upper left kick panel. See <b>Fig. 97</b> . |

| <b>Component</b> | <b>Location</b> |
|---|---|
| Under-Dash Fuse/Relay Box | Left end of dash. See <b>Fig. 97 .</b> |
